Summary Progress Report No. 4
For
Repairs for
Square Rigger
Tall Ships Condominium Project
Salem, South Carolina

MCA Architecture, Inc.
Forensics Division
April 11, 2016
MCA Project No. F11705.G

Summary Progress Report

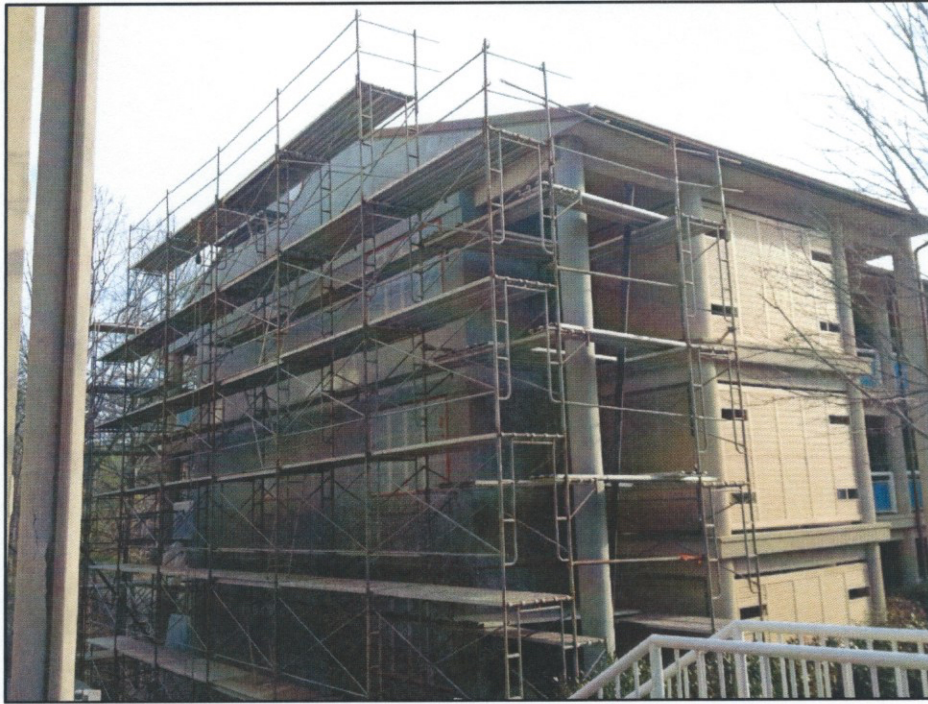
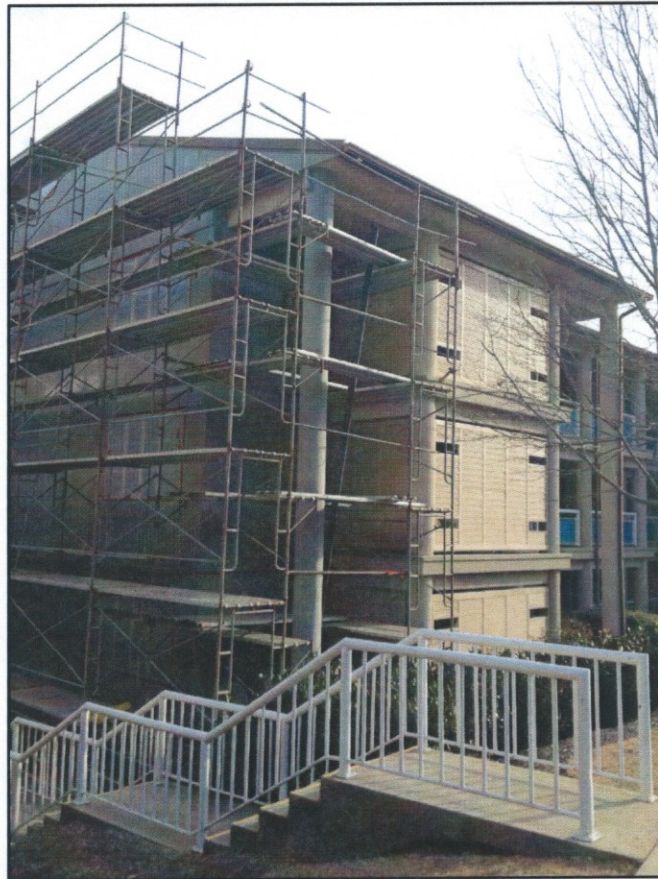
Views taken March 8, 2016

The EIFS base coat application at the west end wall and the tall corner column is in progress.

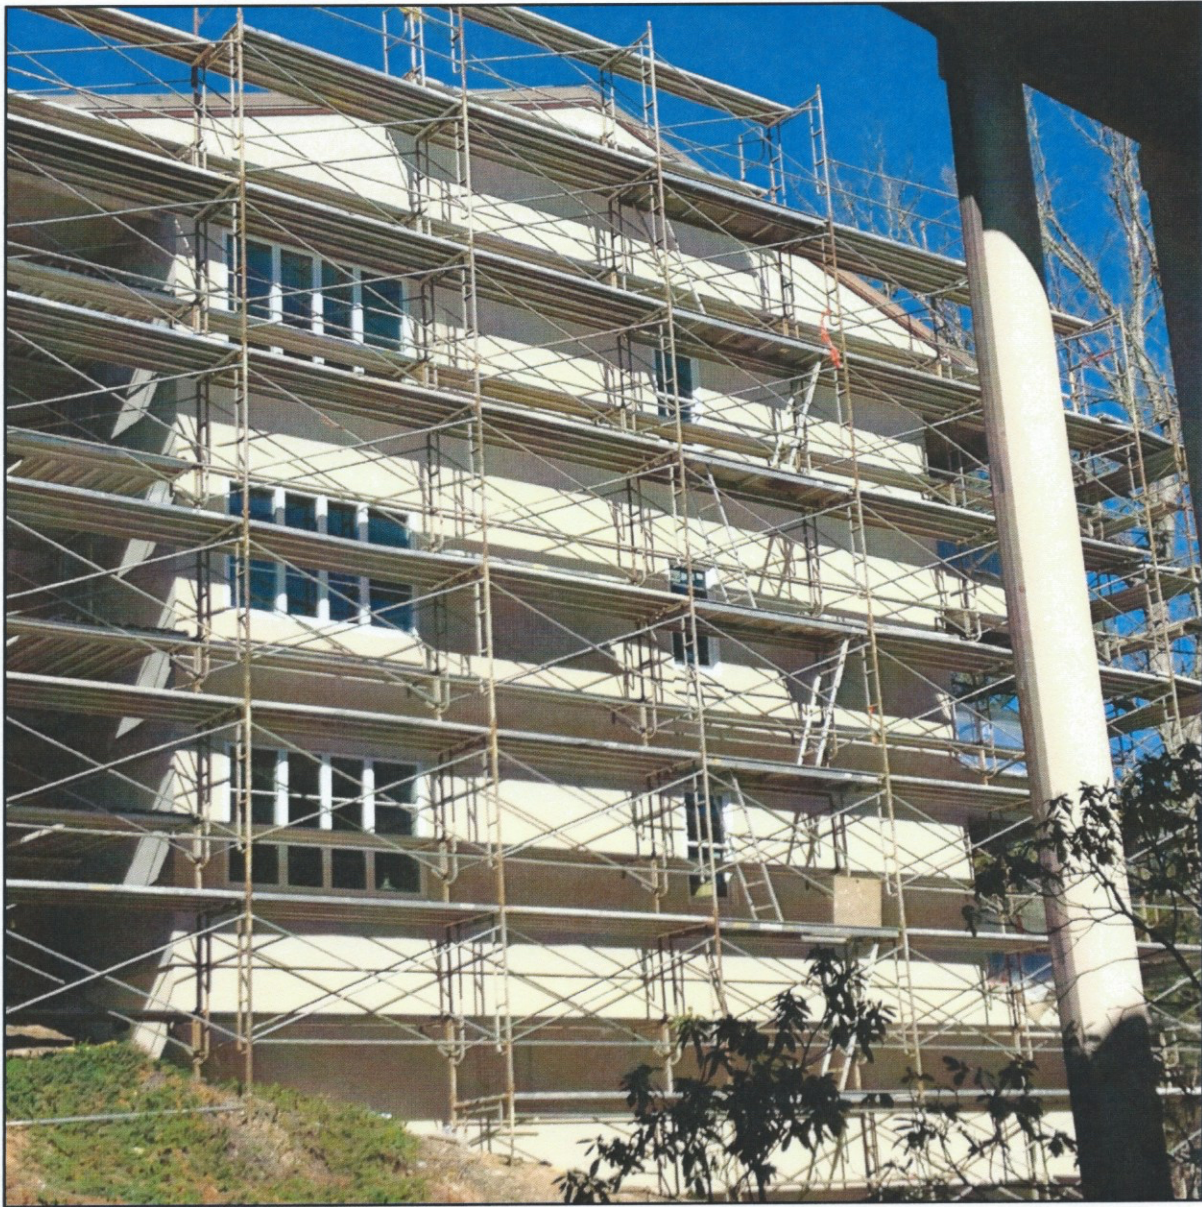
Views taken March 29, 2016

The EIFS finish coat application at the east end wall and the tall corner column is in progress.

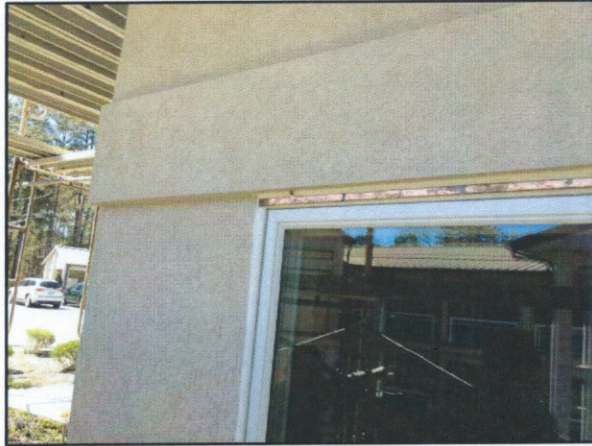
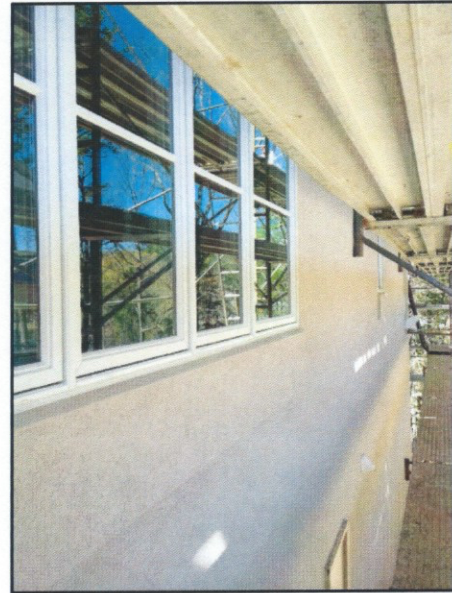
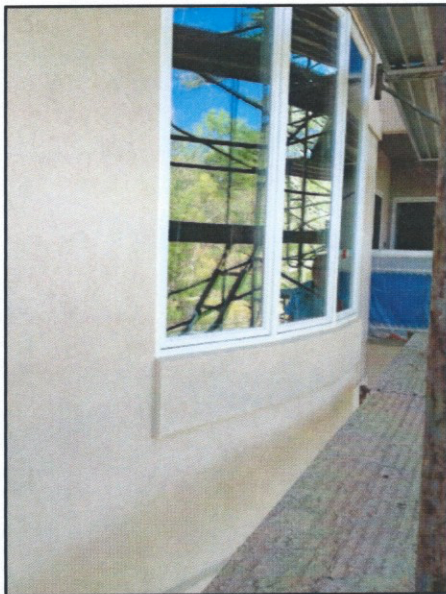
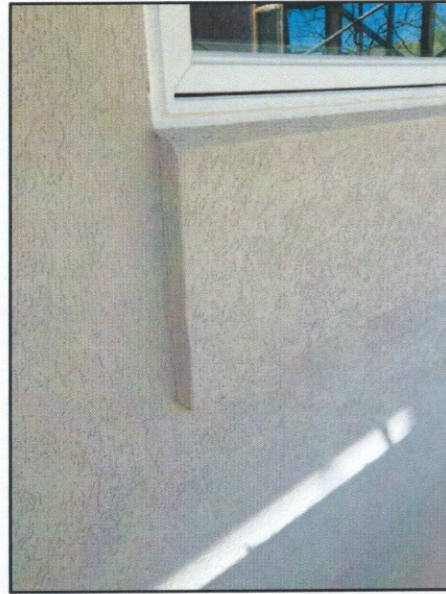
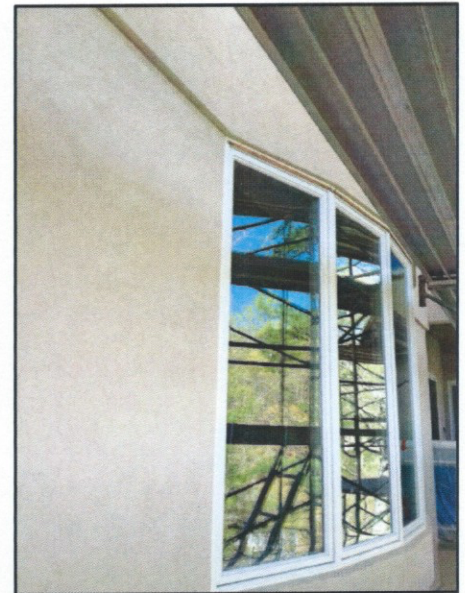
Views taken March 29, 2016

Views of the completed EIFS finish system with copper flashing and sealants applied.

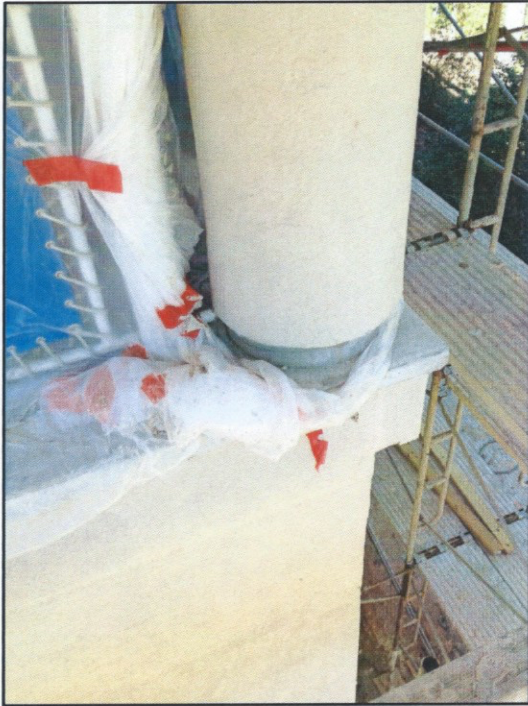
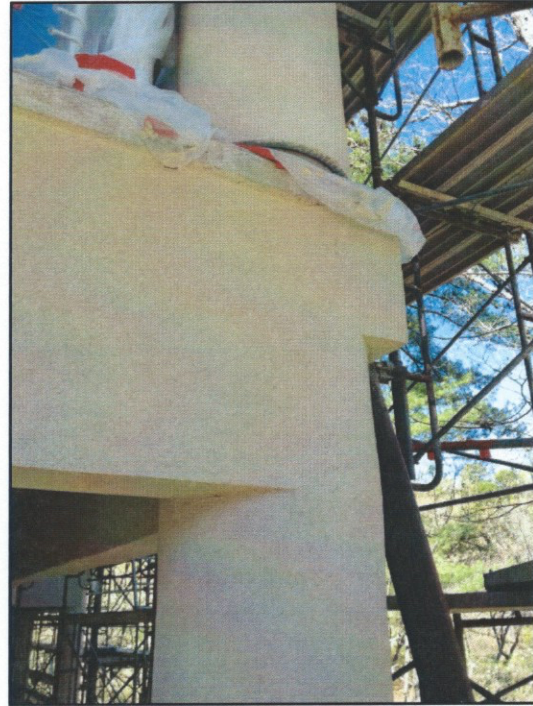
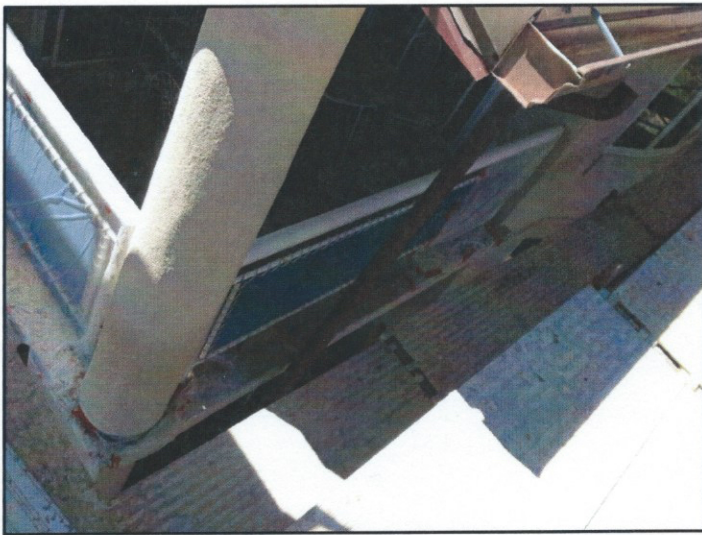
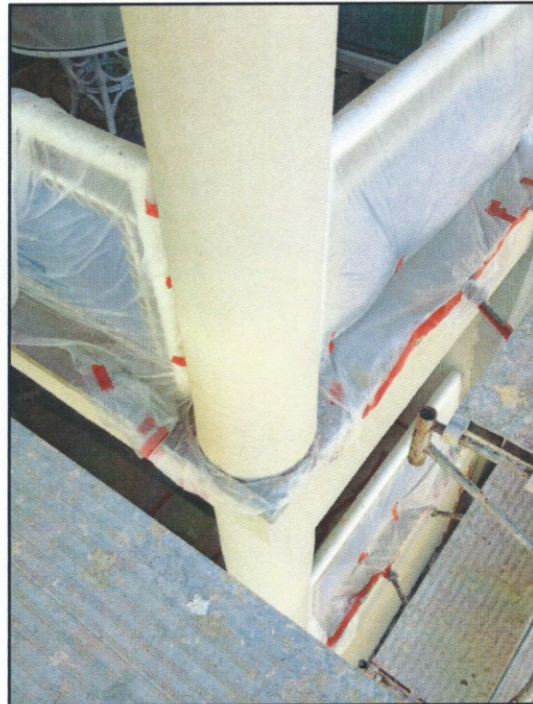
Views taken March 29, 2016

Views of rear porch column work being completed with the urethane deck coating and touch up painting.

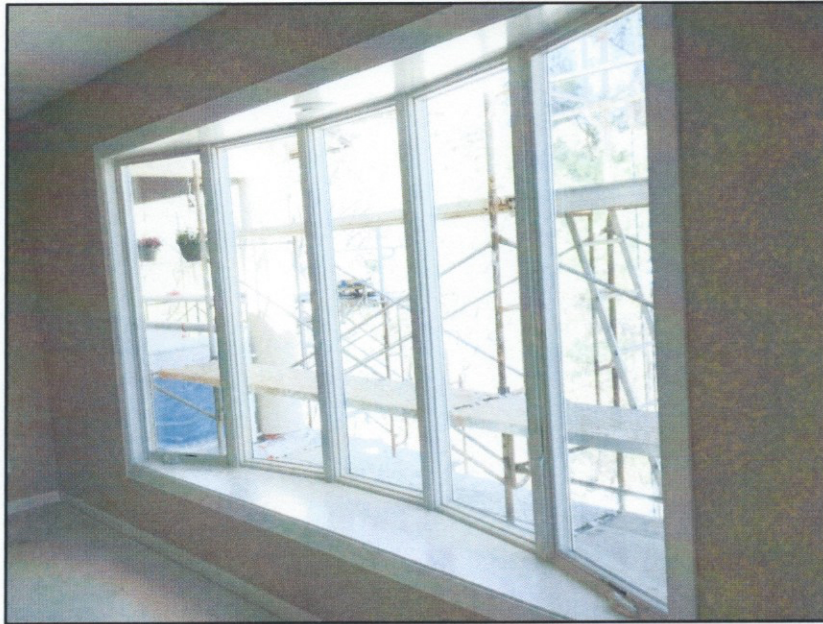
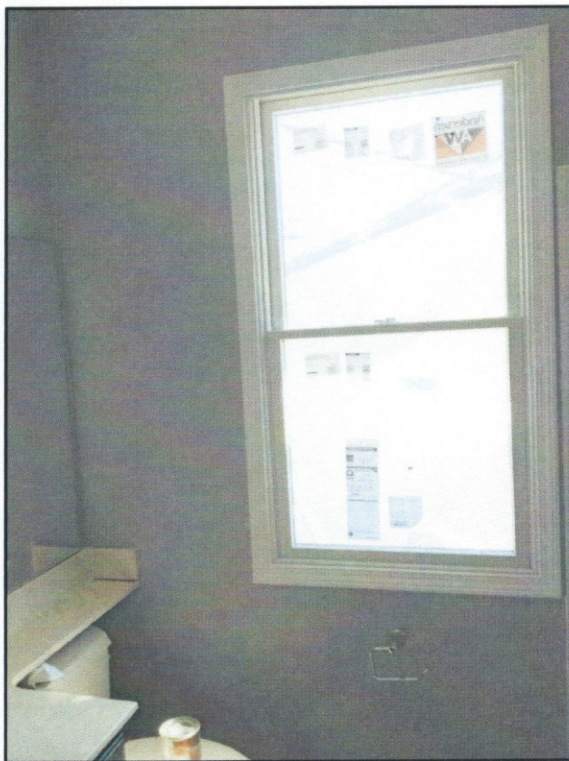
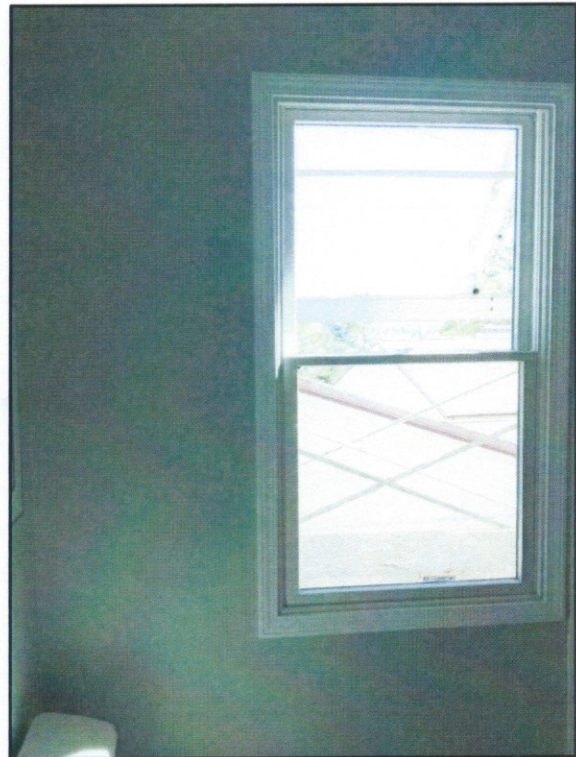
Views taken March 29, 2016

The interior finish work is complete at the bow windows and the bathroom windows.

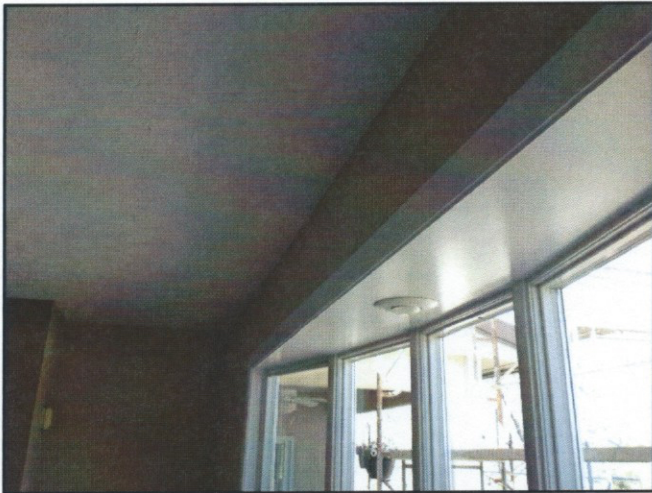
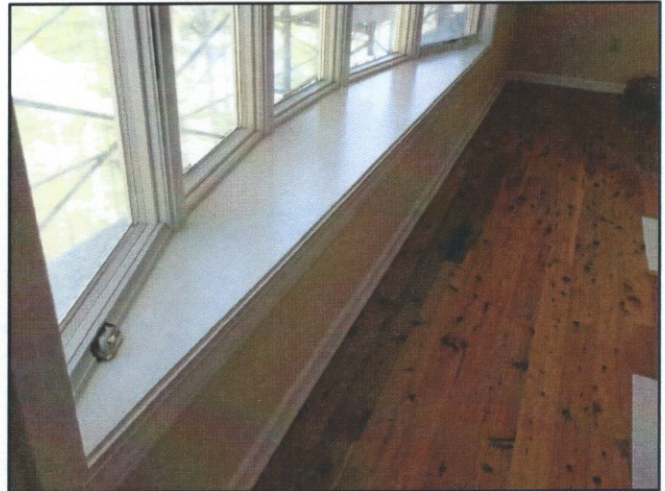
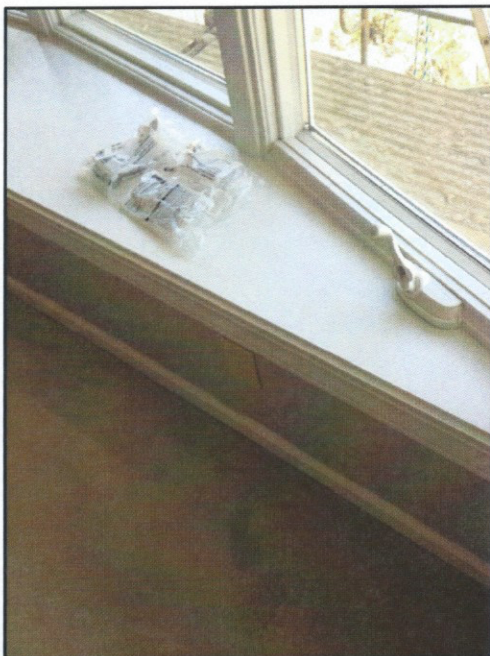
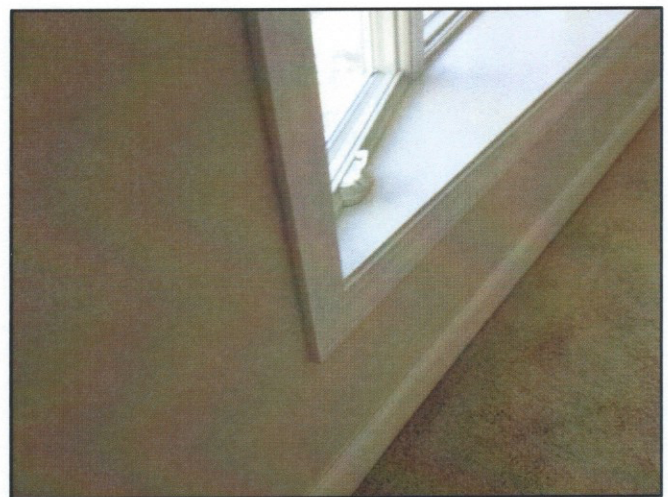
Views taken March 29, 2016

The interior finish work is complete at the bow windows. Window opening restrictor hardware is being installed.

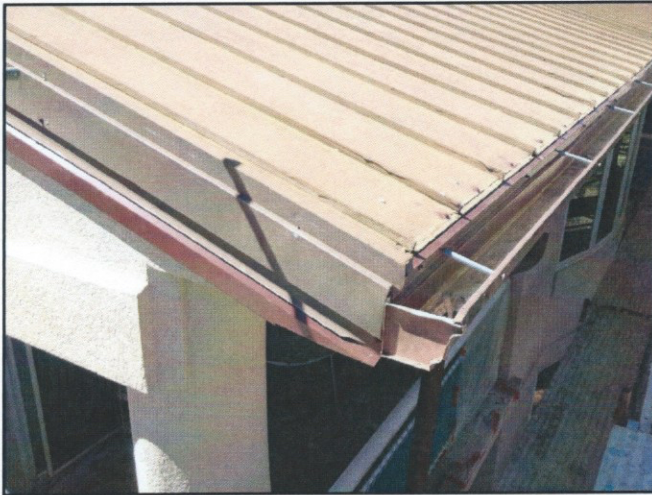
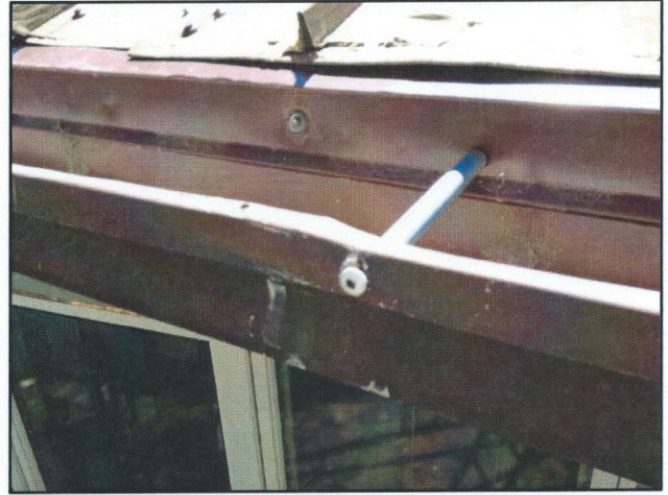
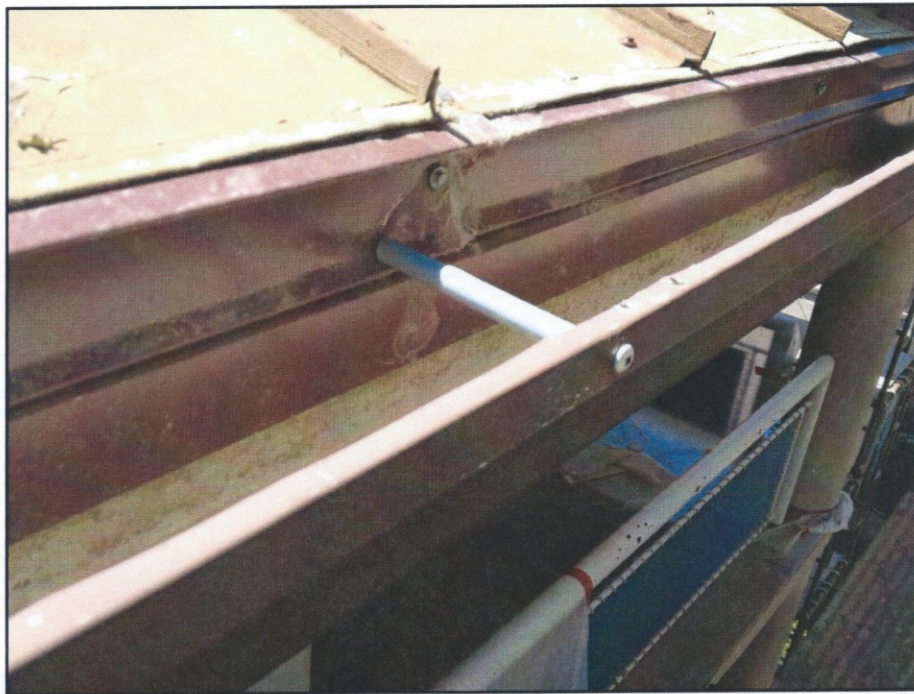
Views taken March 29, 2016

Views of new drip flashing and gutter screw attachments at eaves is complete.

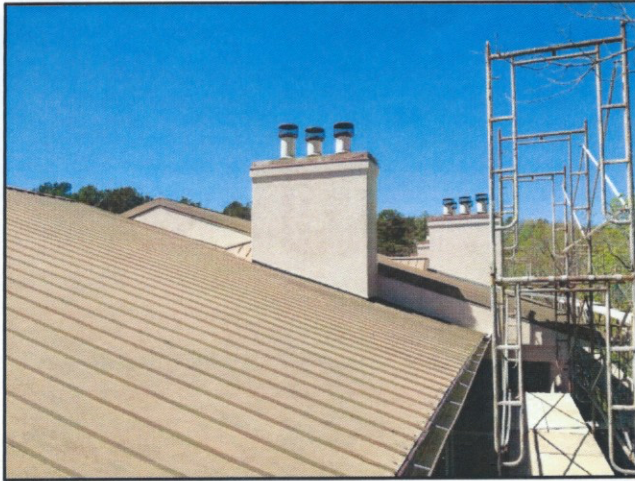
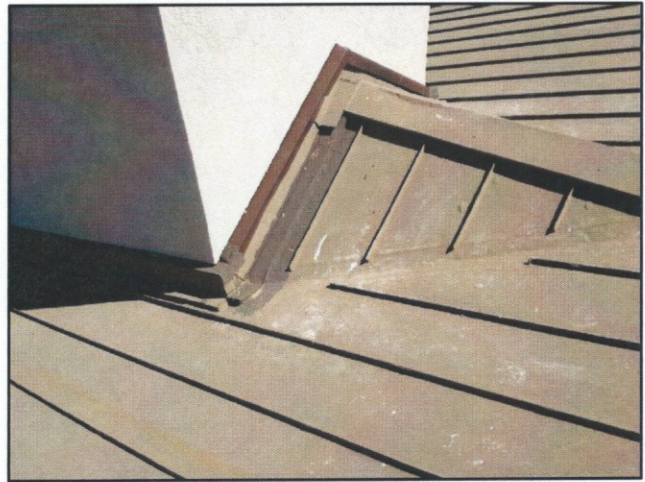
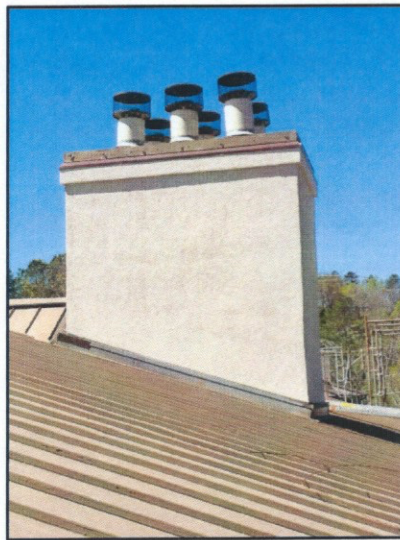
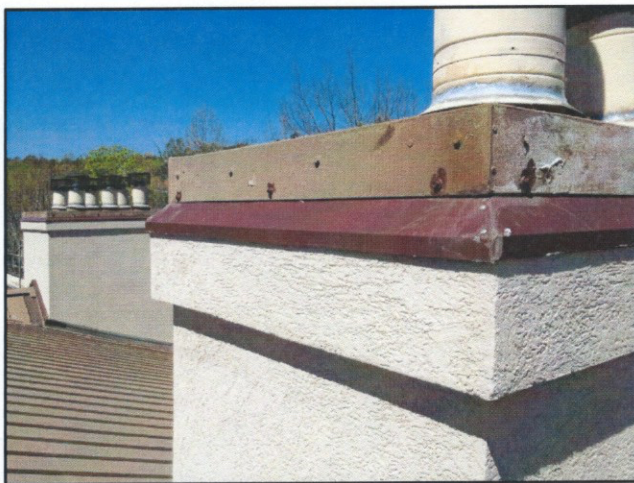
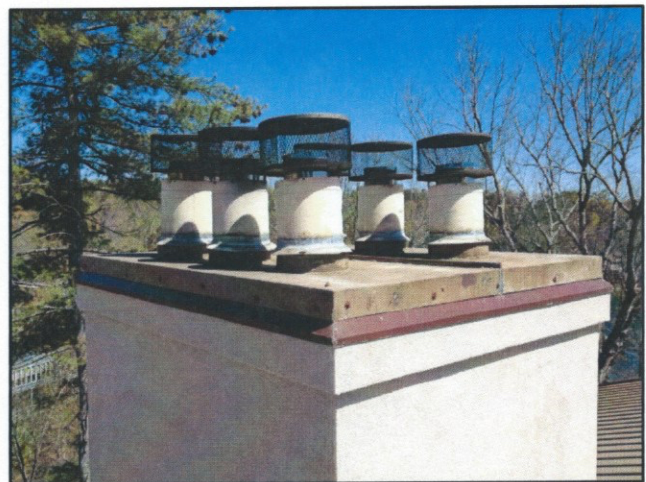
Views taken March 29, 2016

Views of new drip flashing and counter flashing with new EIFS finish system at the chimneys is complete.
