Summary Progress Report No. 4
For
Repairs for
Cutter
Tall Ships Condominium Project
Salem, South Carolina

MCA Architecture, Inc.
Forensics Division
August 9, 2016
MCA Project No. F11705.H

Project Facts

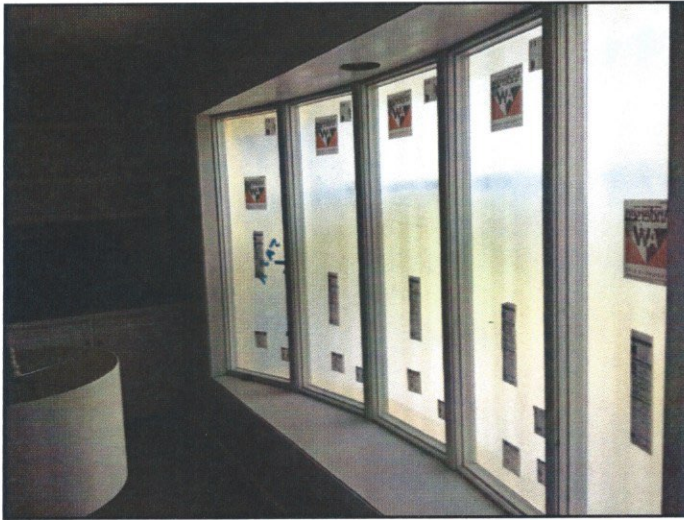
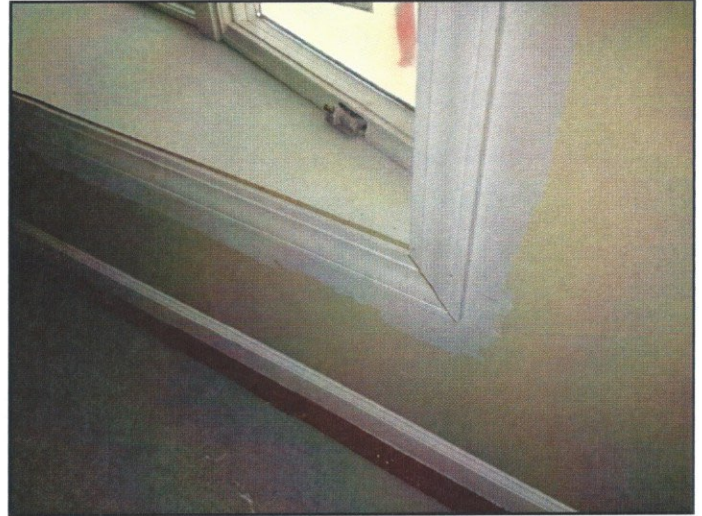
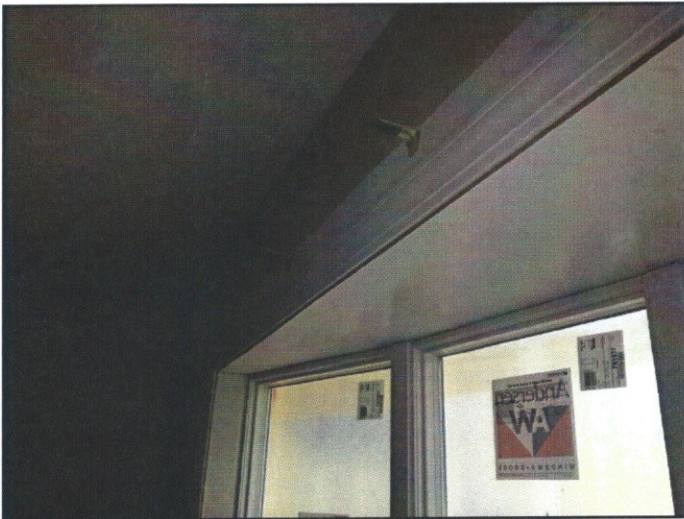
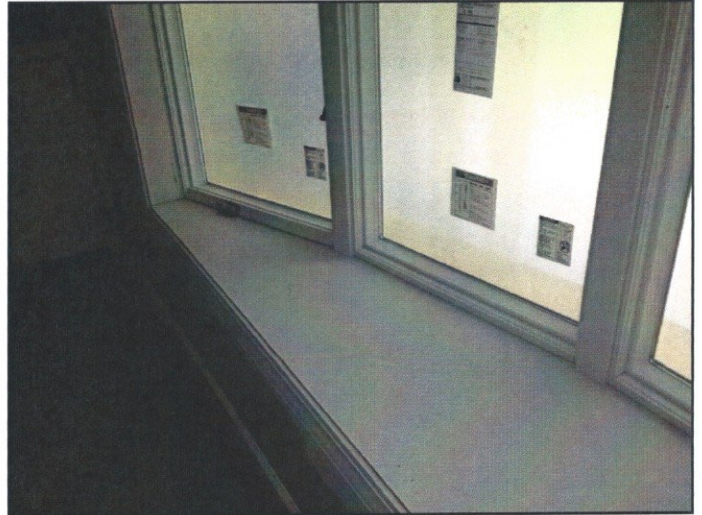
Views taken July 12, 2016.

Views of new bow windows being installed with new head and seat boards.
New trim installation is in progress.

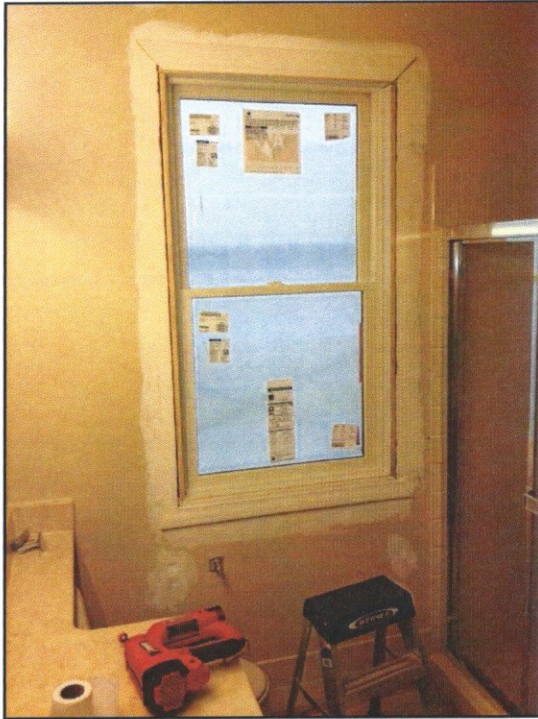
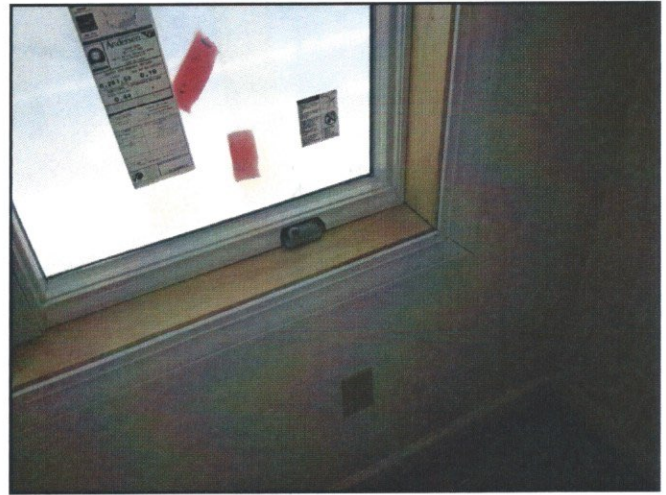
Views taken July 12, 2016.

Views of new bathroom windows being installed. New trim installation is in progress.

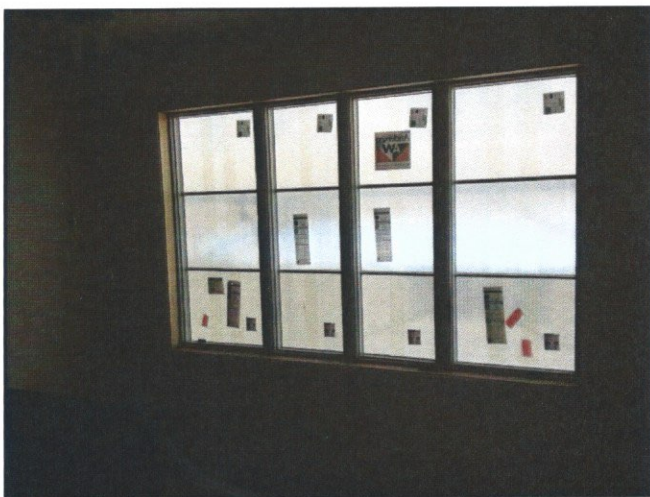
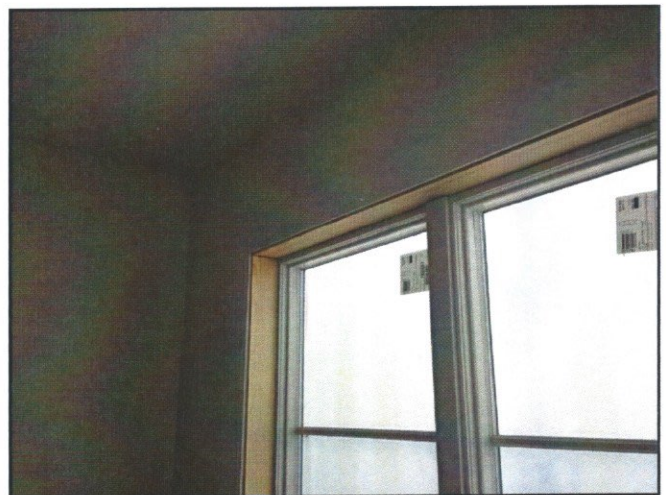
Views of new bedroom windows at end walls being installed. New trim installation is in progress.

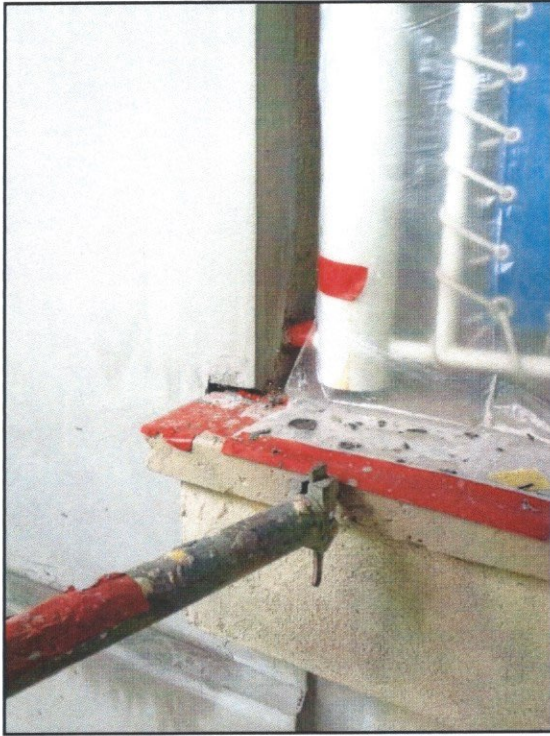
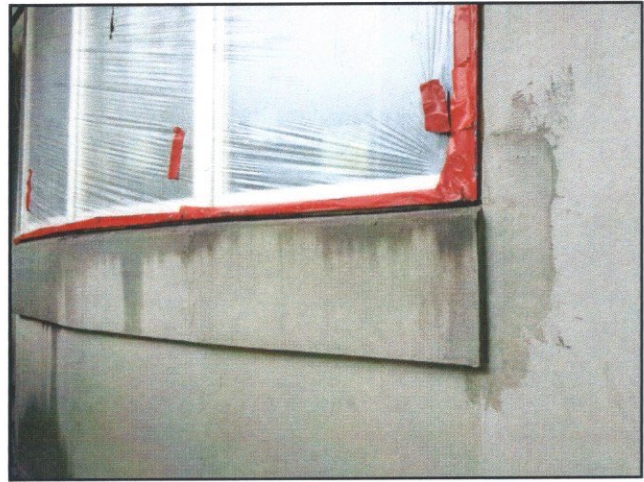
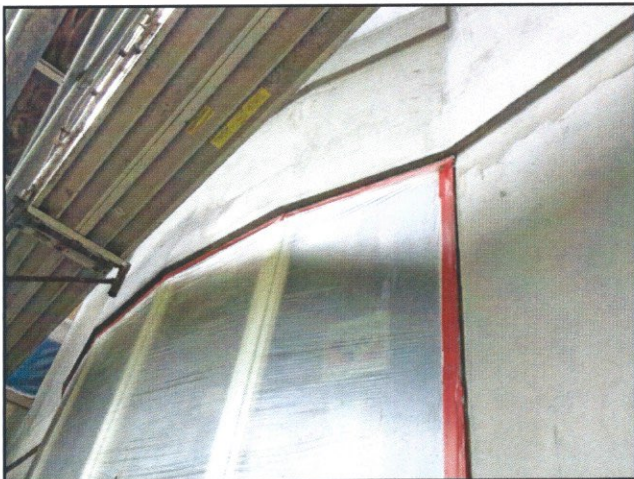
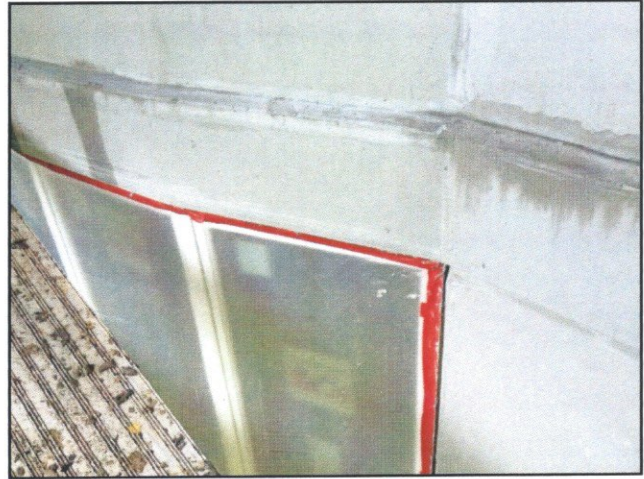
Views taken July 12, 2016.

Views of new EIFS base coat application with accent banding in progress.

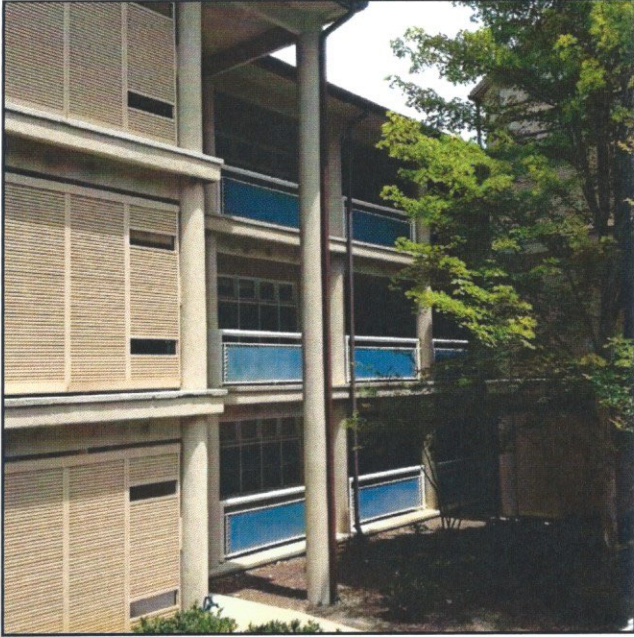
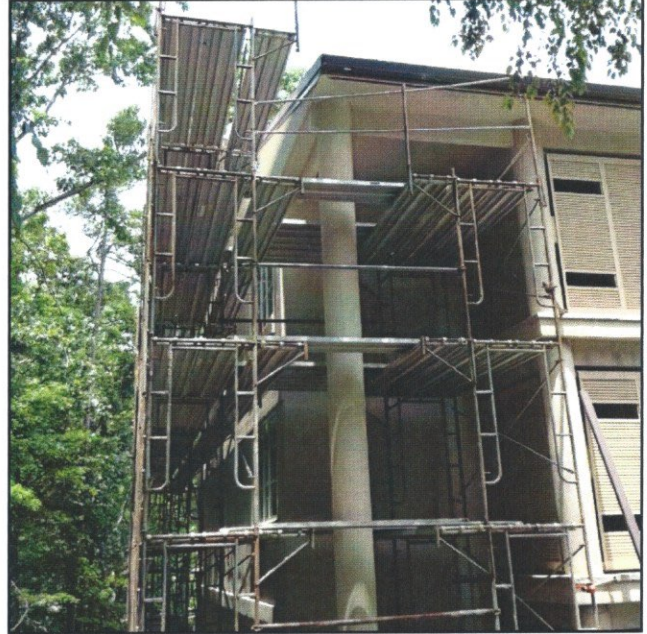
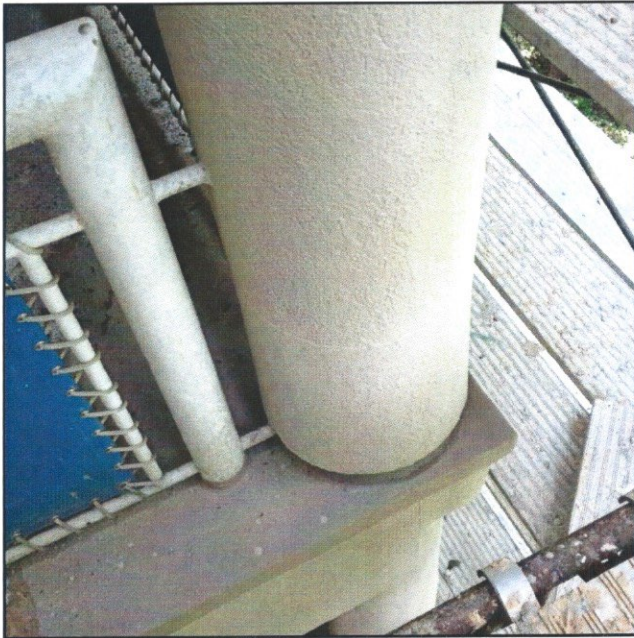
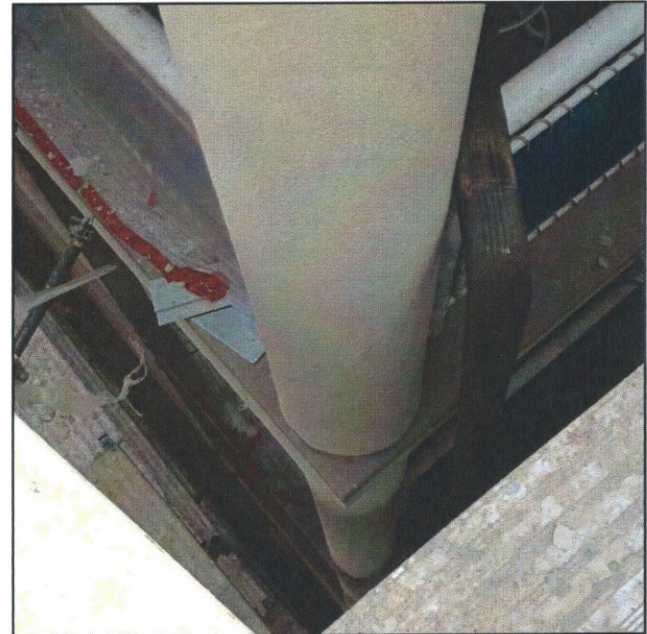
Views taken July 21, 2016.

Views of repaired tall columns at front and rear unit porch columns.

At the rear porch column work the framing has been repaired to assure structural load path is maintained floor to floor. Some columns required major rot replacement. Others were not rotted. The framing work is complete at all porch columns and the new concrete floor and curb has been poured. The urethane floor coating has been applied around the column.

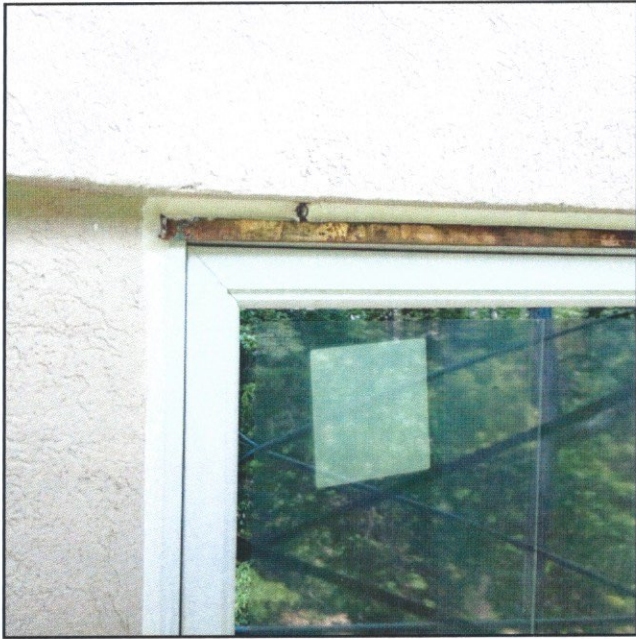
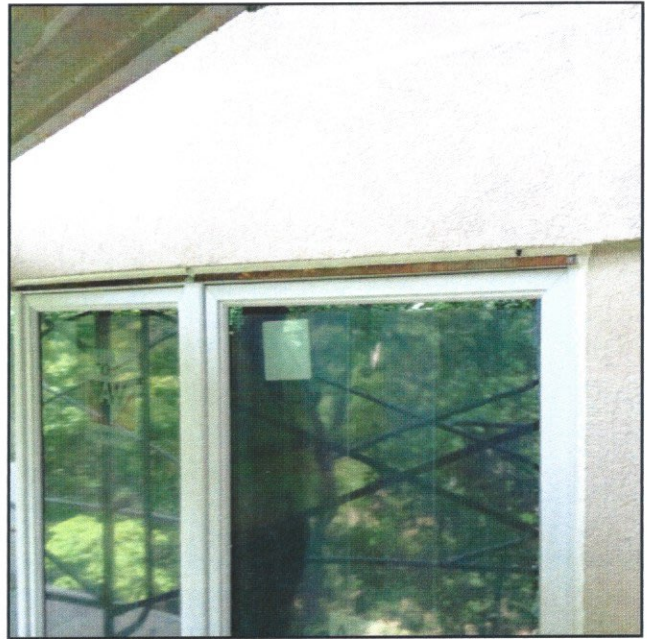
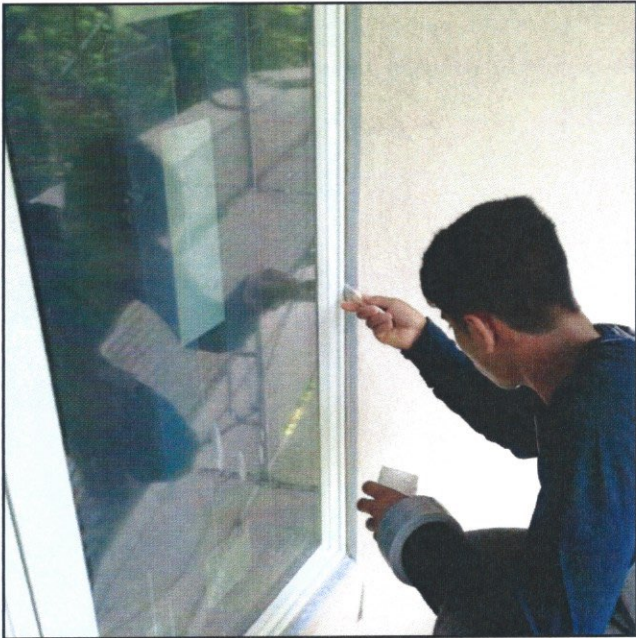
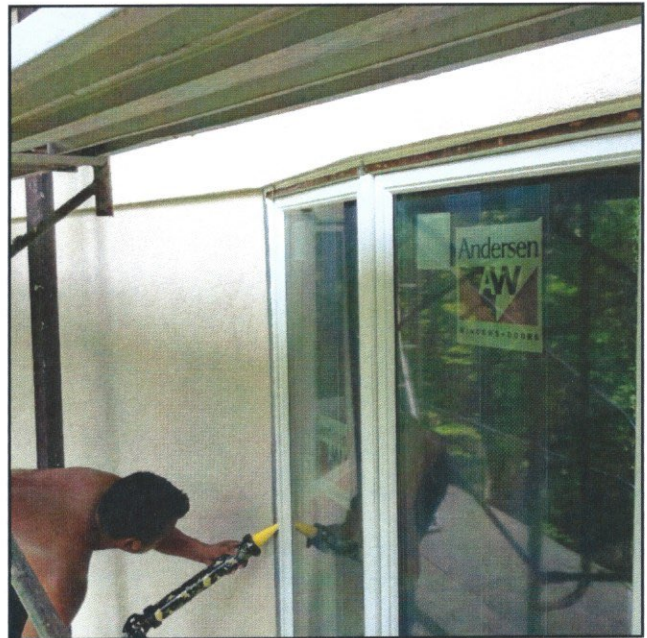
Views taken July 21, 2016.

Views of installed copper flashings, joint backer rod application and final sealant application.

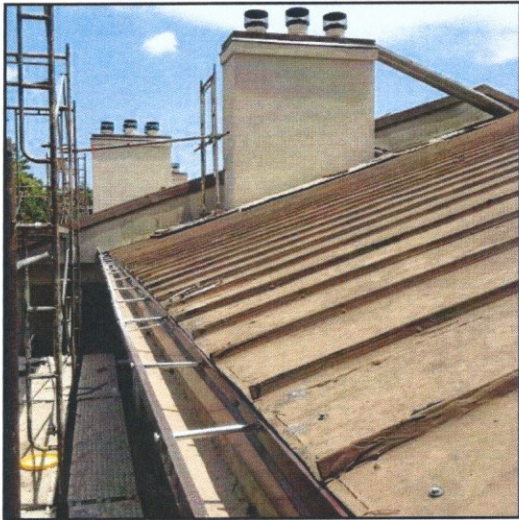
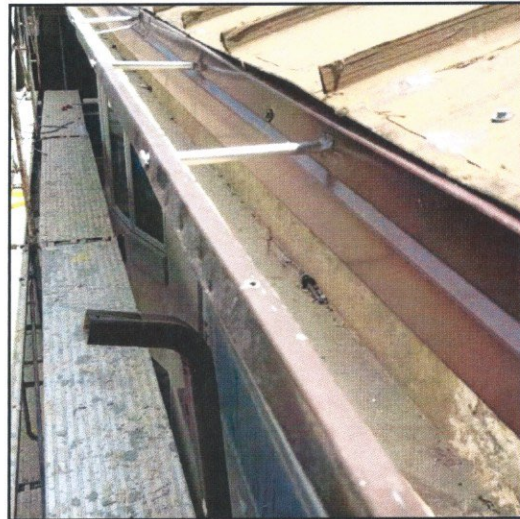
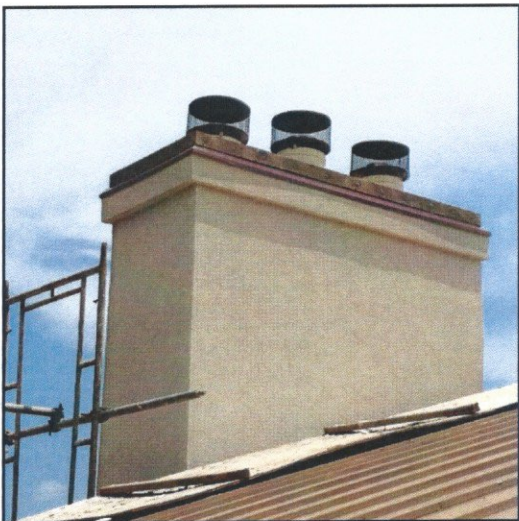
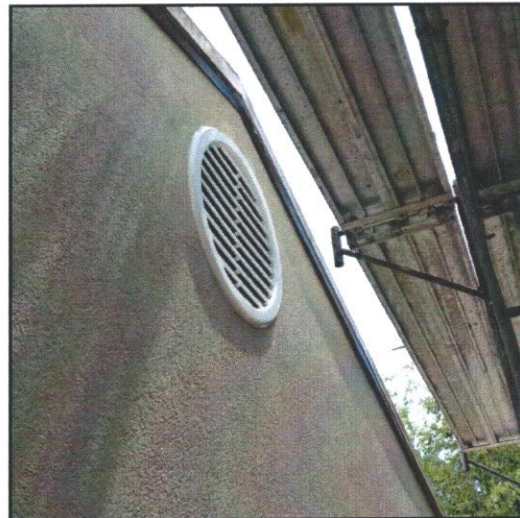
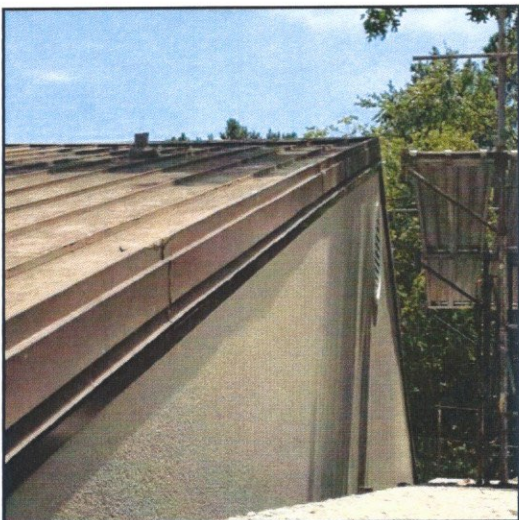
Views taken July 21, 2016.

Views of repaired chimneys, installed aluminum flashing at roof eaves and new gutter straps. A new vinyl circular louver has been installed replacing the existing wood louvers.

The repair work at the chimneys is complete.

The repair work at the fascia and gutter eaves is complete.

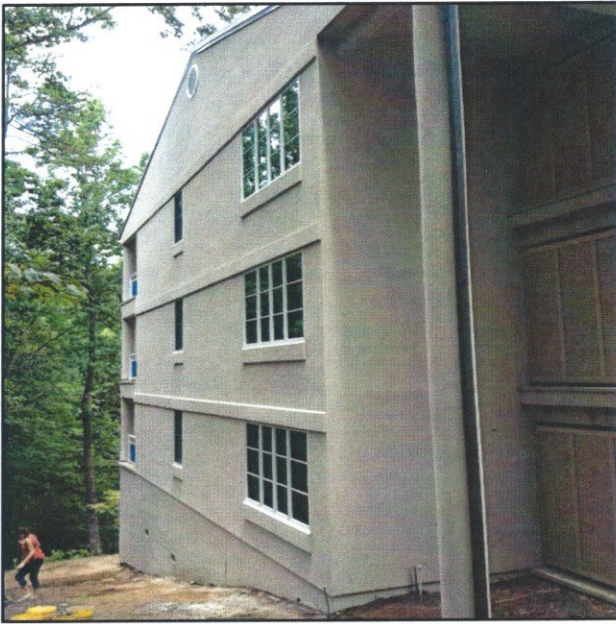
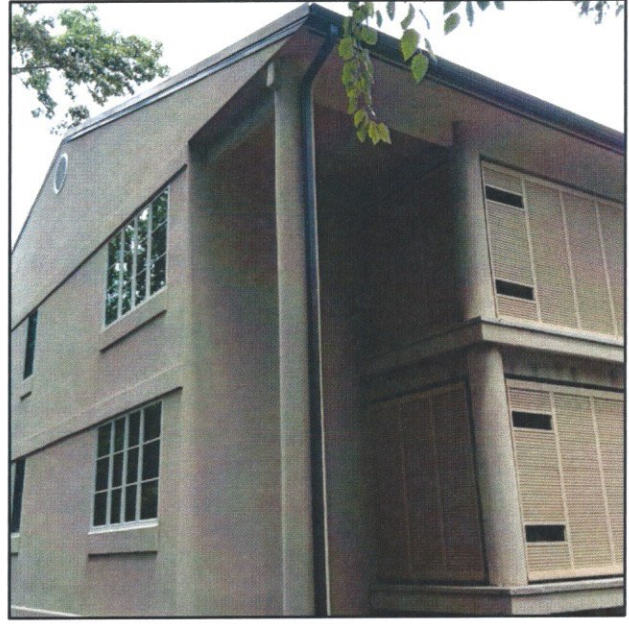
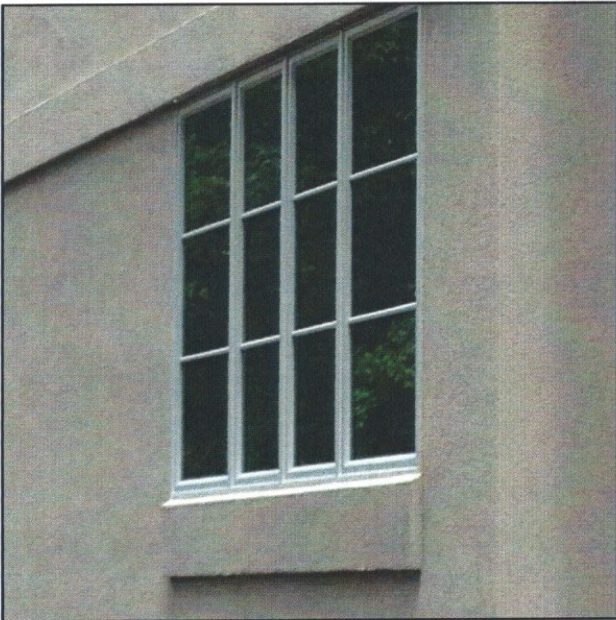
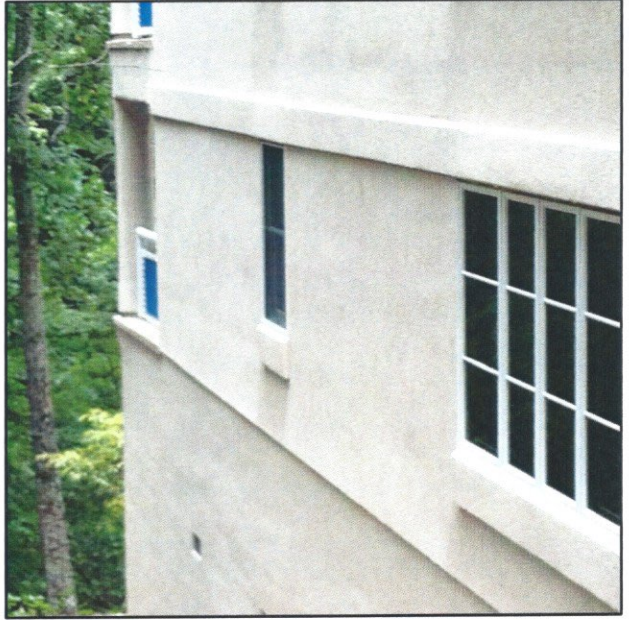
Views taken August 4, 2016.

View of finished work at west end wall.

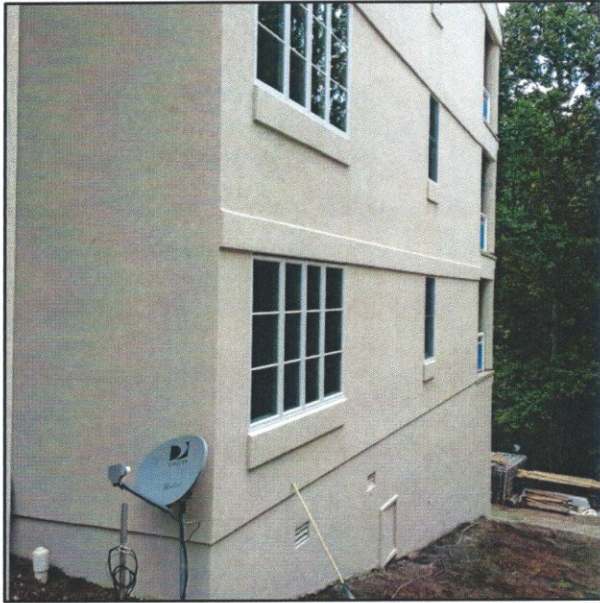
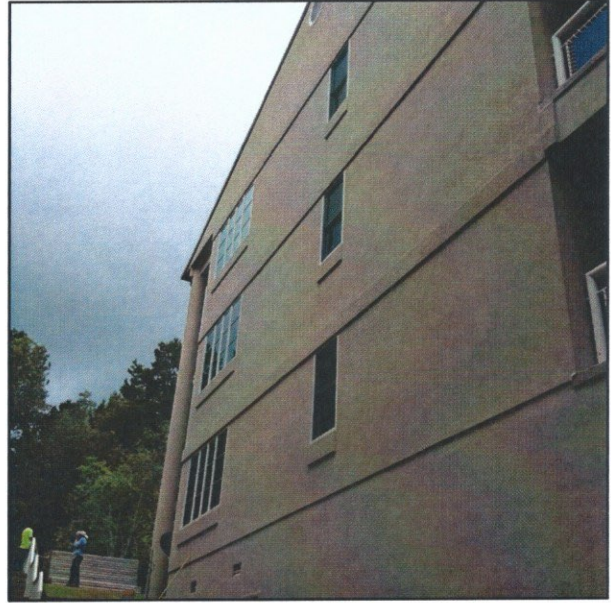
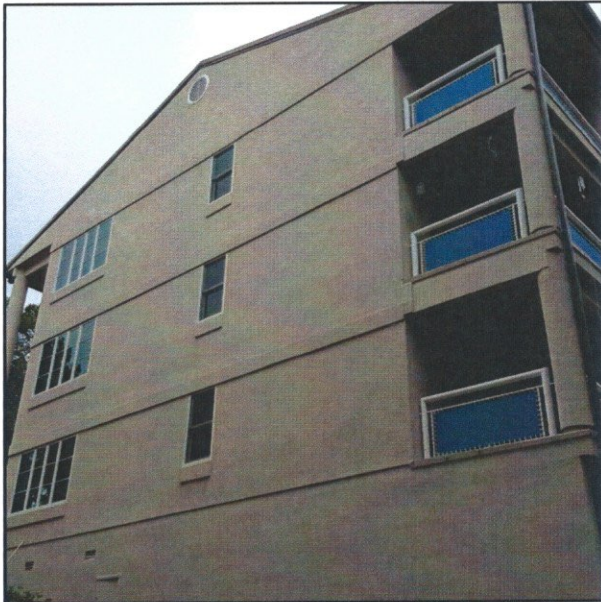
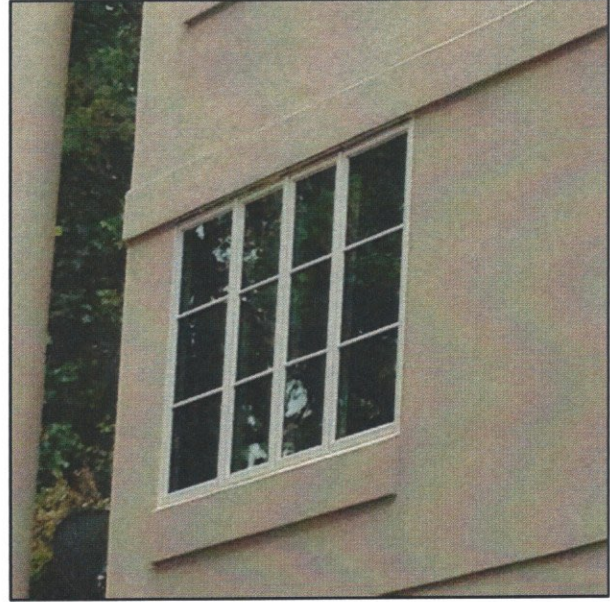
Views taken August 4, 2016.

Views of finished work at east end wall.

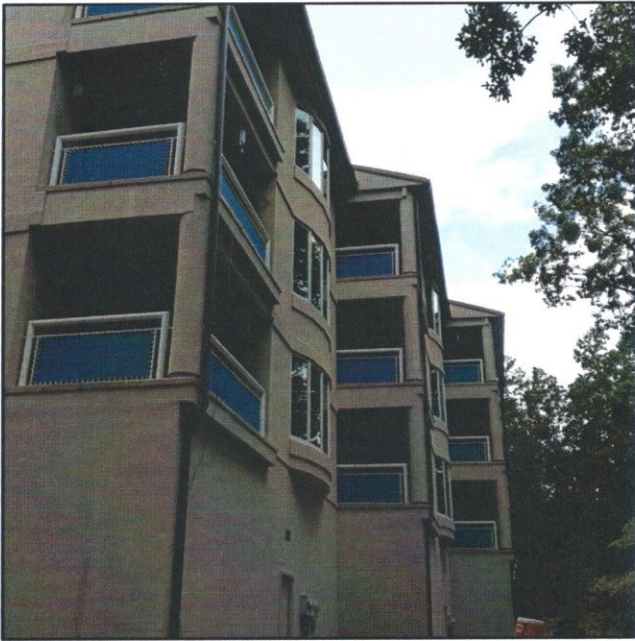
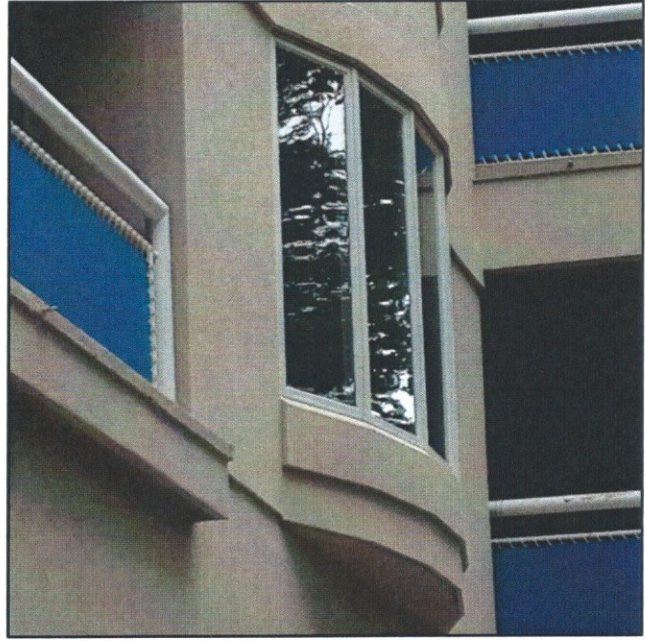
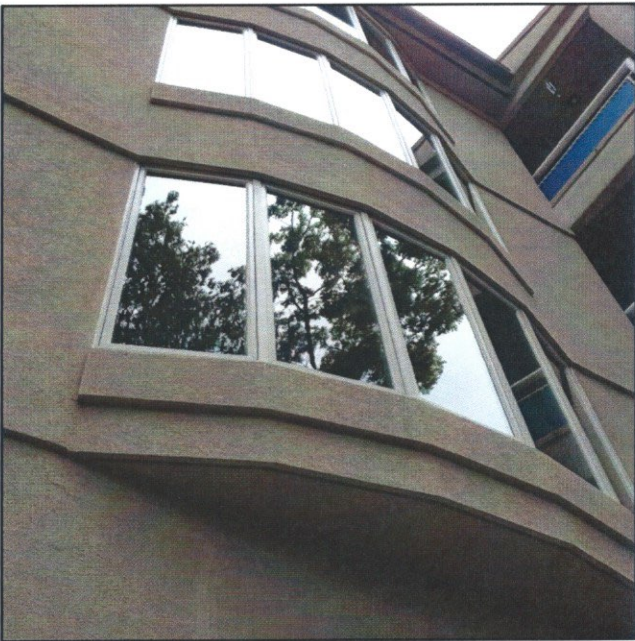
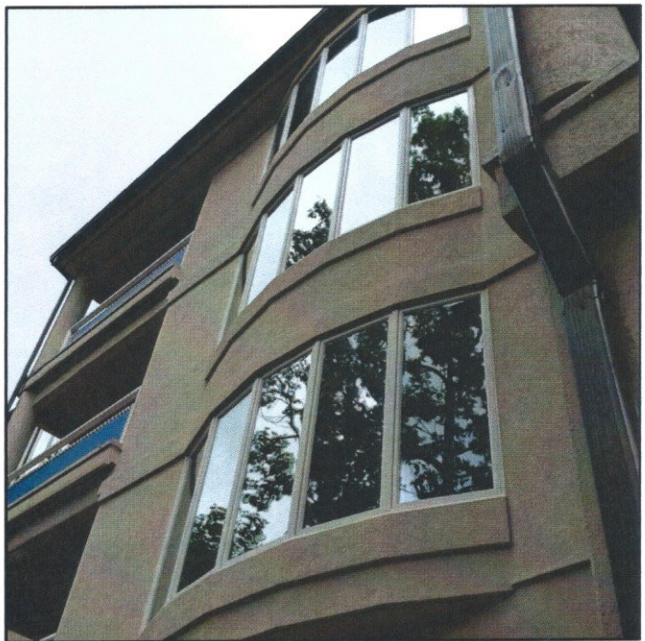
Views taken August 4, 2016.

Views of finished work at bow windows and private porches at rear north wall.

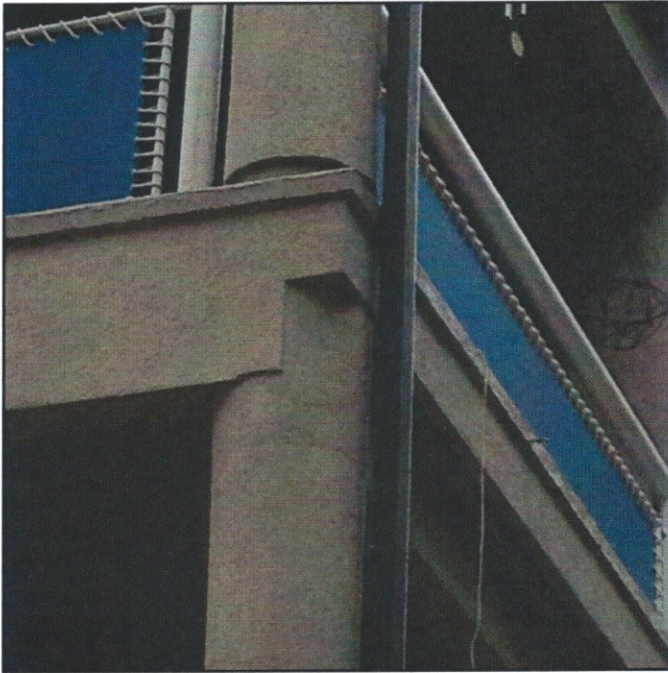
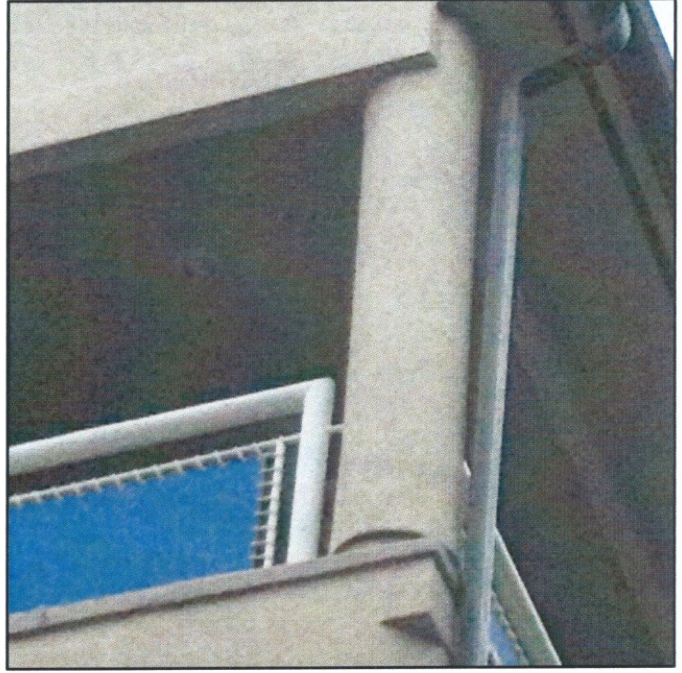
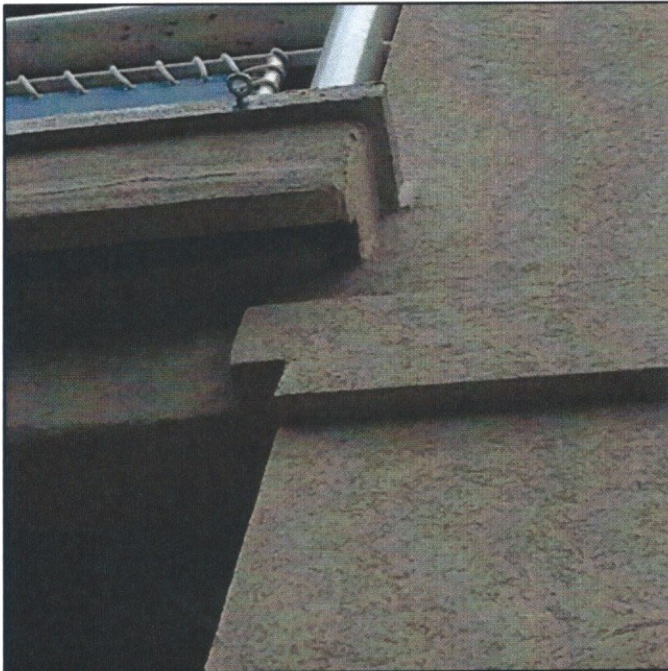
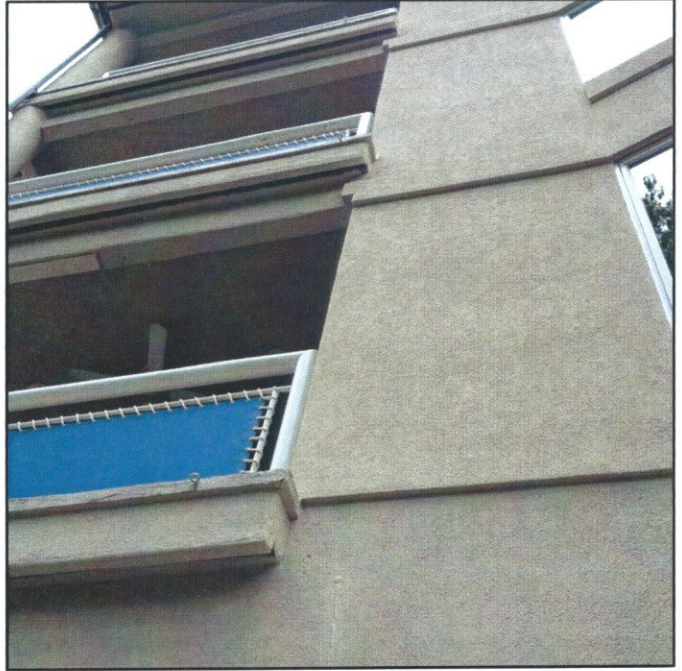
Views taken August 4, 2016.

Views of finish work at Unit rear porches and corner columns.

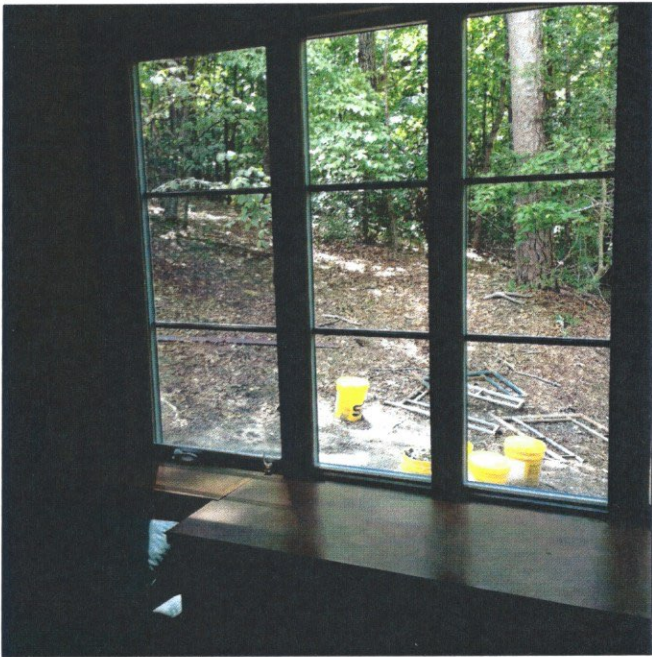
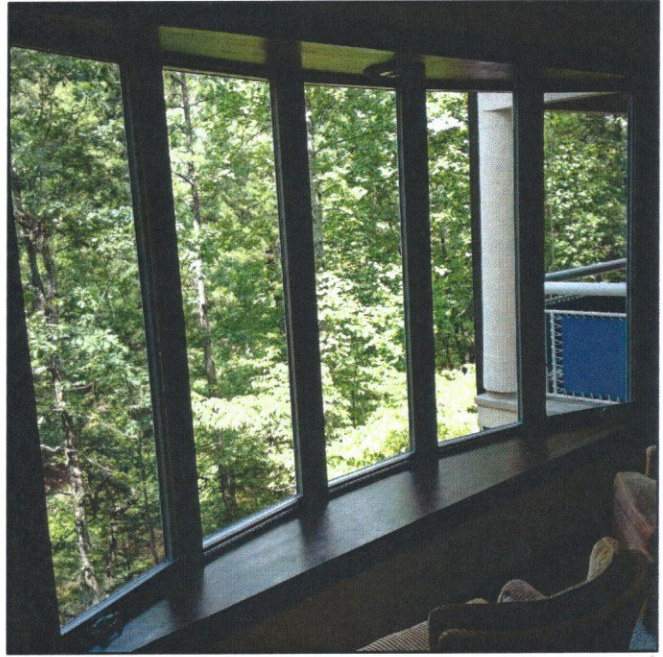
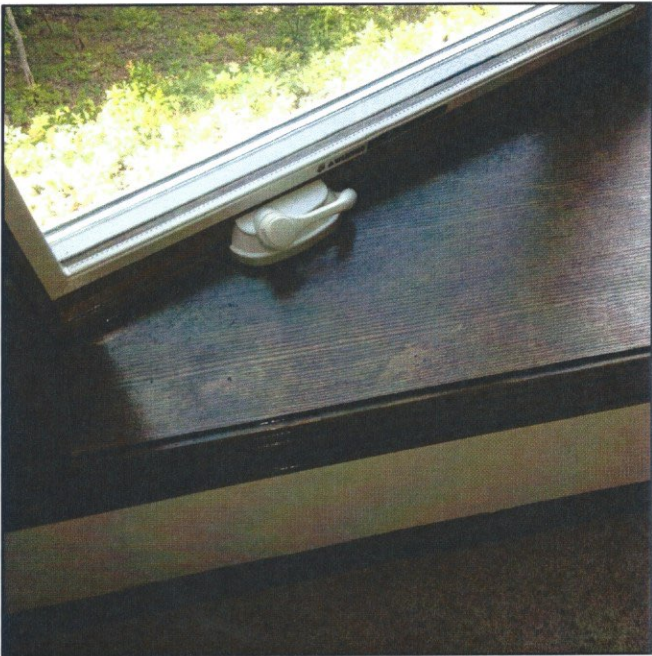
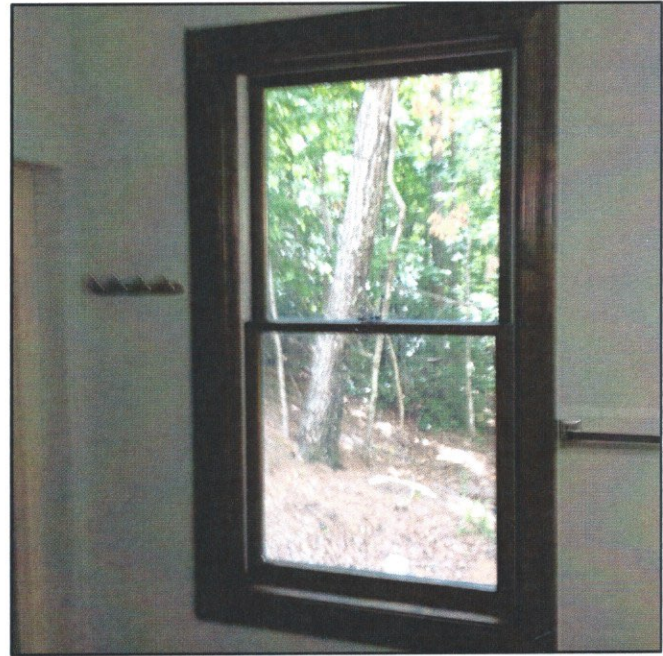
Views taken August 4, 2016.

Views of completed interior finish work at Unit 121 windows with natural wood finish.

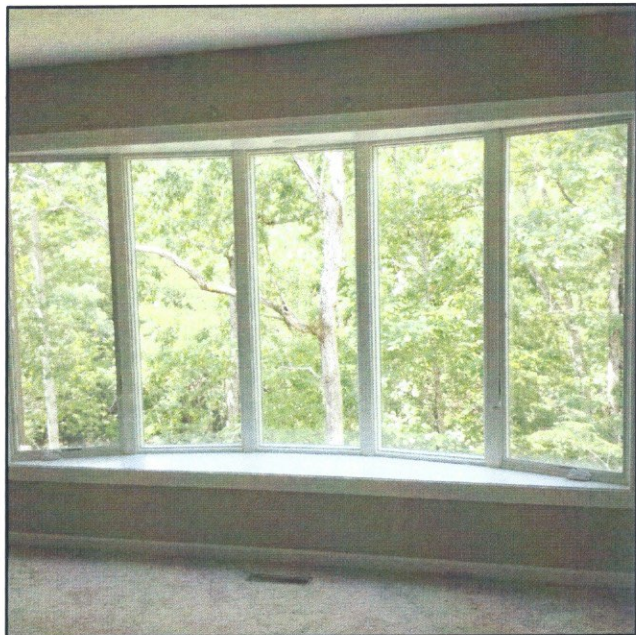
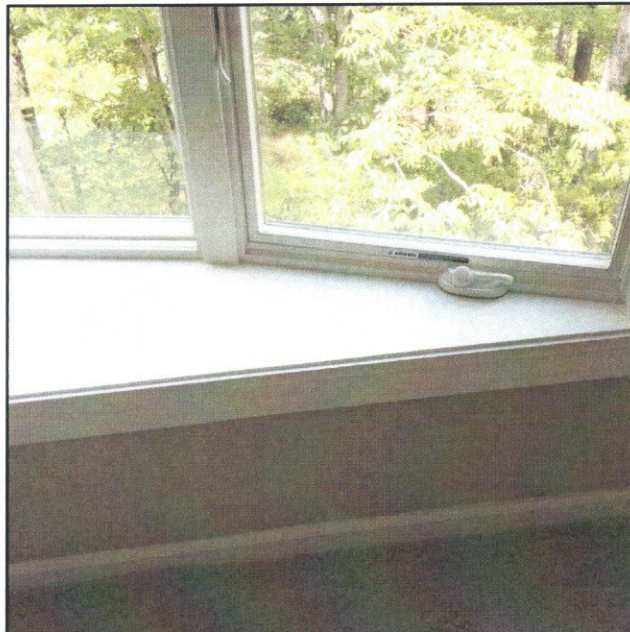
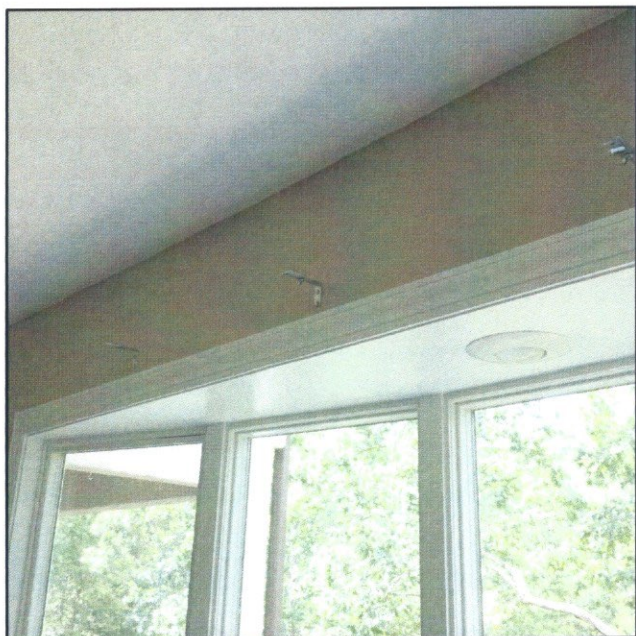
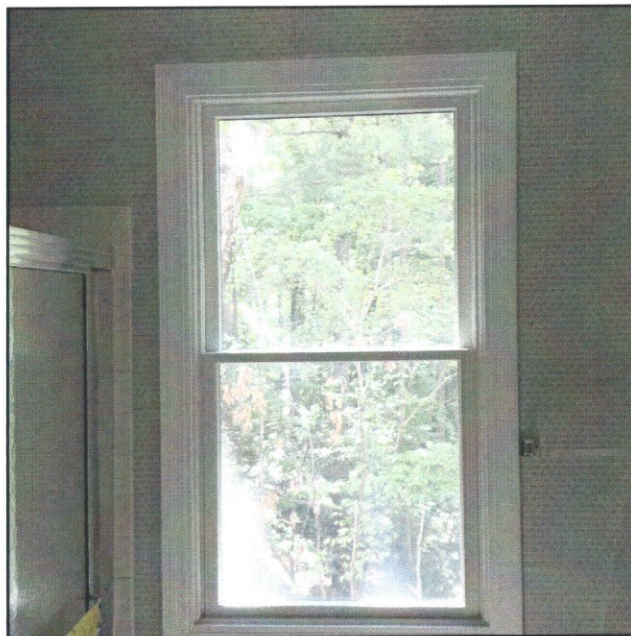
Views taken August 4, 2016.

Views of completed interior finish work at typical Unit windows with painted finish.

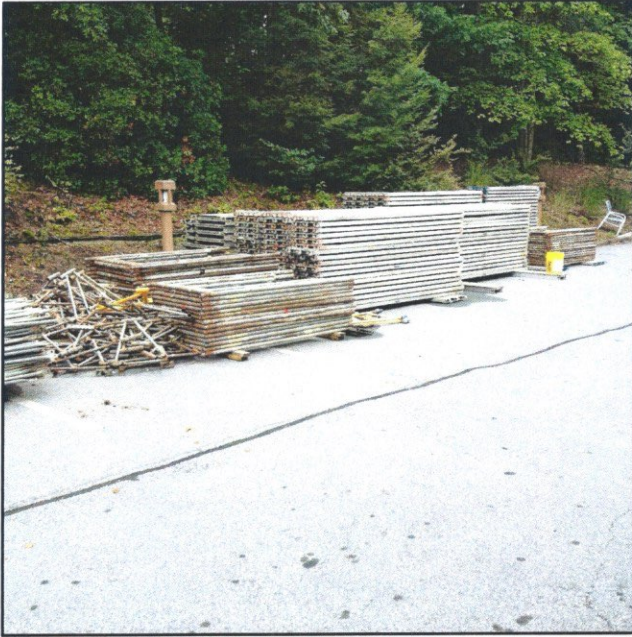
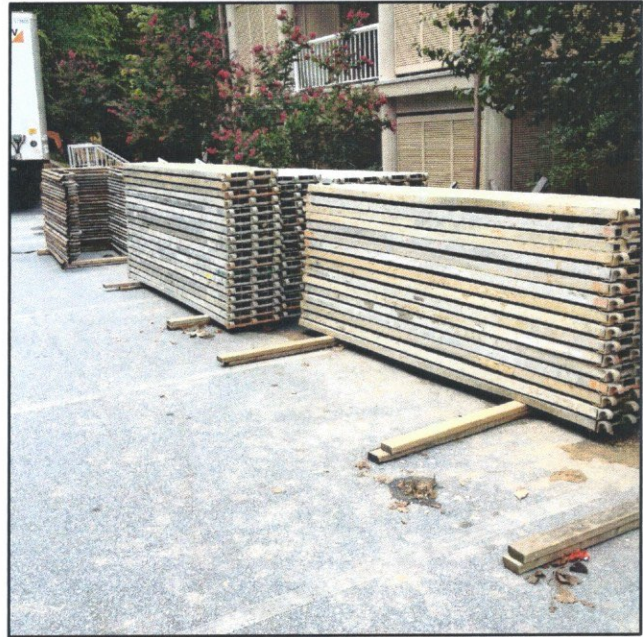
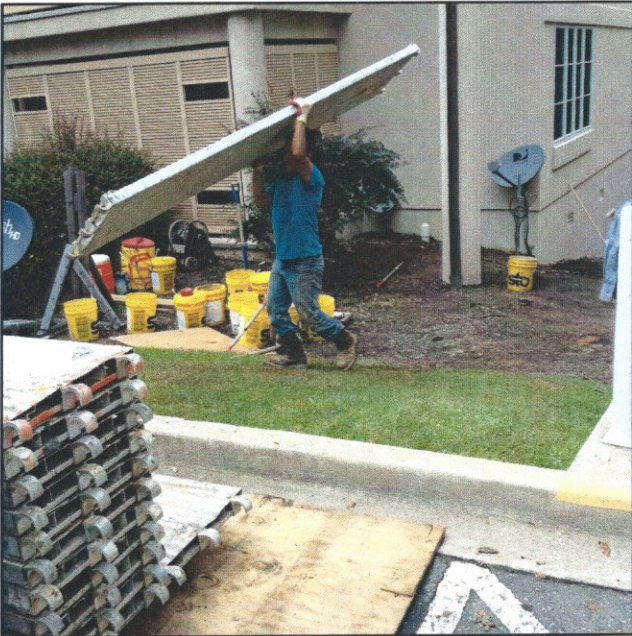
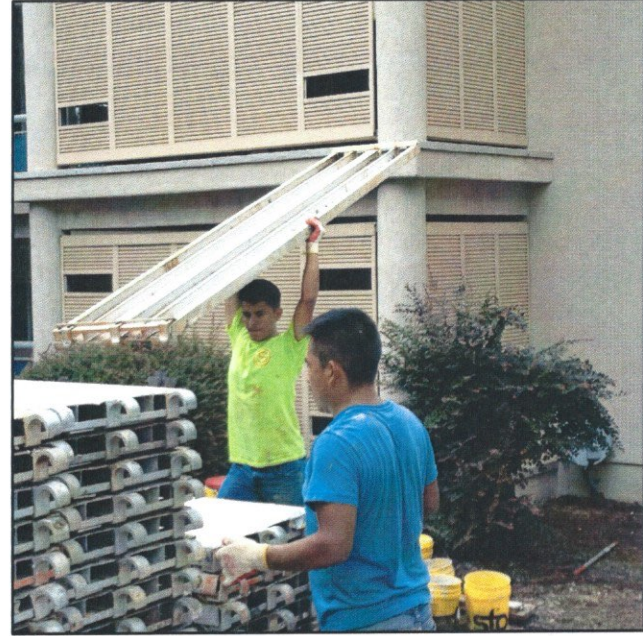
Views taken August 4, 2016.

Scaffolding has been removed. Views of scaffolding stacks ready for shipment to leave the Tall Ship Property.
