Summary Progress Report No. 2
For
Repairs for
Cutter
Tall Ships Condominium Project
Salem, South Carolina

MCA Architecture, Inc.
Forensics Division
June 13, 2016
MCA Project No. F11705.H

1. Summary Progress Report No. 2
 2. Supporting Photographs
 3. Application for Payment No. 2
 4. MCA Invoice No. 3
-

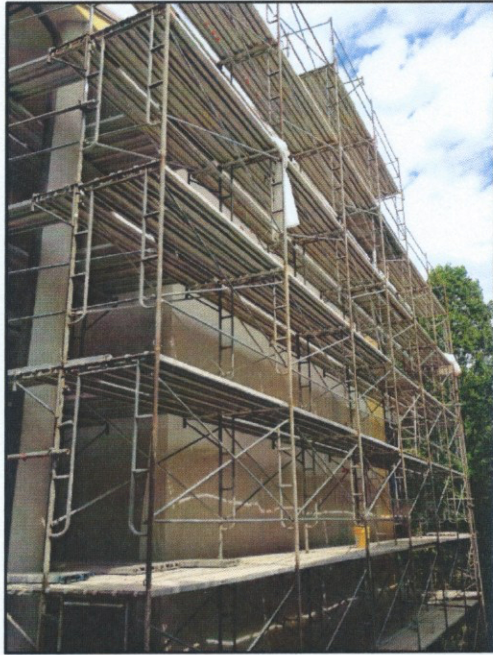
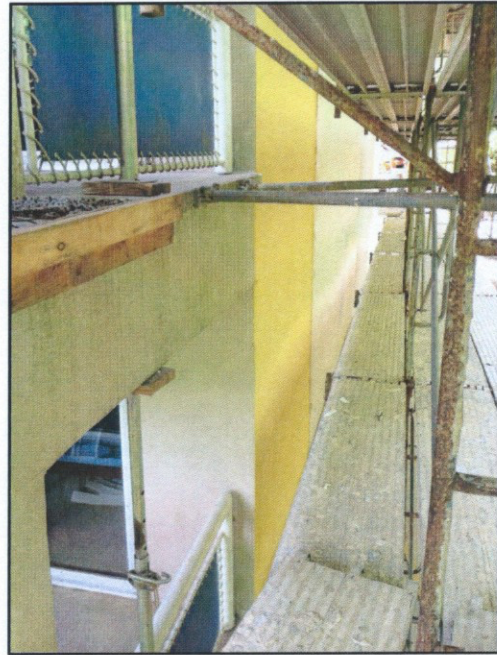
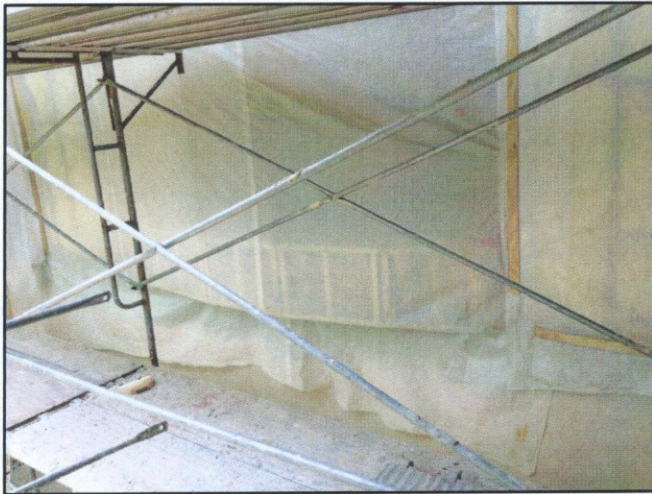
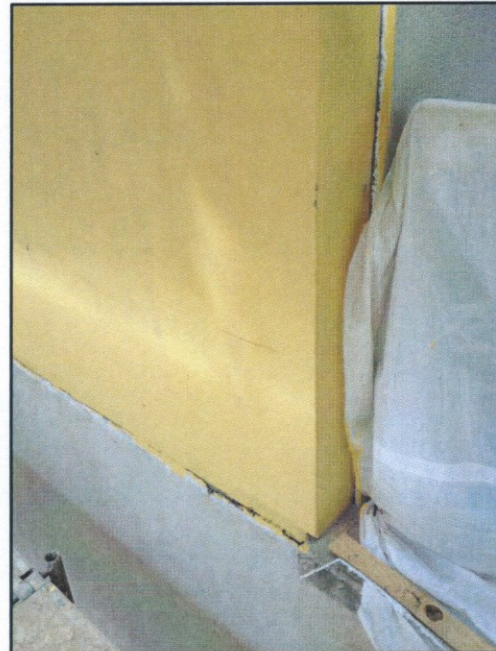
Views taken May 10, 2016.

Views of end wall and bow window stack indicating waterproof coating (STO Gold Coat) and new framing at bow window openings .

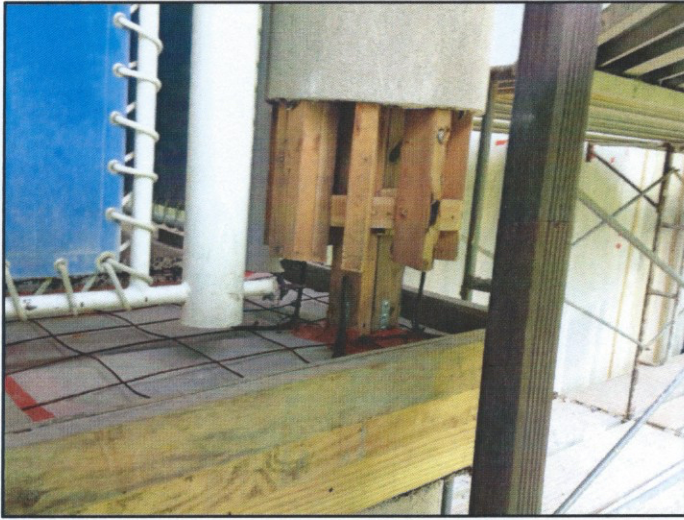
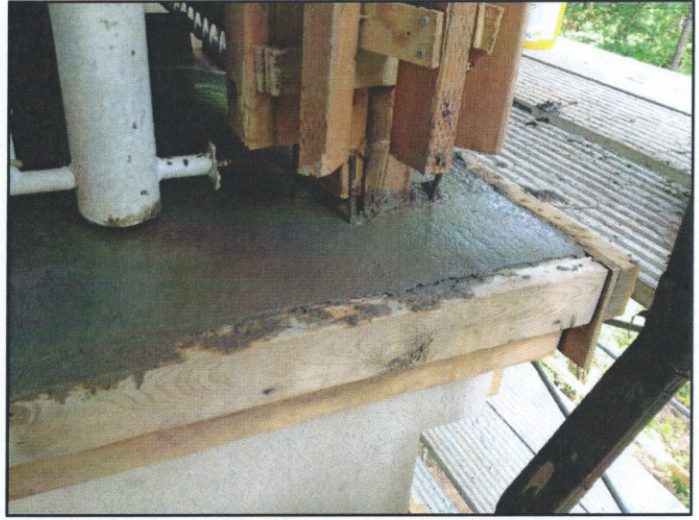
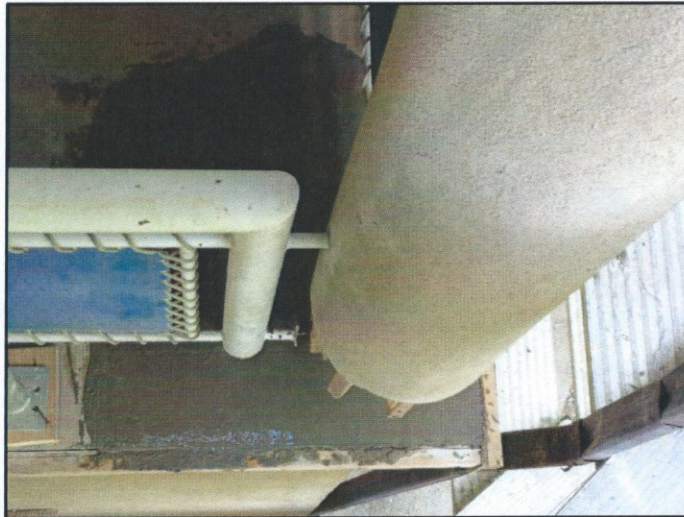
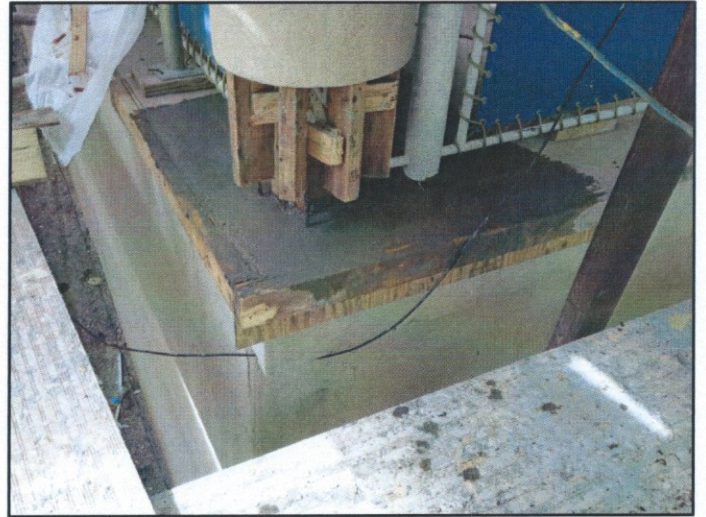
Views taken May 10, 2016.

At the rear porch column work the framing has been repaired to assure structural load path is maintained floor to floor. Some columns required major rot replacement. Others were not rotted. The framing work is complete at all porch columns and the new concrete floor and curb has been poured. The concrete will cure for 30 days and then the urethane floor coating will be applied.

Views of rear porch column base repairs in progress.

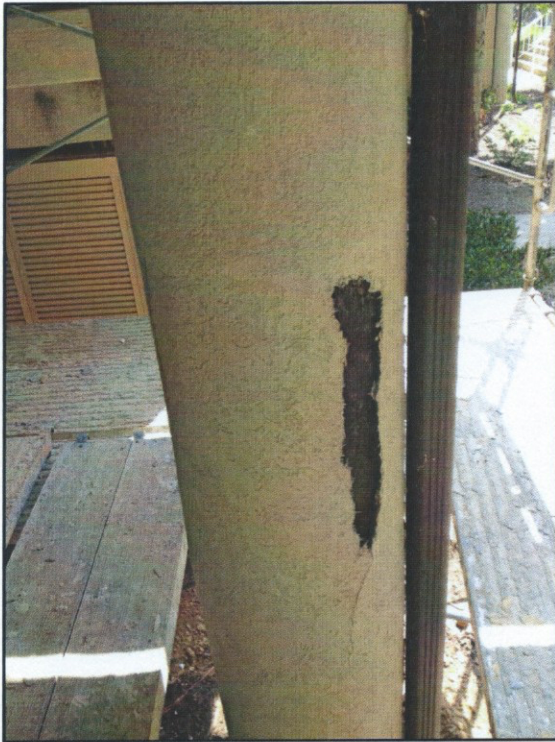
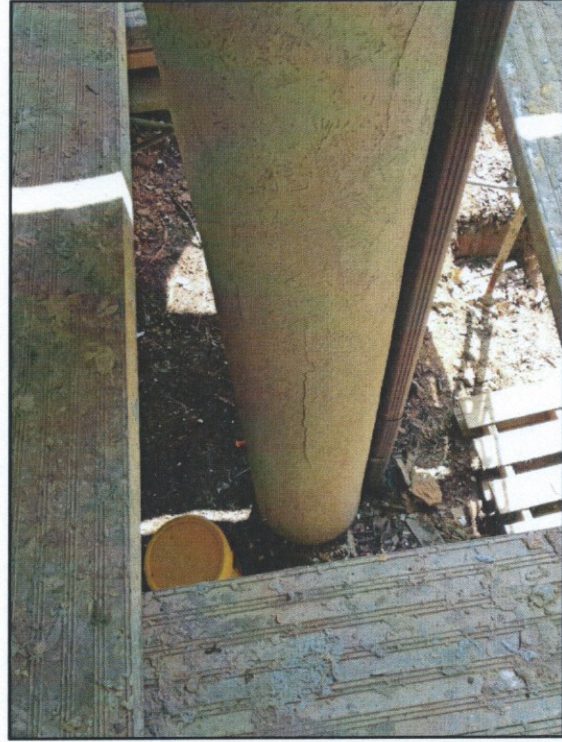
Views taken May 10, 2016.

Views of existing condition of front corner tall columns.

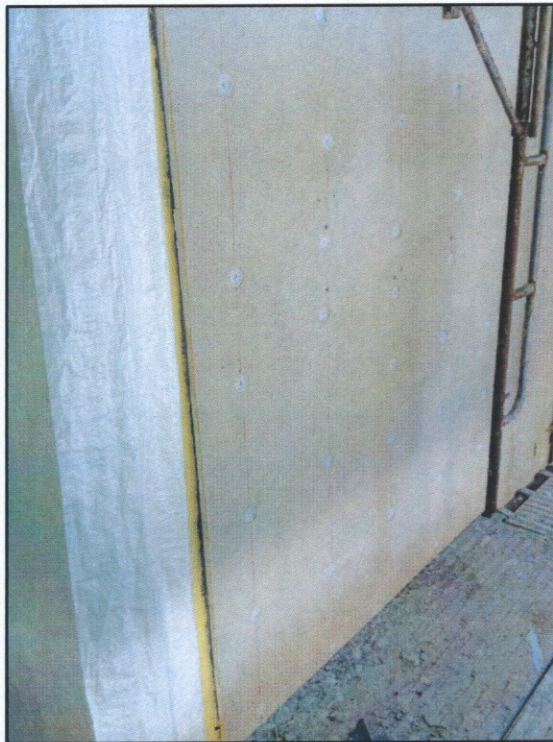
View of application of wind-lock fasteners being applied to front corner wall behind the tall columns. This wall is ready for the application of a new EIFS base and finish coat.

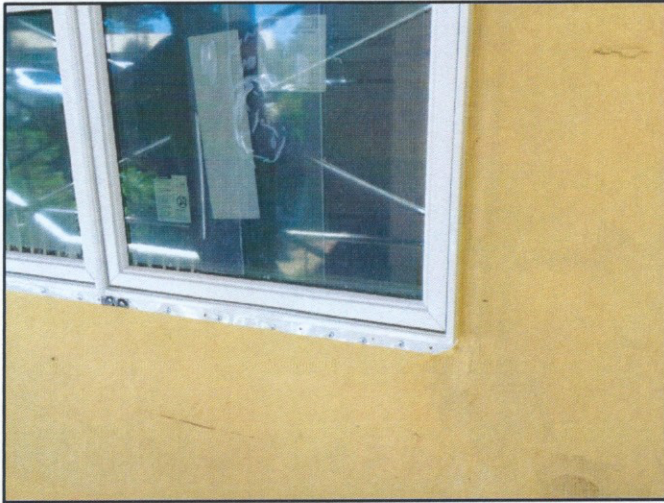
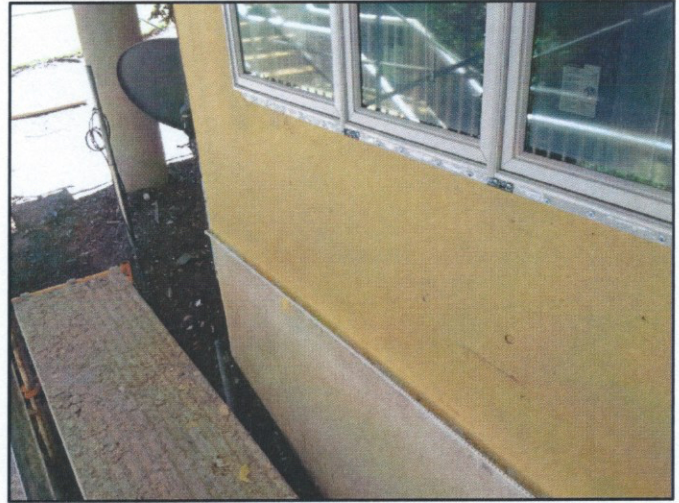
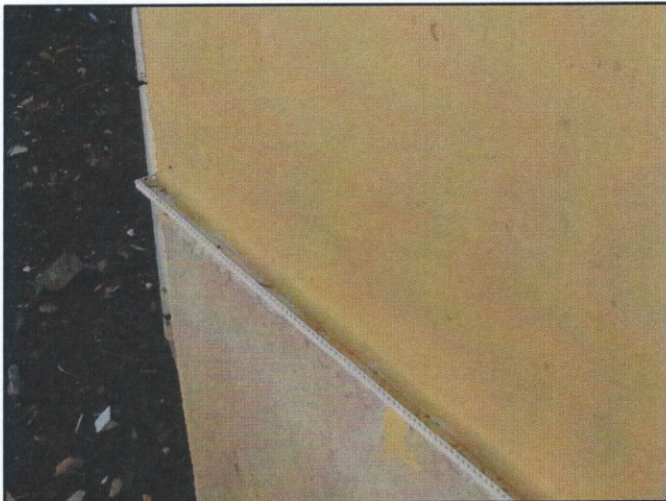
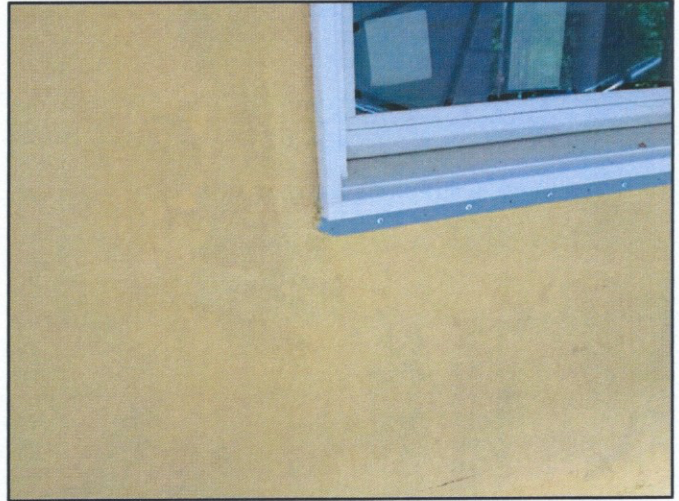
Views taken June 8, 2016.

Views of end wall window installation showing the waterproof coating correctly over the window flange at the jamb and showing the window flange at the sill installed correctly over the waterproof coating. Also shown is the termination vinyl drip screed installed at the bottom for the EIFS system.

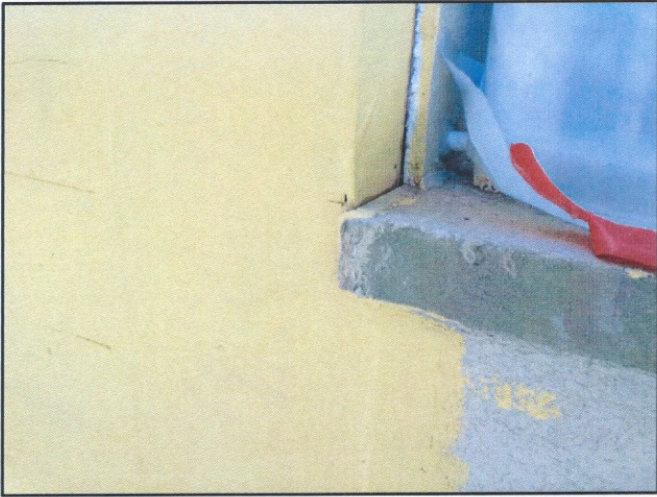
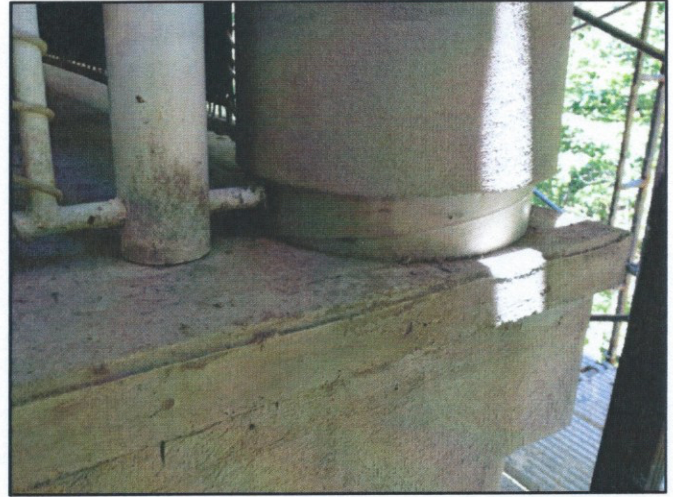
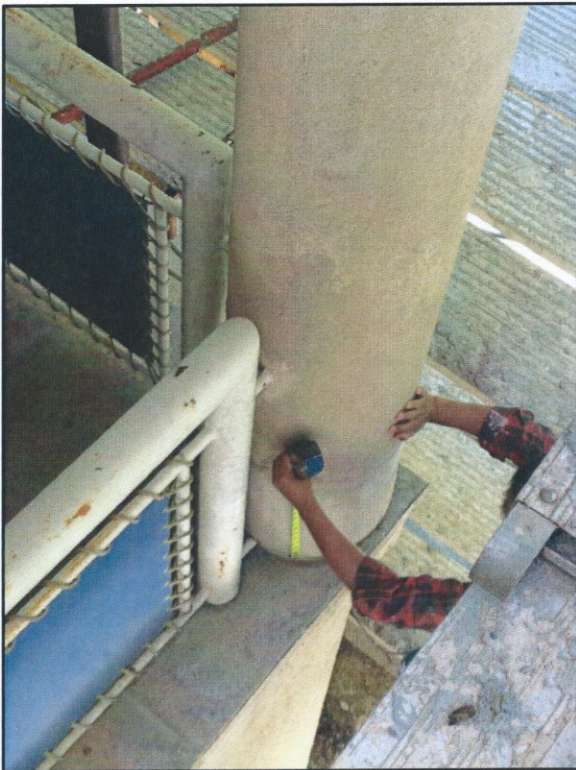
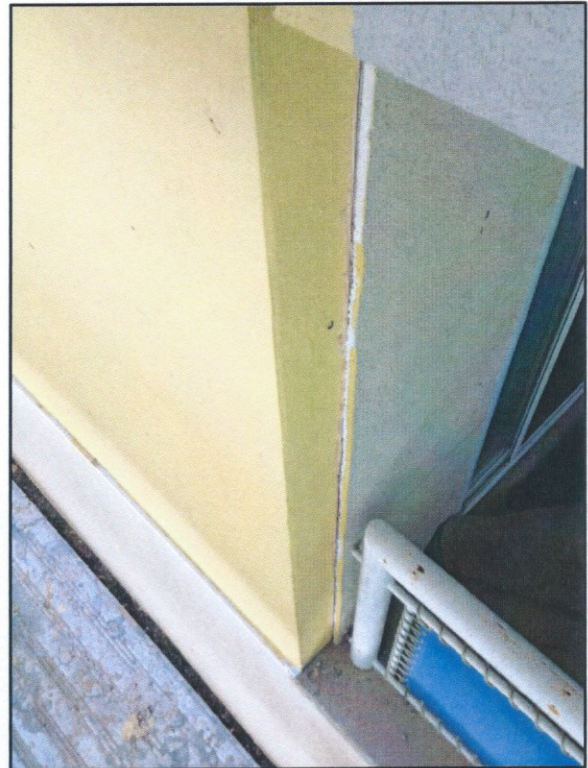
Views taken June 8, 2016.

Views of porch column base stucco application in progress and the detail where the end wall veneer system turns into the Unit rear porches. Sealant will be applied at these intersections prior to the EIFS system application.

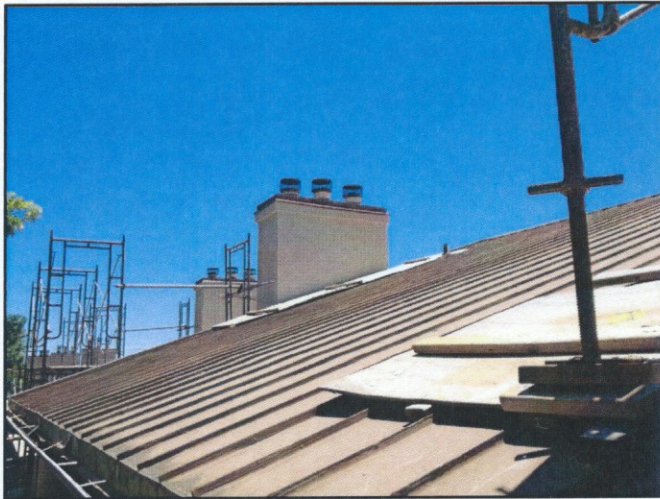
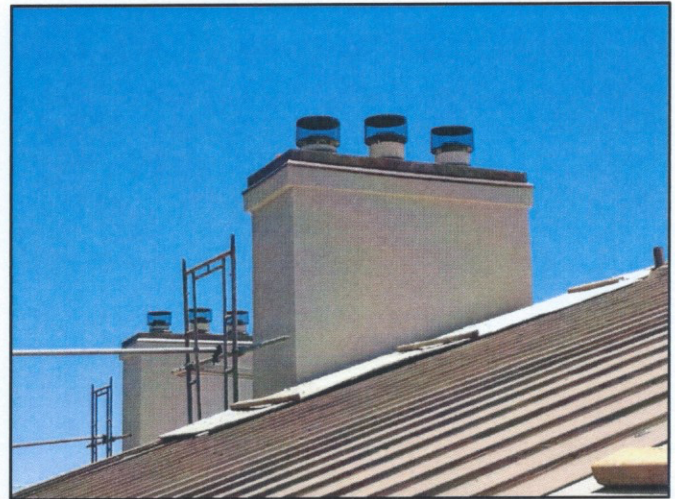
Views taken June 8, 2016.

The repair work at the chimneys is in progress and is 80% complete.

Views of chimney veneer repairs. New flashing at the top has been installed. EIFS veneer application is in progress.

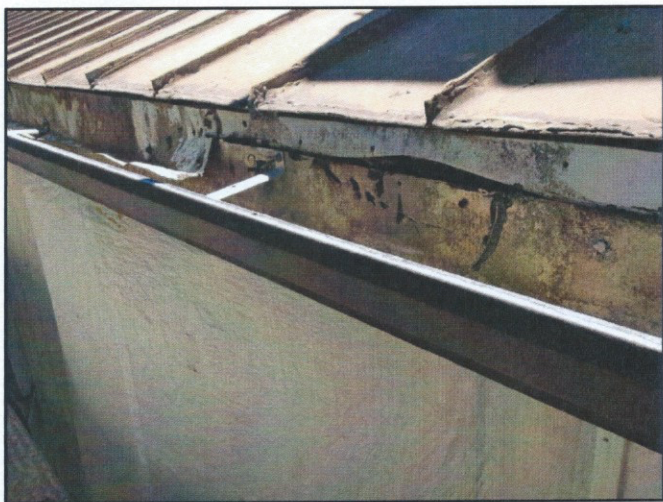
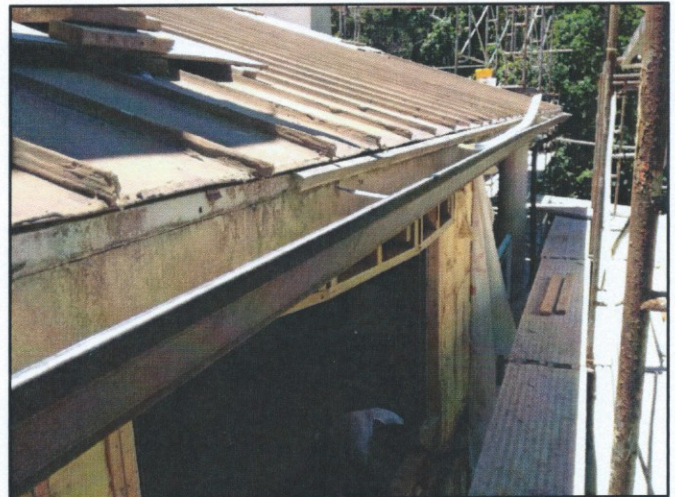
Views of roof eave drip line and gutter. This flashing metal was found to be in very poor condition. The drip flashing will be replaced and new gutter straps will be installed.
