Summary Progress Report No. 3
For
Repairs for
Square Rigger
Tall Ships Condominium Project
Salem, South Carolina

MCA Architecture, Inc.
Forensics Division
March 7, 2016
MCA Project No. F11705.G

Summary Progress Report

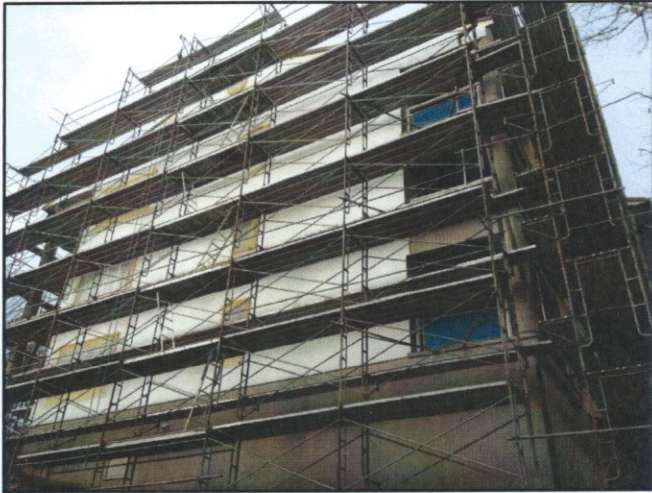
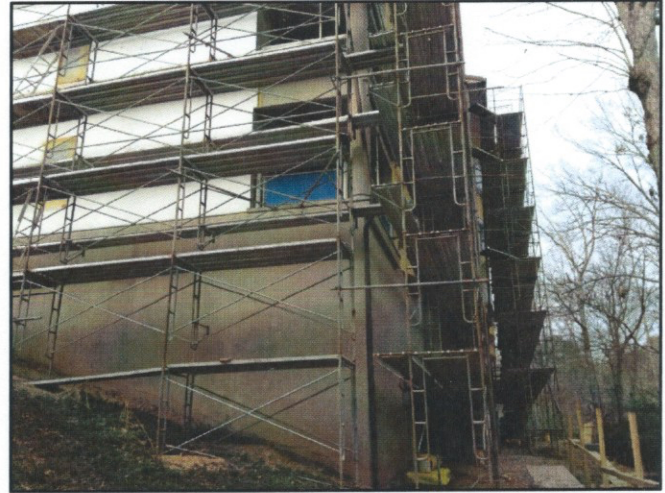
EIFS veneer system foam board insulation is being installed on the east end.

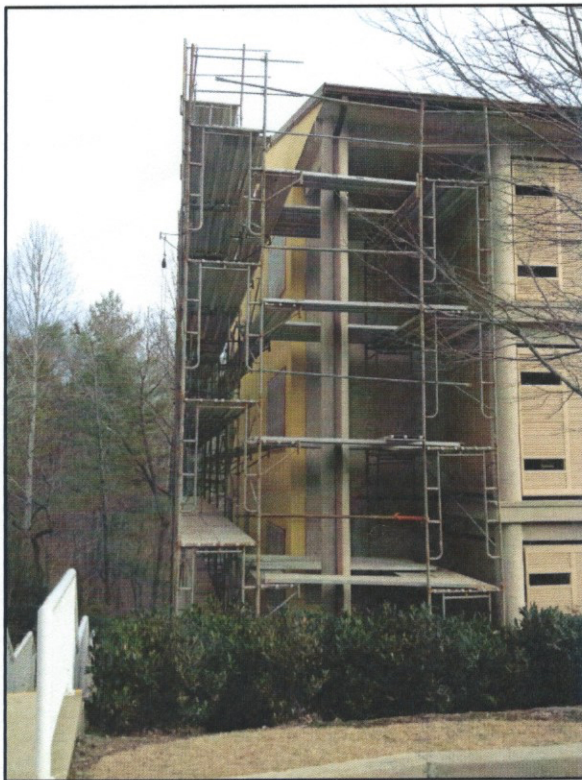
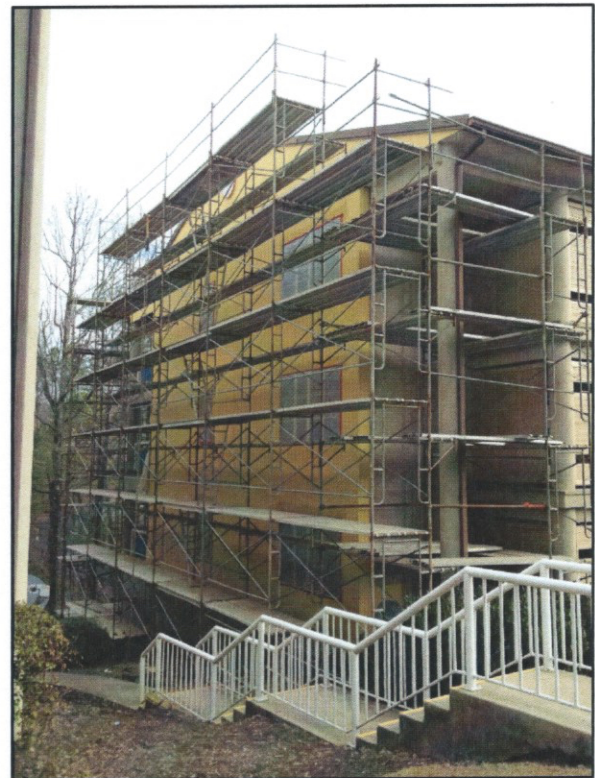
Water resistive coating has been applied over the entire building work area.

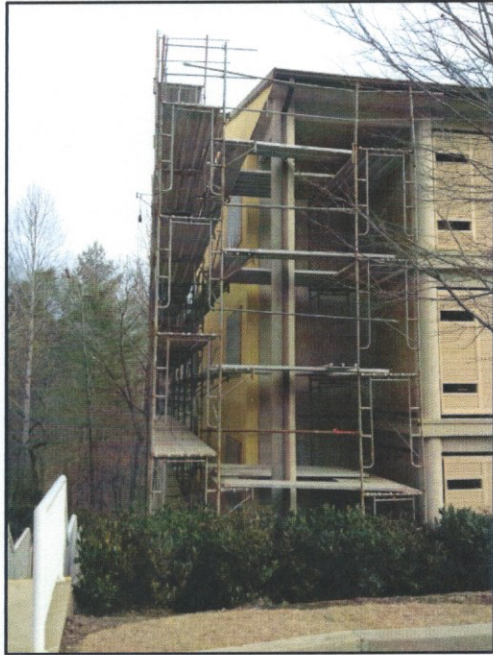
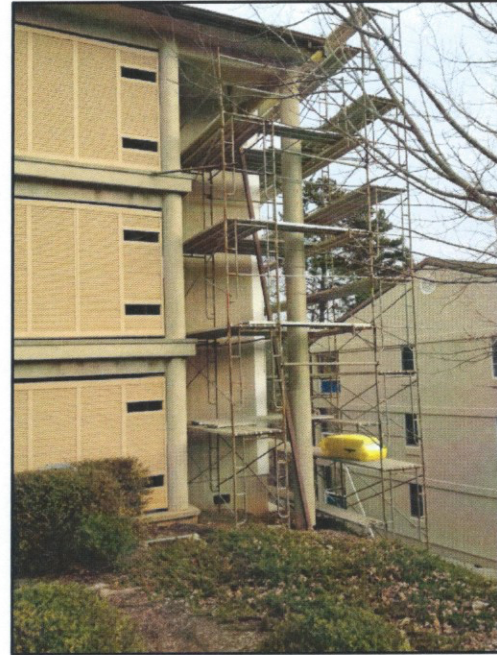
Repair work at front tall columns and corner walls is in progress.

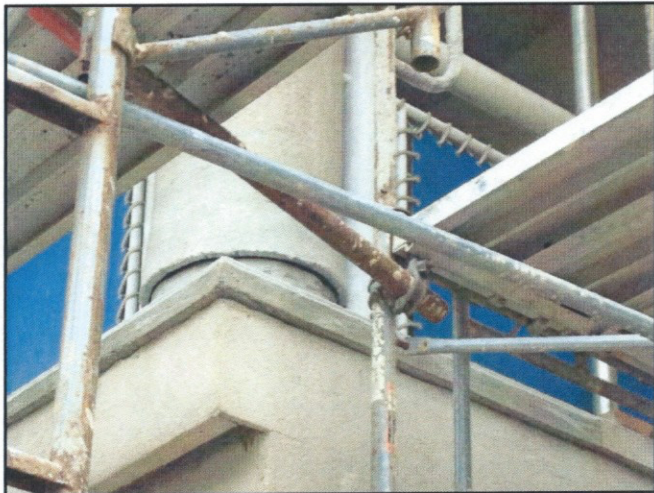
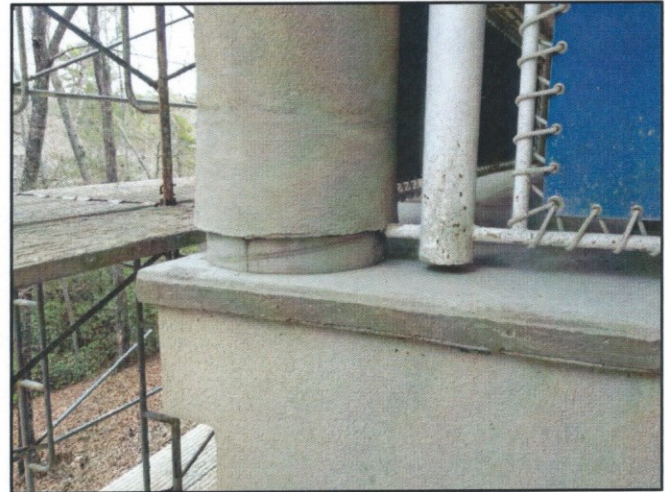
Private balcony corner column wood repairs are complete. Concrete floor and curbs are being installed. Stucco is being reapplied at the base of the columns.

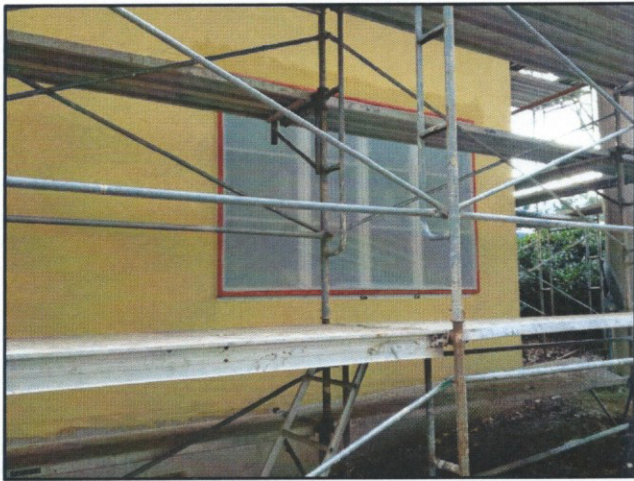
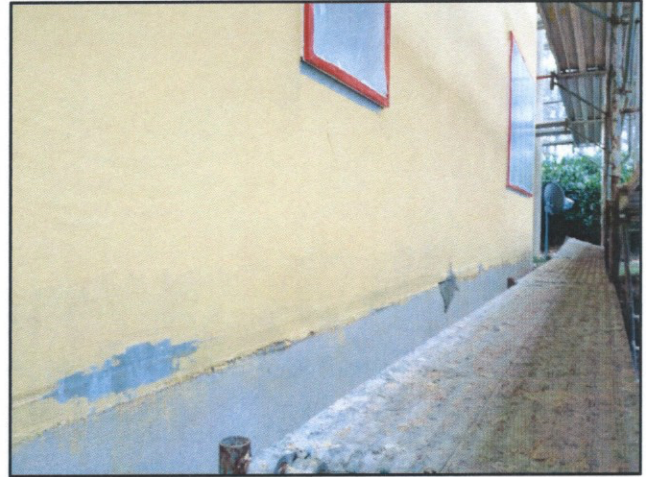
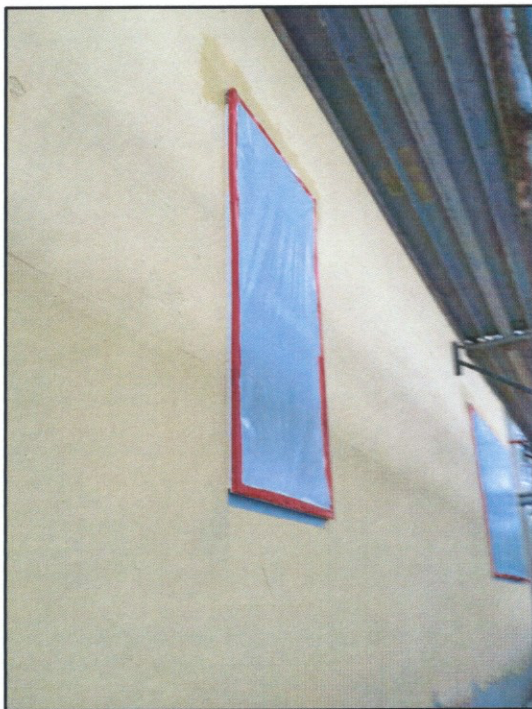
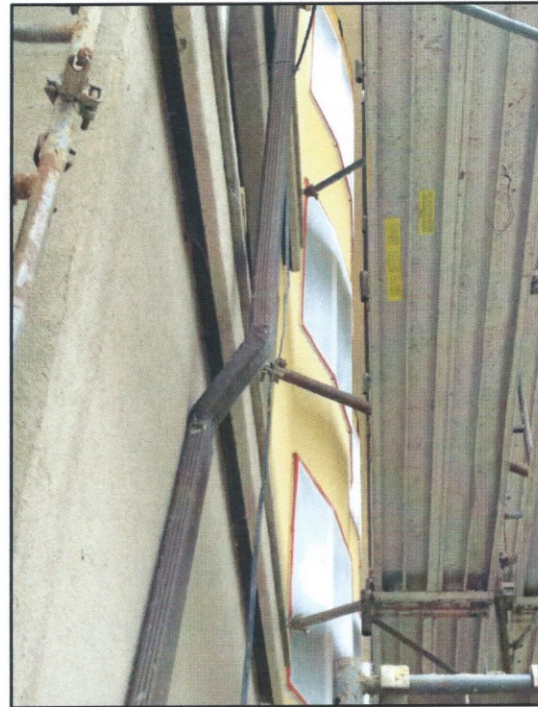
Selected views of water resistive coating with new windows installed at end walls and rear bow window walls.

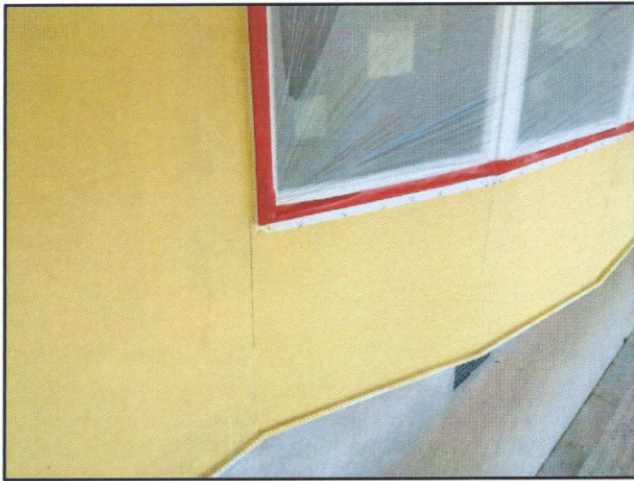
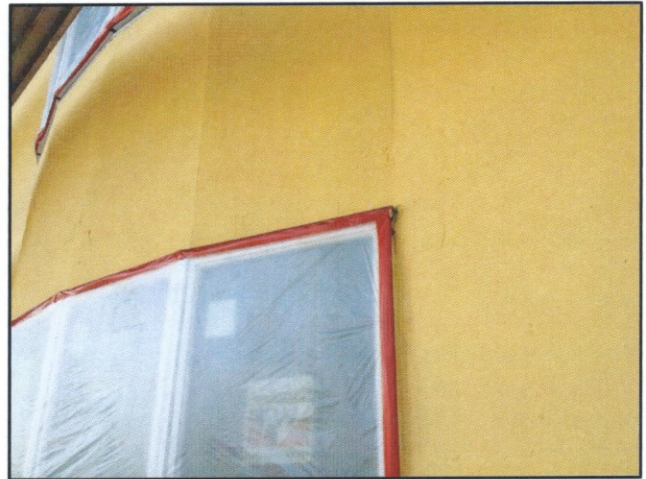
Selected views of water resistive coating with new windows installed at rear bow window walls.

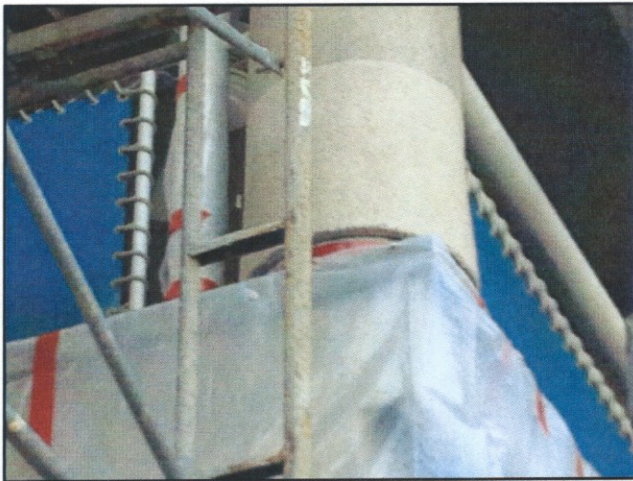
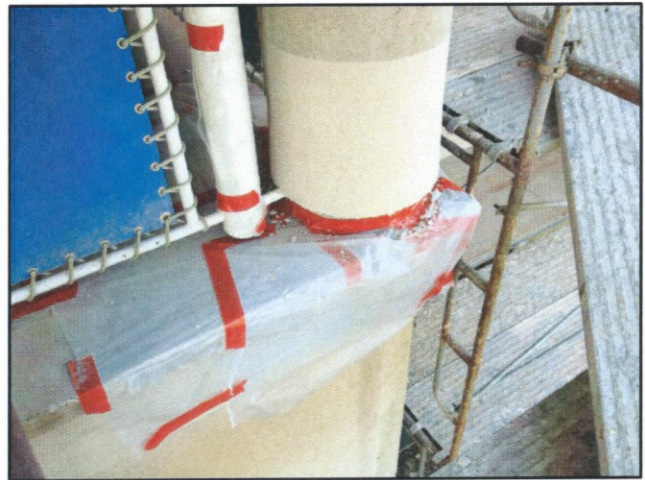
Private balcony corner column wood repairs are complete. Concrete floor and curbs are being installed. Stucco is being reapplied at the base of the columns.

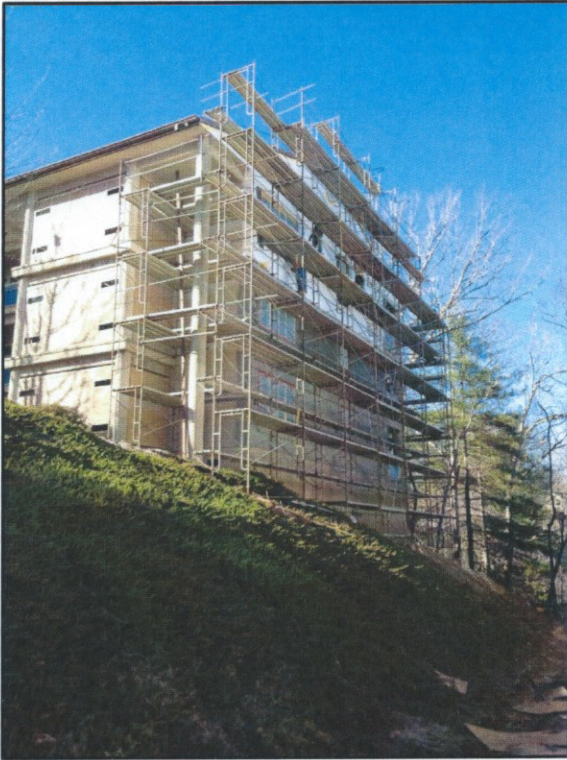
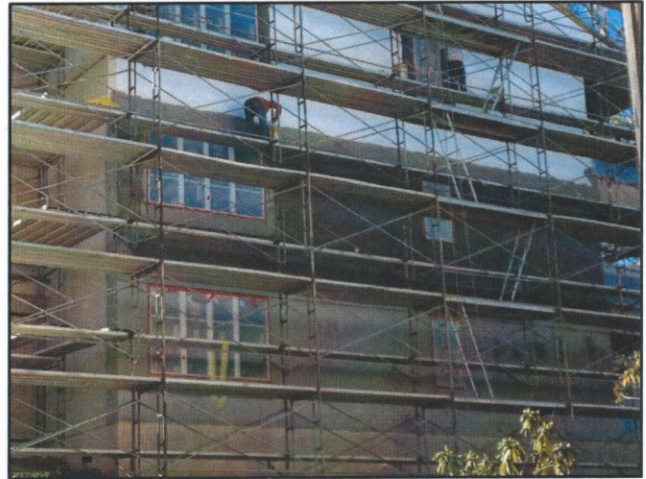
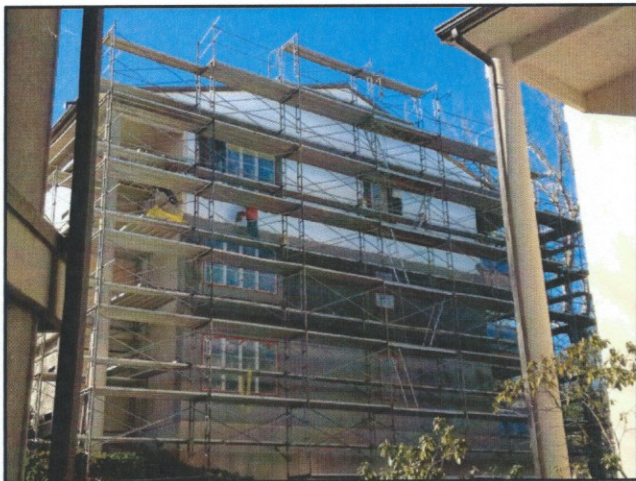
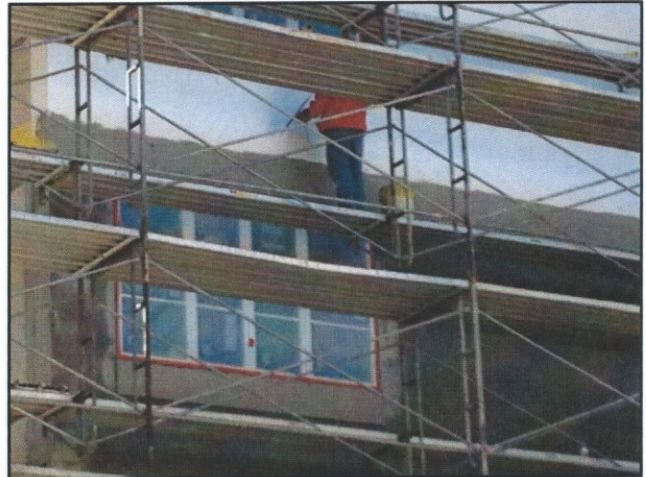
EIFS base coat is being applied over foam board at the east end wall.
