Summary Progress Report No. 3
For
Repairs for
Emergency Repairs to Schooner / Frigate
Tall Ships Condominium Project
Salem, South Carolina

MCA Architecture, Inc.
Forensics Division
November 15, 2016
MCA Project No. F11705.J

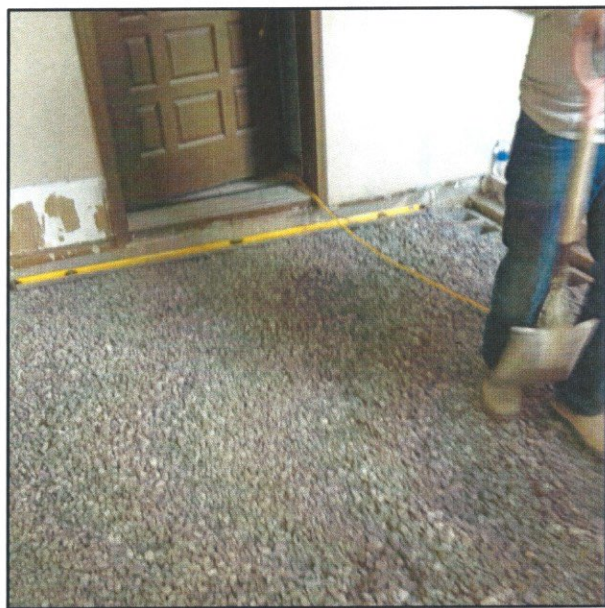
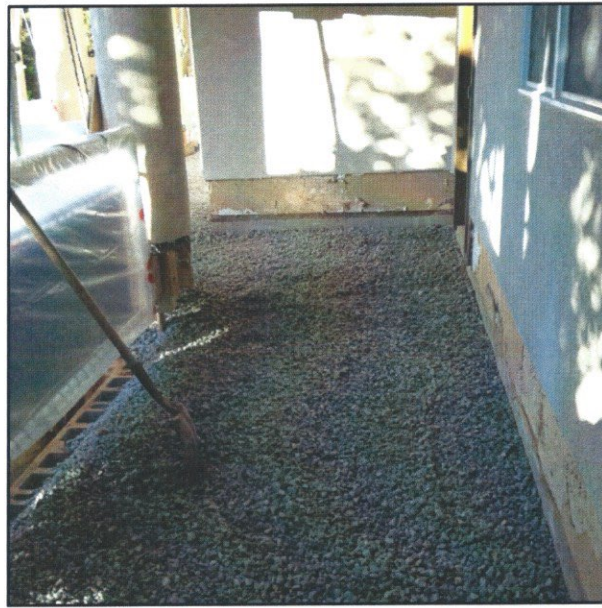
Views taken at Schooner Building October 11, 2016.

Views of installation of the washed stone sub base to support new concrete floor.

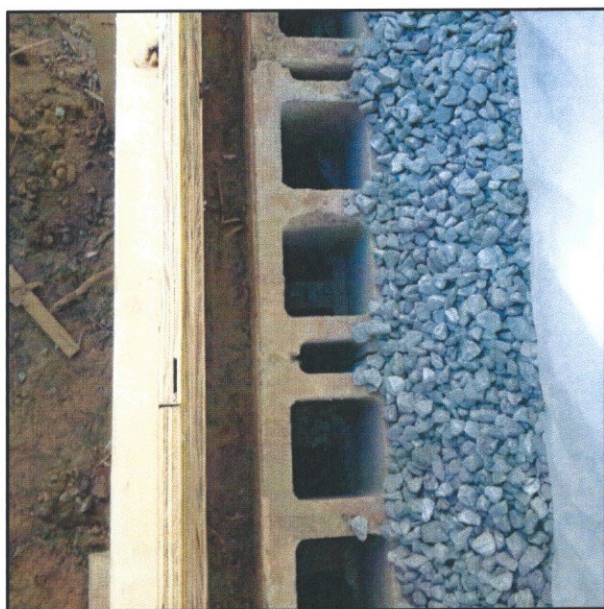
View showing wood edge forms and existing concrete masonry wall prepared to receive new concrete.

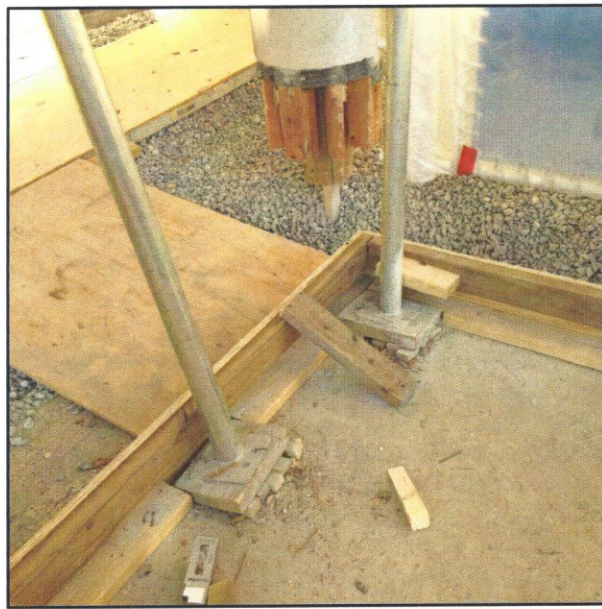
View showing wood edge forms and temporary wood walkway for Unit 101 access.

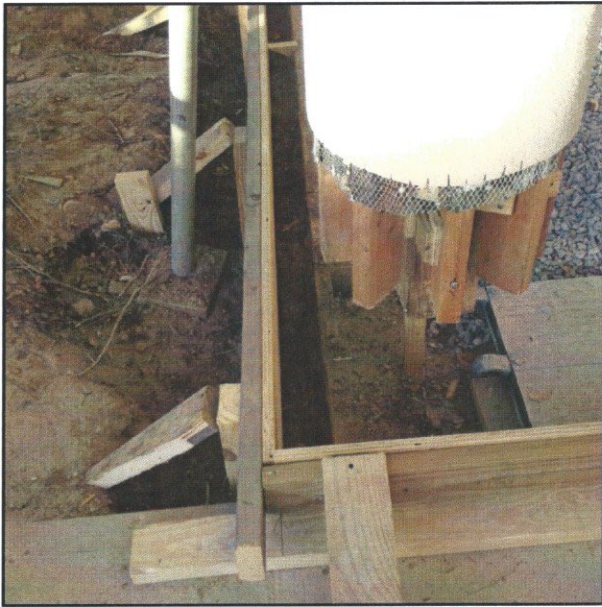
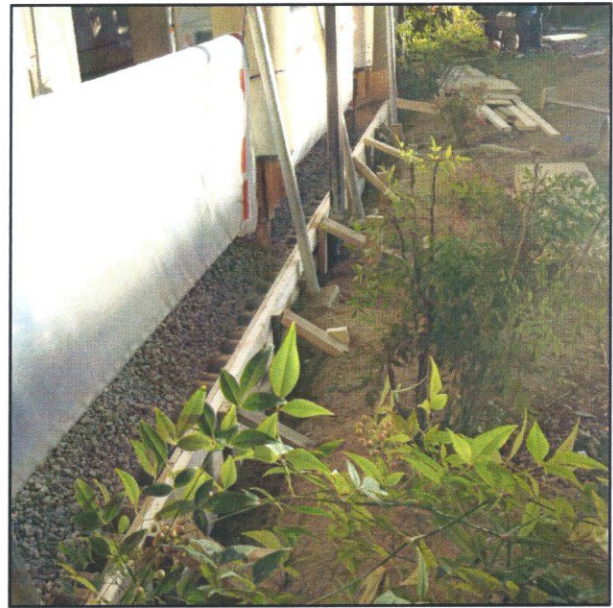
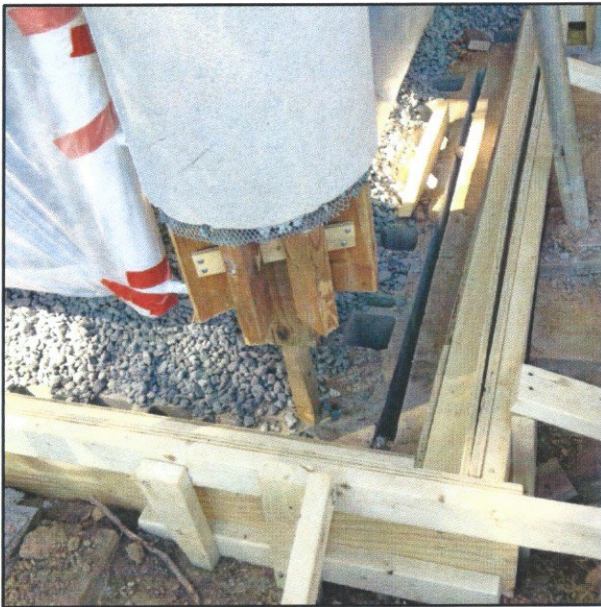
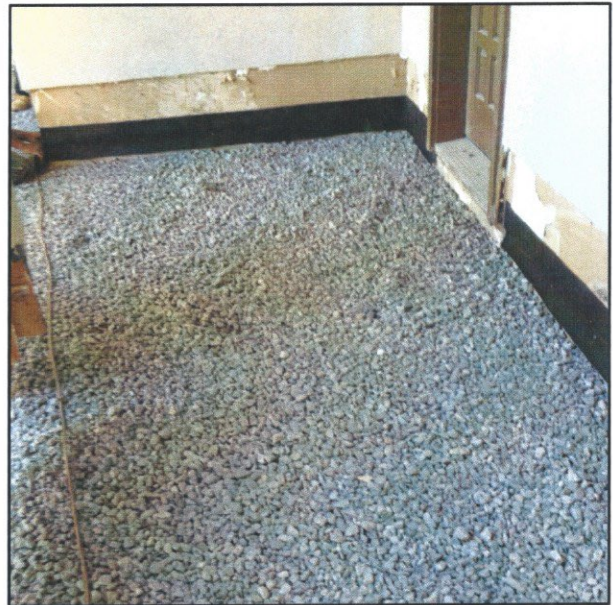
Views taken at Schooner Building October 11, 2016.

Views of installation of the washed stone sub base and edge form work.

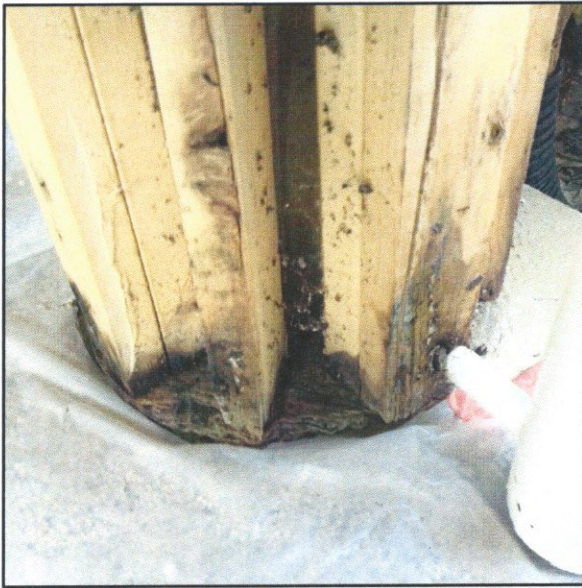
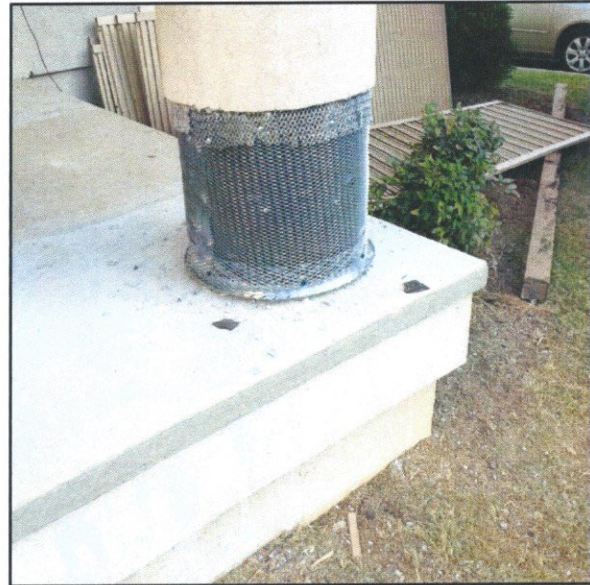
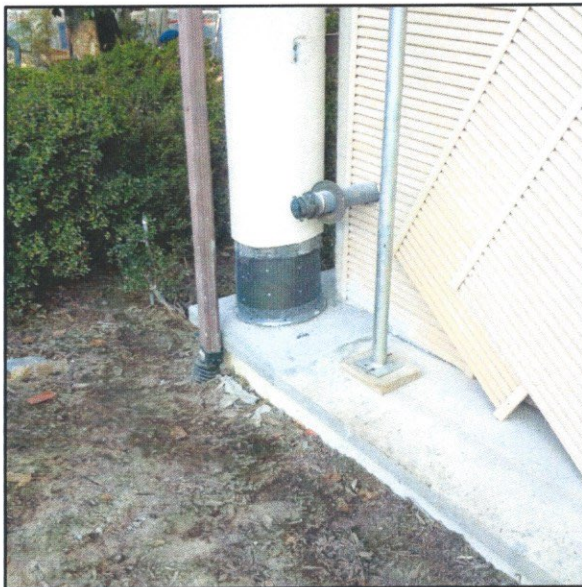
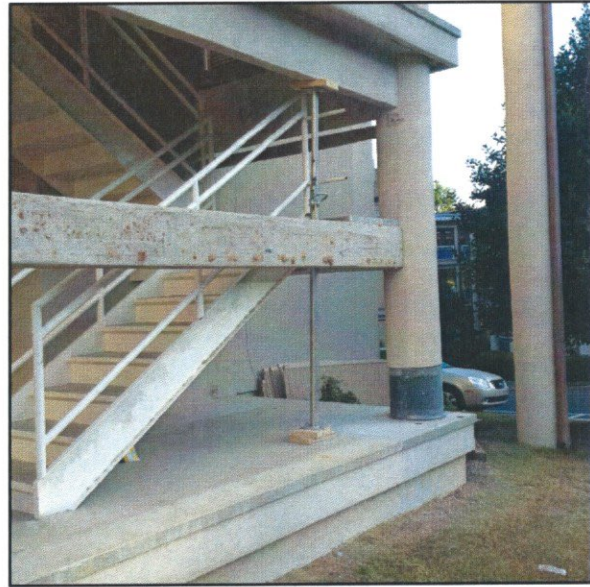
Views taken at Schooner Building October 11, 2016.

Views of column wood rot repair, application of new stucco lathe and the repair of the concrete floor at the base of the column.

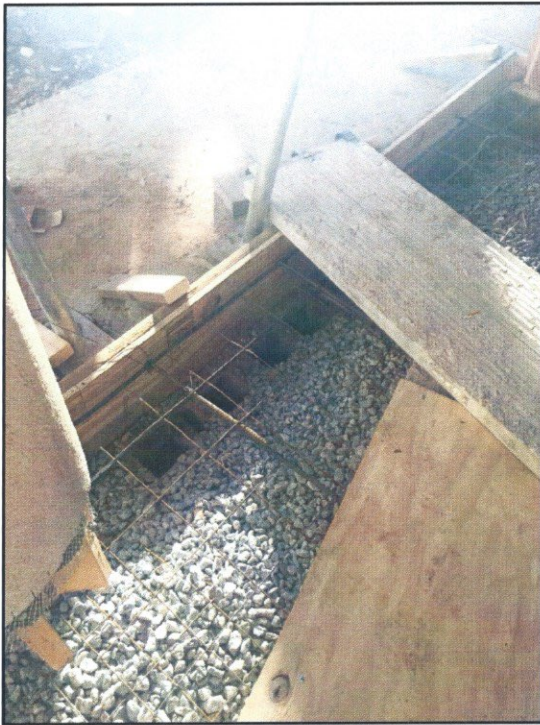
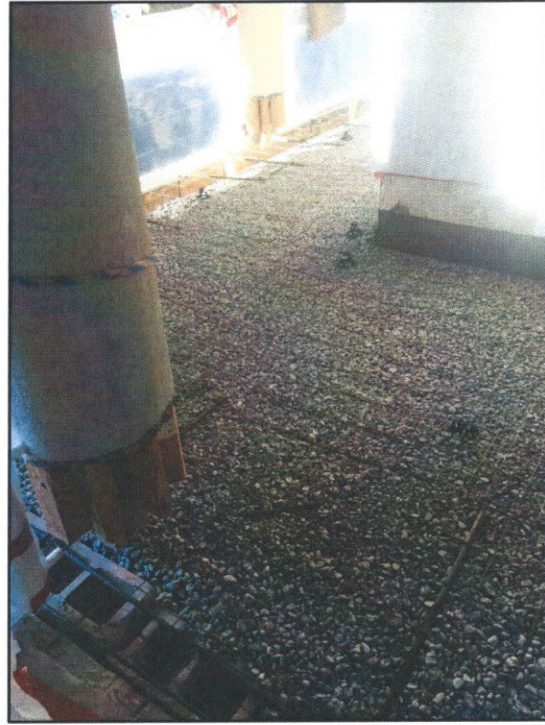
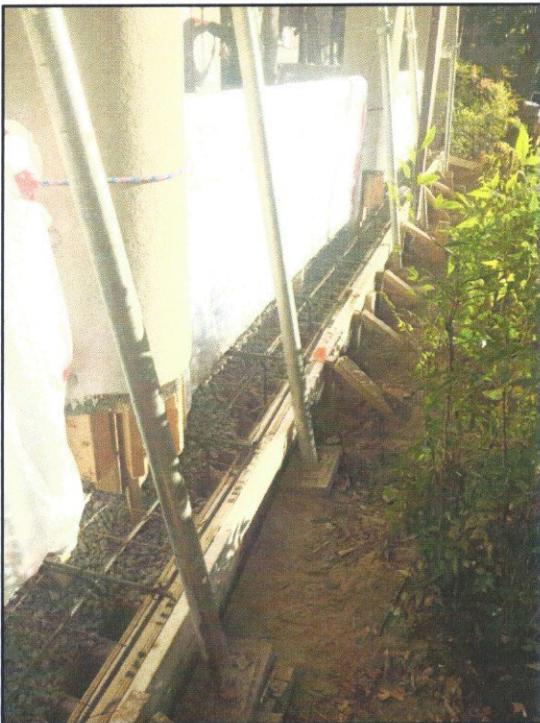
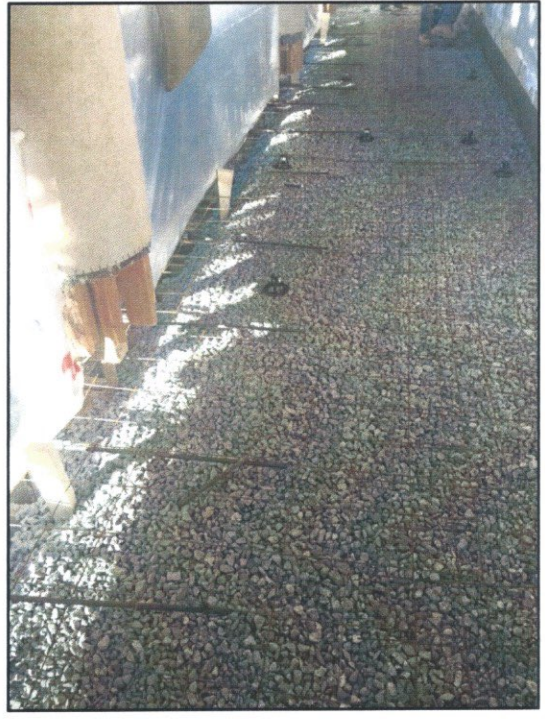
Views taken at Schooner Building October 12, 2016.

Views of reinforcing bars, washed stone and edge forms ready for pouring of concrete.

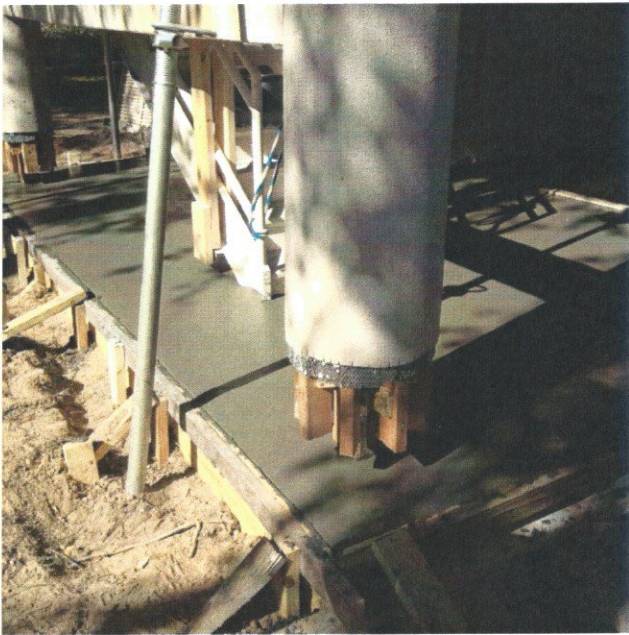
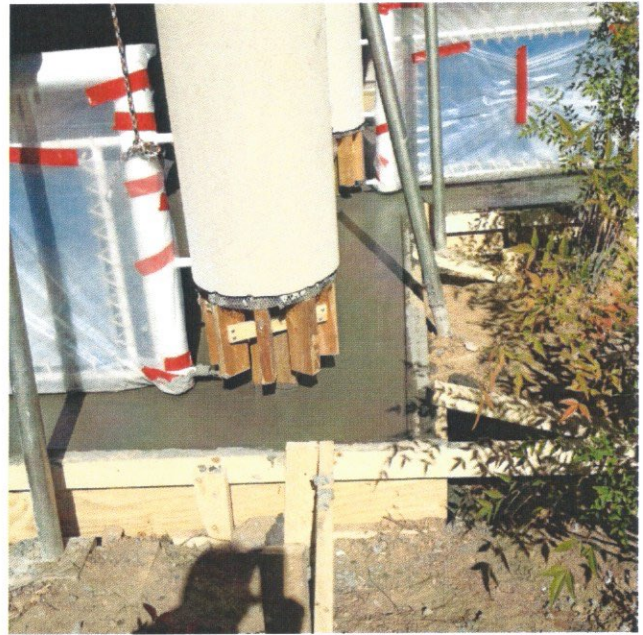
Views taken at Schooner Building October 12, 2016.

Views of new concrete pour at corner columns.

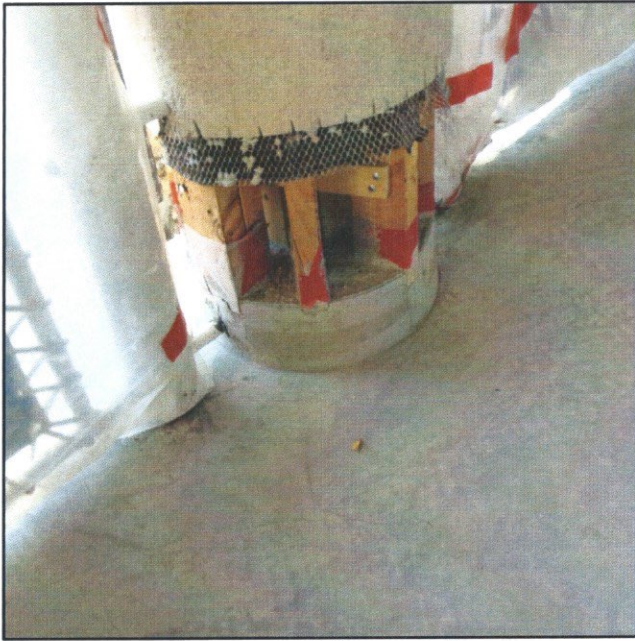
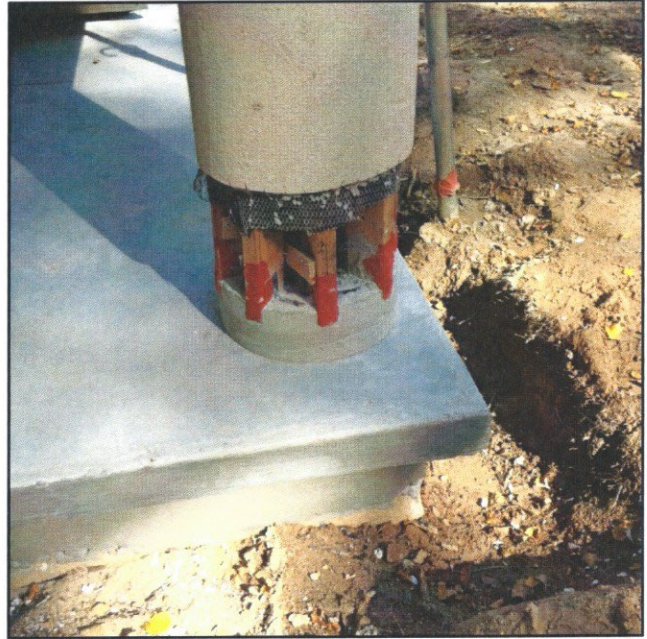
Views taken at Schooner Building October 17, 2016.

Views of new concrete curb at corner columns.

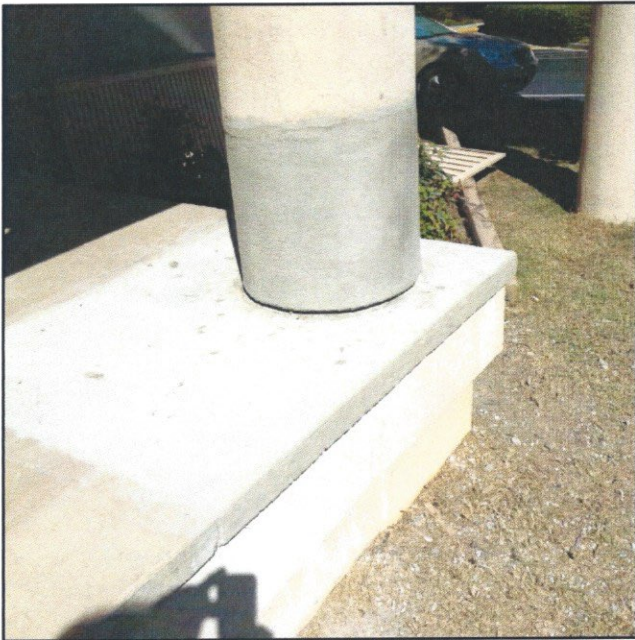
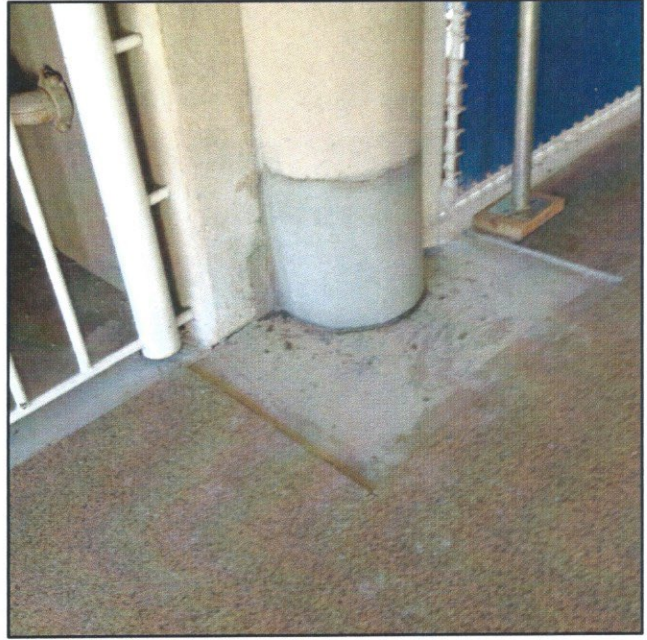
View of new stucco applied to corner columns.

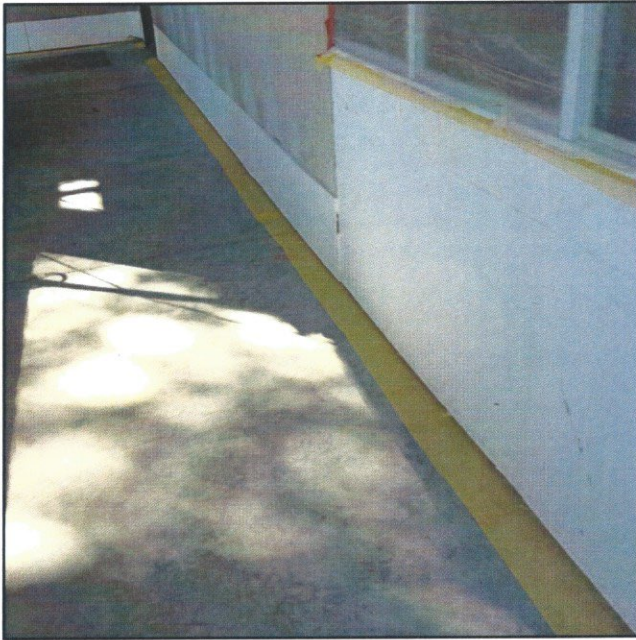
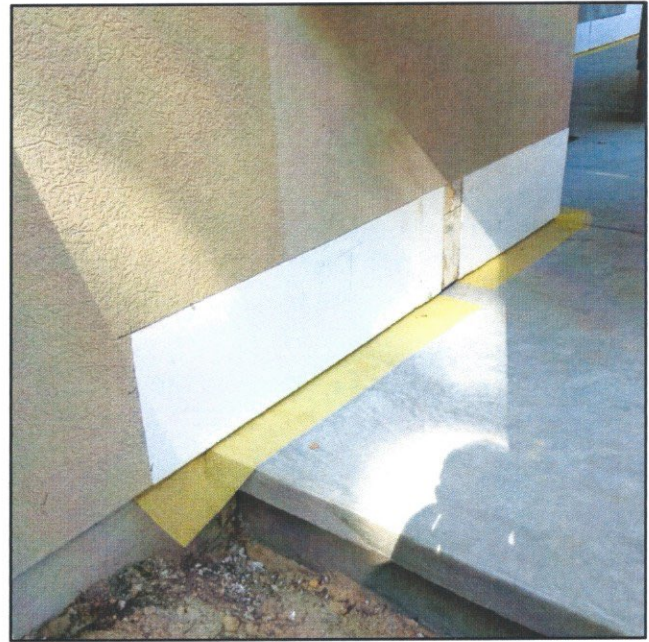
Views taken at Schooner Building October 17, 2016.

Views of new EIFS wall system being installed at floor.

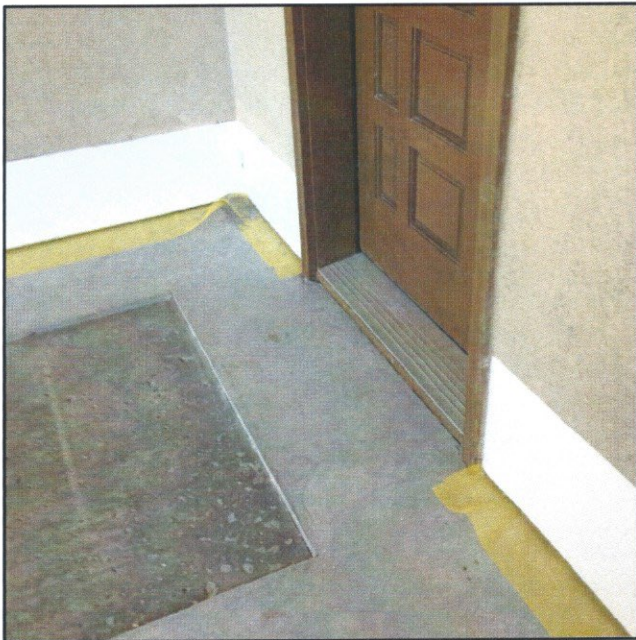
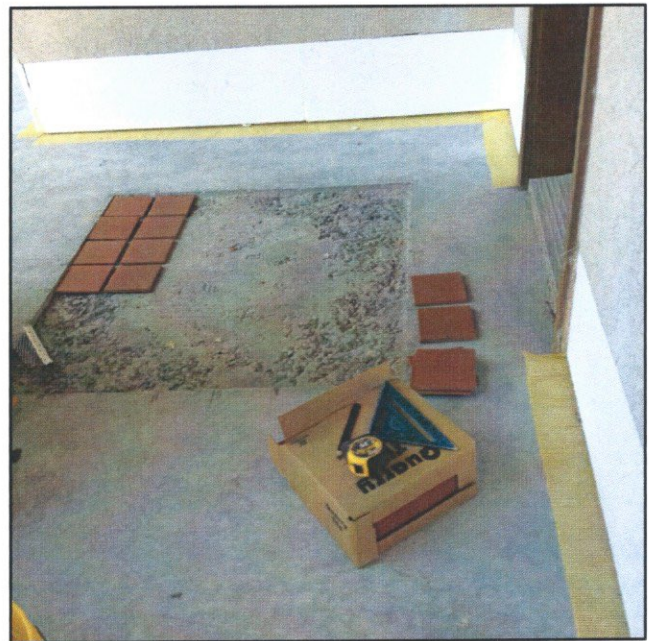
Views of floor cut out prepared to receive new terra cotta tile.

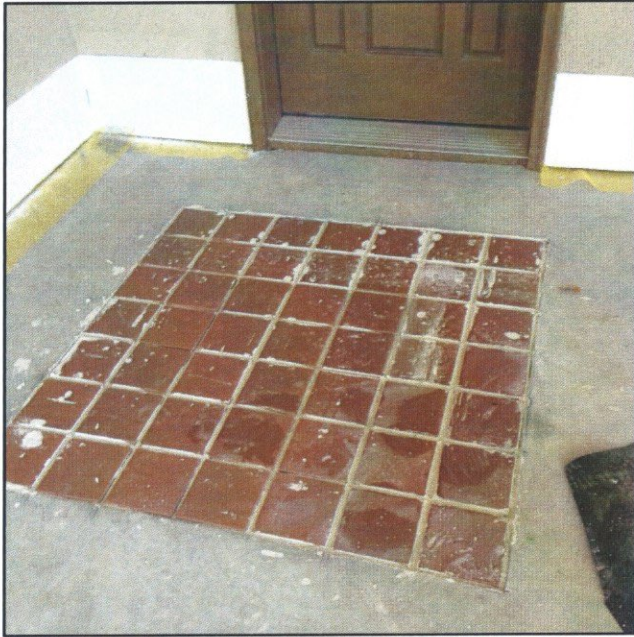
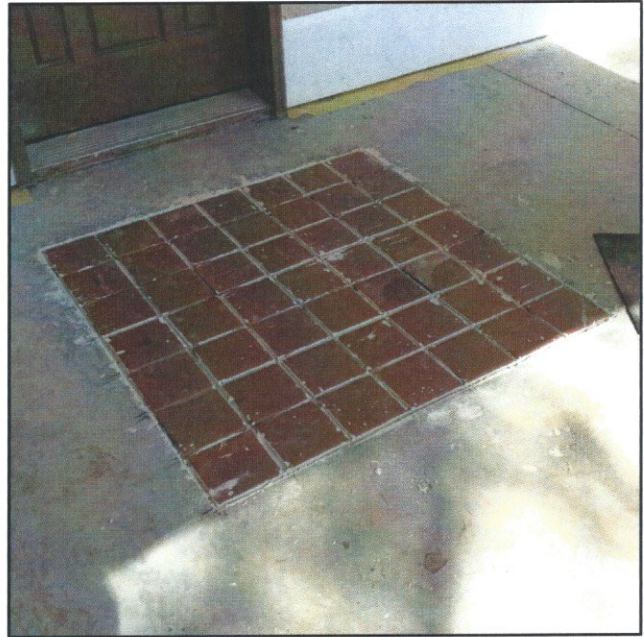
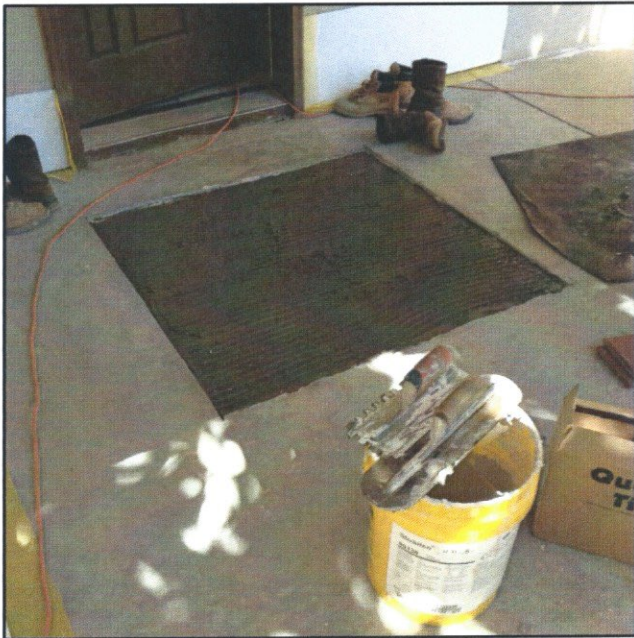
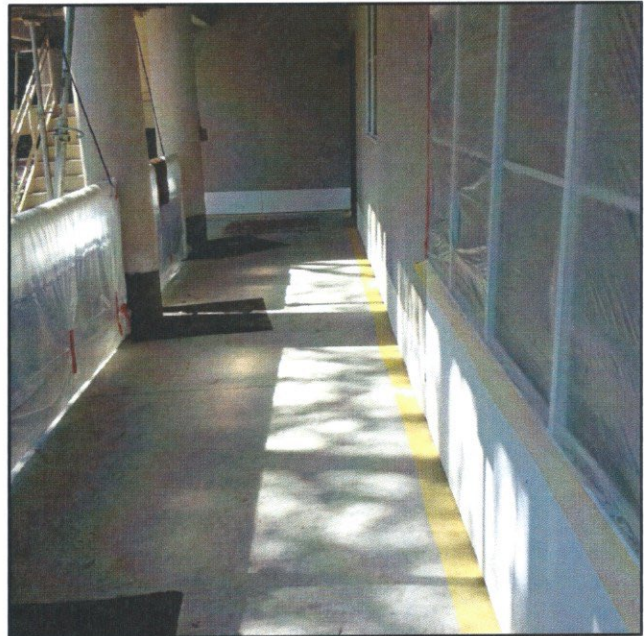
Views taken at Schooner Building October 18, 2016.

Views of terra cotta tile installation at the entrance doors of Units 101, 102 and 103. View at corridor showing work in progress to finish columns and new work at existing walls.

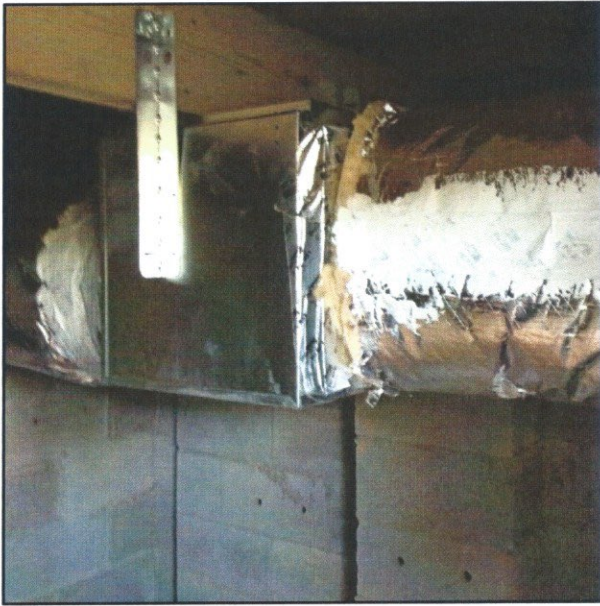
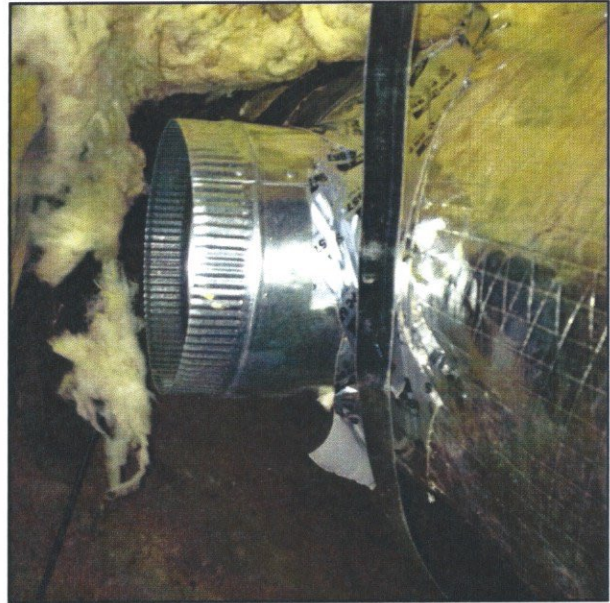
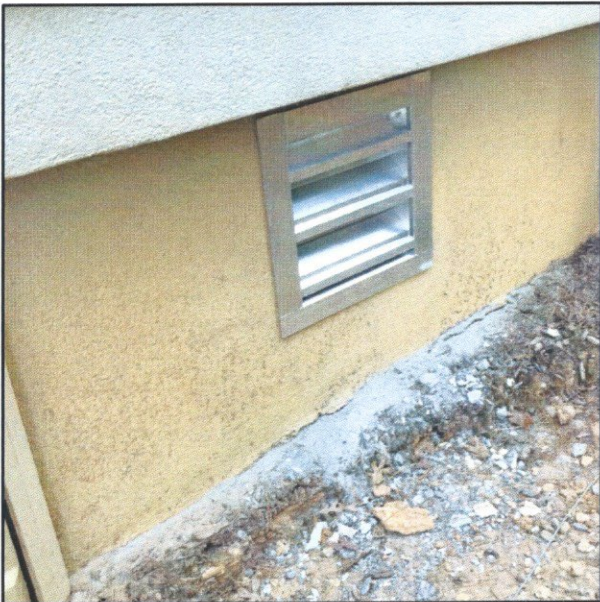
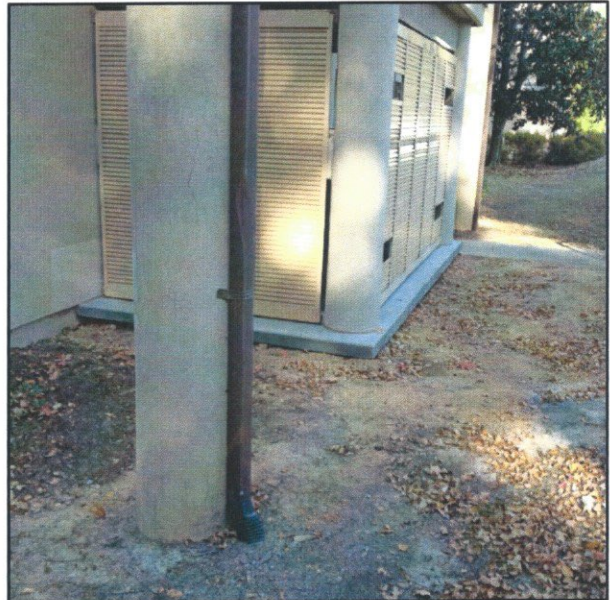
Views taken at Schooner Building November 10, 2016.

Views of new mechanical ventilation system at crawl space areas and the replacement of metal screen panels at stairways.
