Summary Progress Report No. 1
For
Repairs for
Emergency Repairs to Schooner / Frigate
Tall Ships Condominium Project
Salem, South Carolina

MCA Architecture, Inc.
Forensics Division
September 12, 2016
MCA Project No. F11705.J

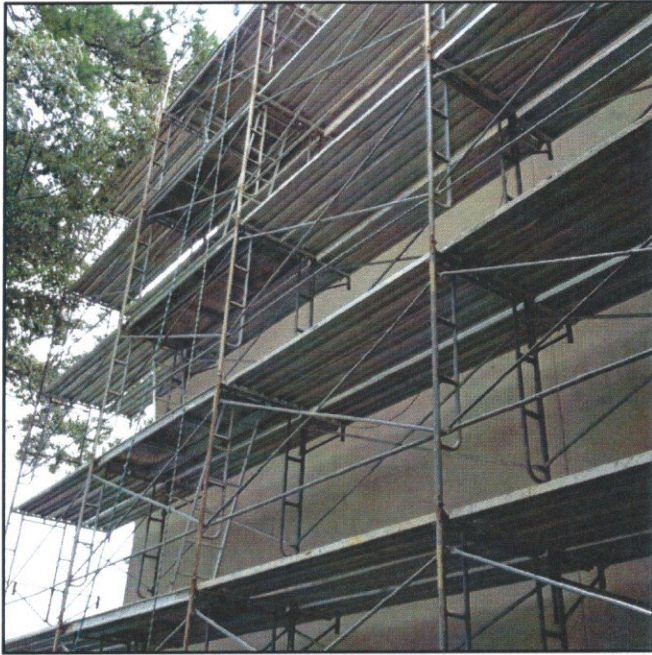
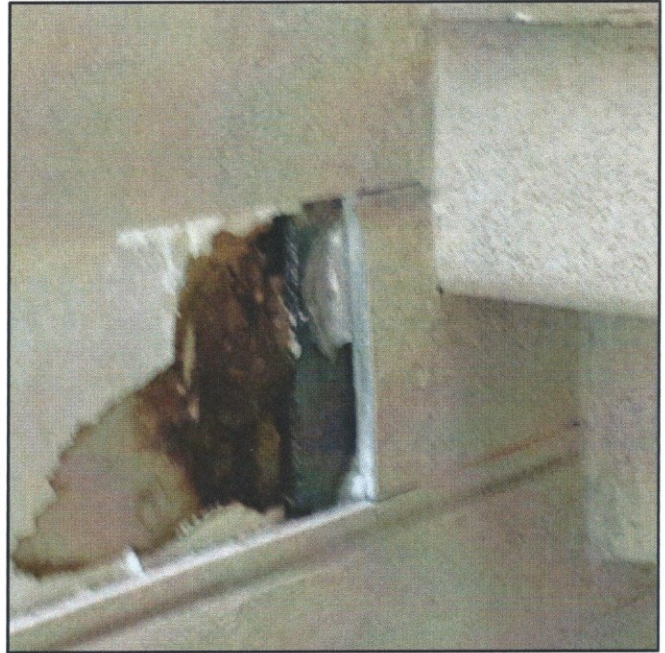
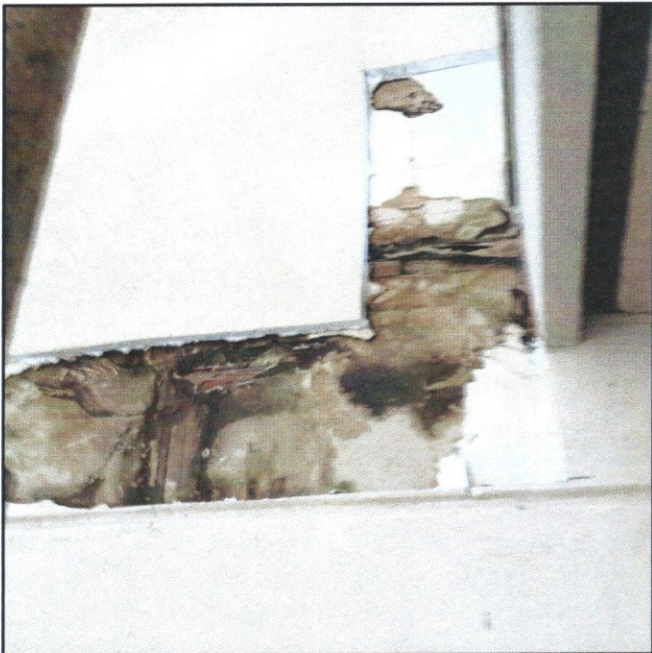
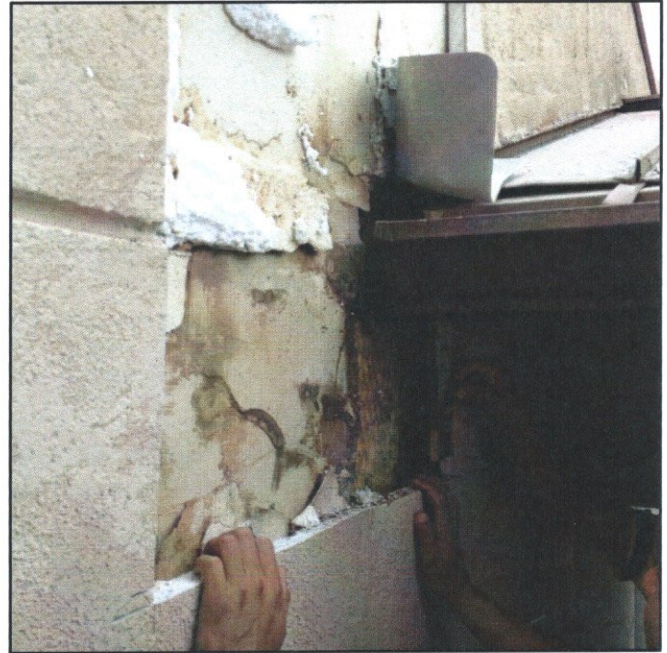
Views taken August 4, 2016.

Views of moisture intrusion and sheathing damage at the end wall intersections to the roof and walkway floors. The existing flashing installations were improper to shed the water from the roof and from the floors directly to the outside.

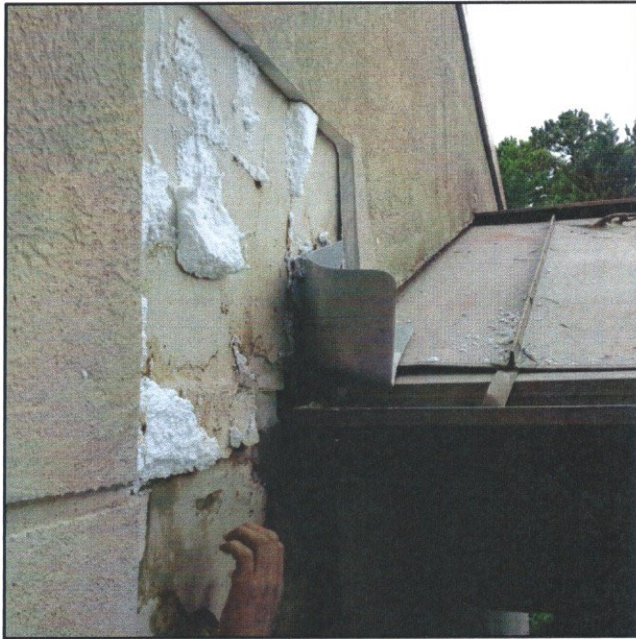
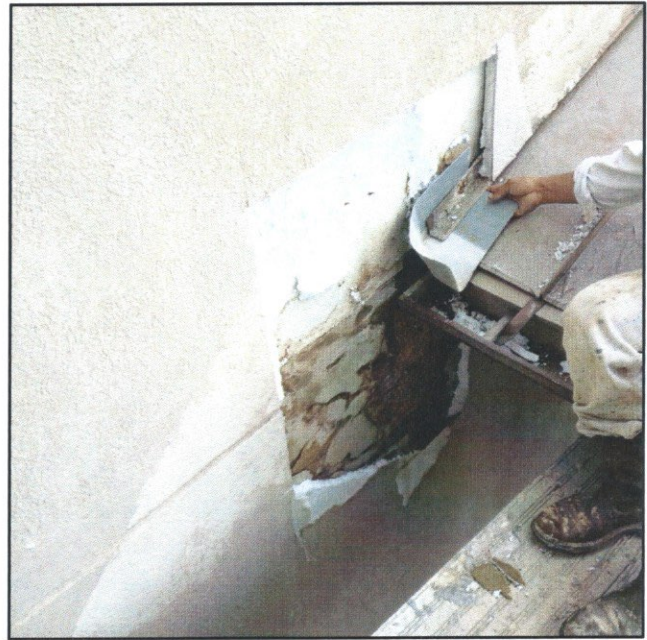
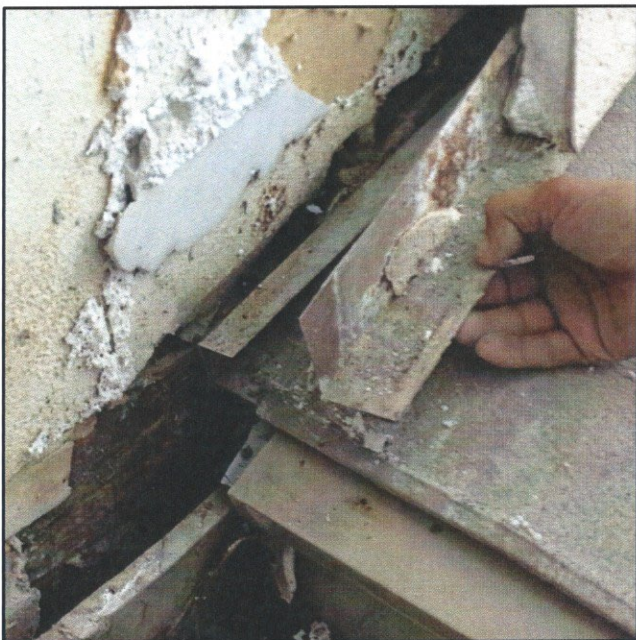
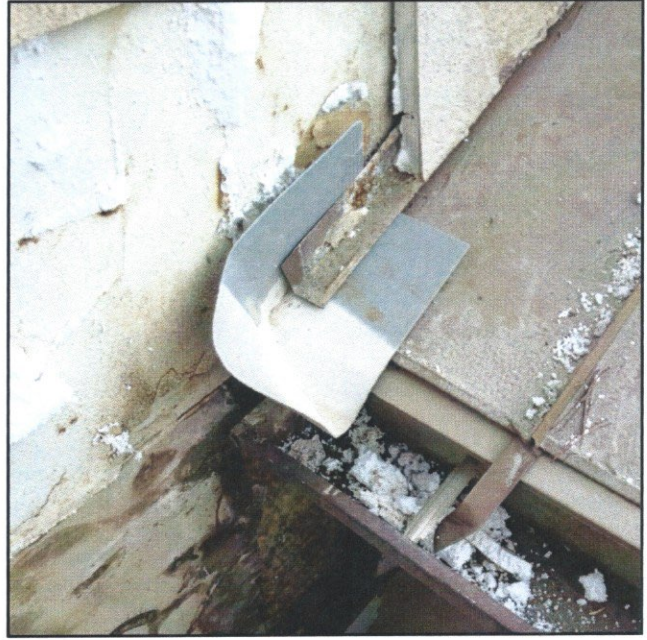
Views taken August 4, 2016.

Views of existing roof to wall detail. Water at the roof was not able to be shed outboard of the existing EIFS veneer system. Water damage has been occurring for many years in this area.

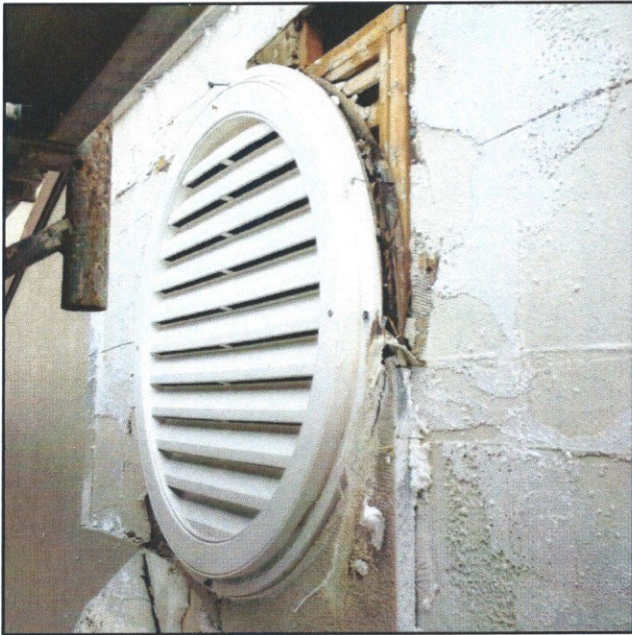
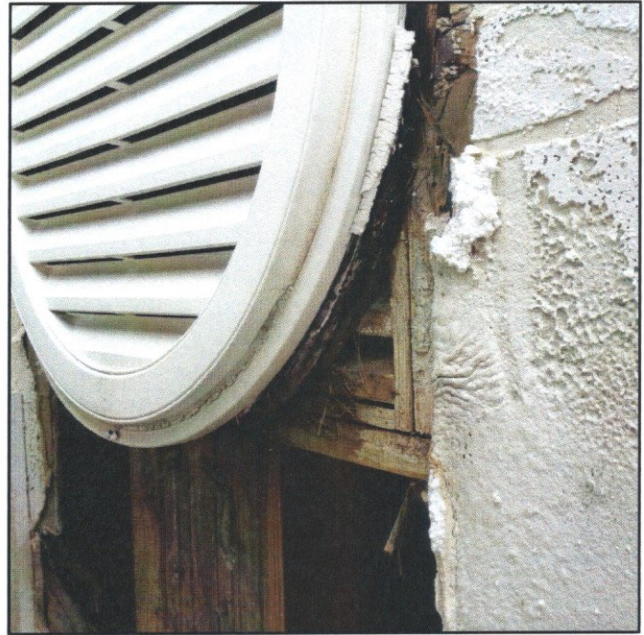
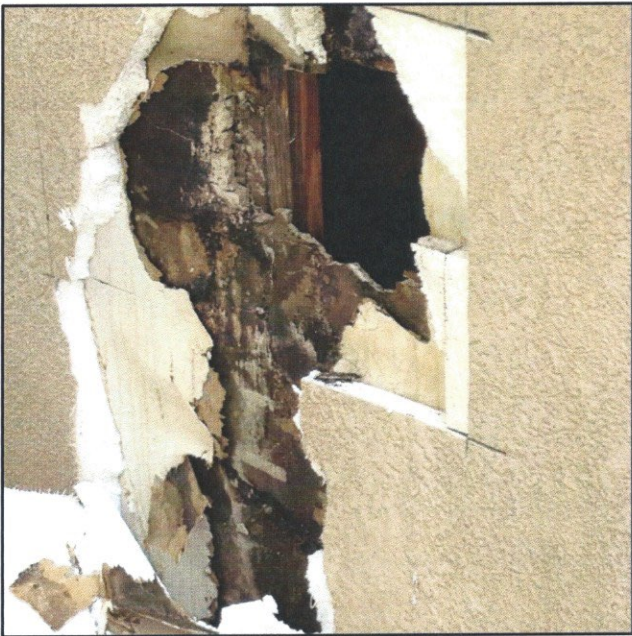
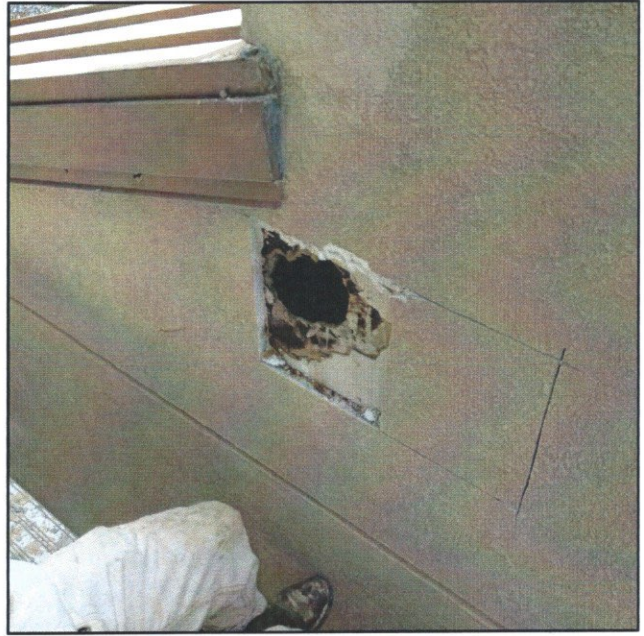
Views taken August 4, 2016.

Views of moisture intrusion, framing and sheathing damage at the end wall intersections to the attic louver and the chimney to roof intersection. The existing flashing installations were improper to shed the water directly to the outside.

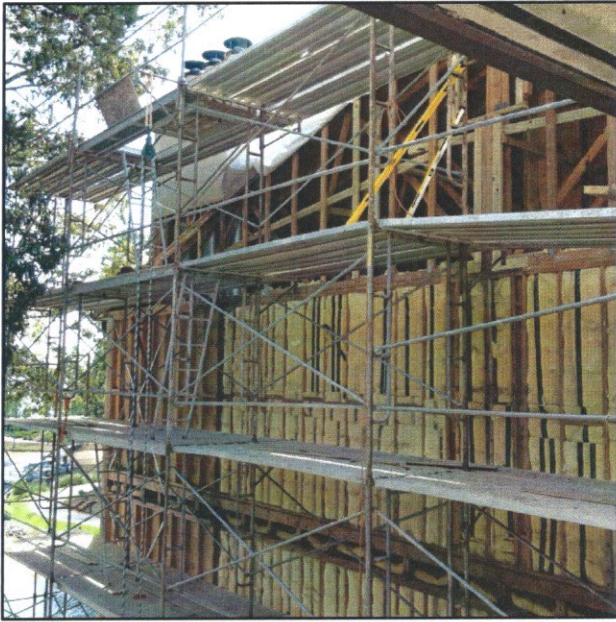
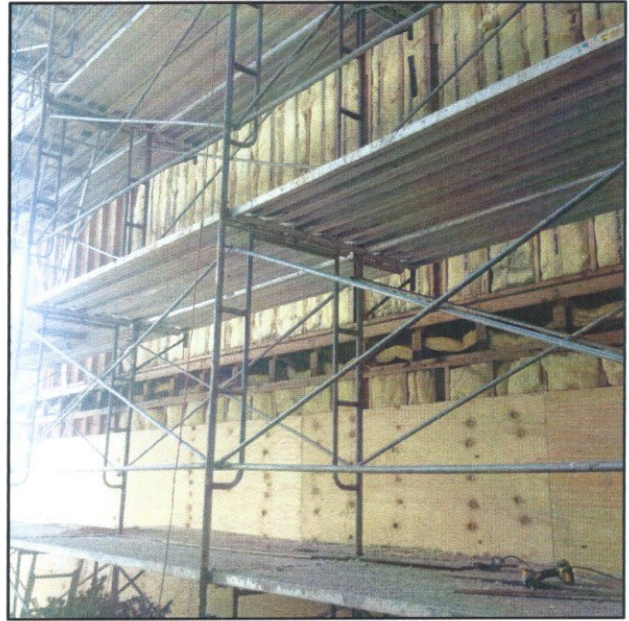
Views taken September 8, 2016.

Views of existing framing and insulation with new plywood sheathing starting at the bottom.

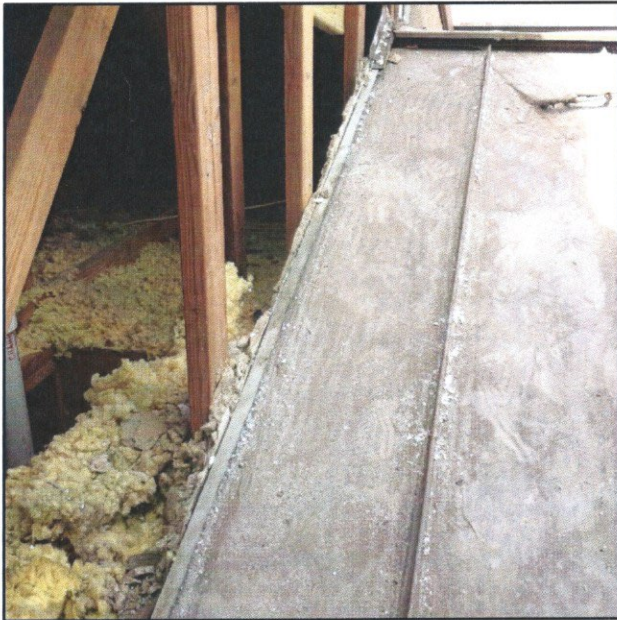
Views of roof to attic wall intersection. A new flashing detail will be developed to repair this area.

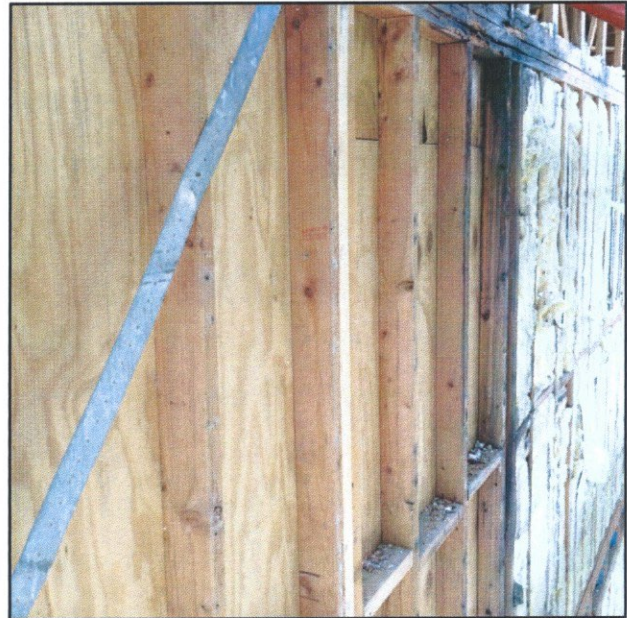
View of eastern portion of the north wall. This wall has been historically repaired at all three floors. Note that the wall insulation was not found to exist. New wall insulation will be installed.

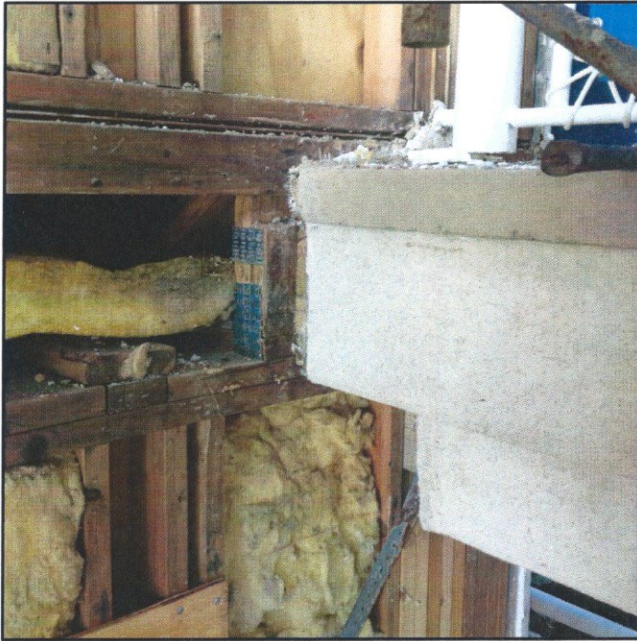
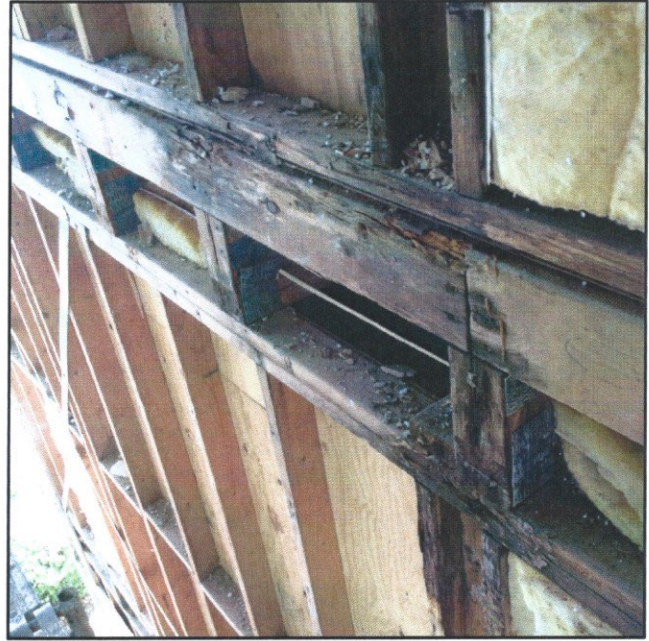
Views taken September 8, 2016.

Views of damaged framing at floor to wall intersection and below the attic louver. This framing will be replaced.

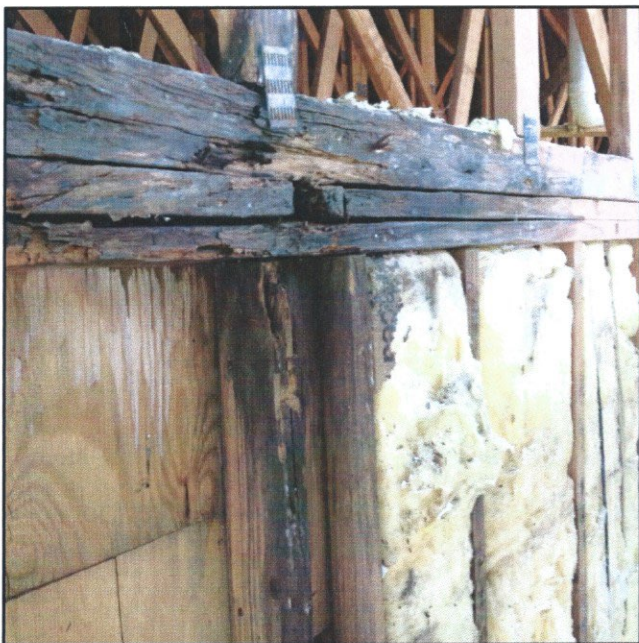
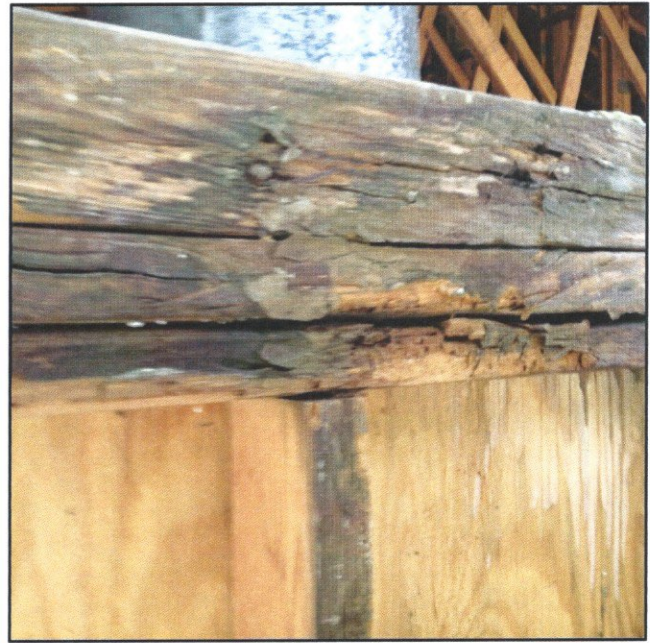
Views of damage framing at the wall behind the chimney. This framing will be replaced.

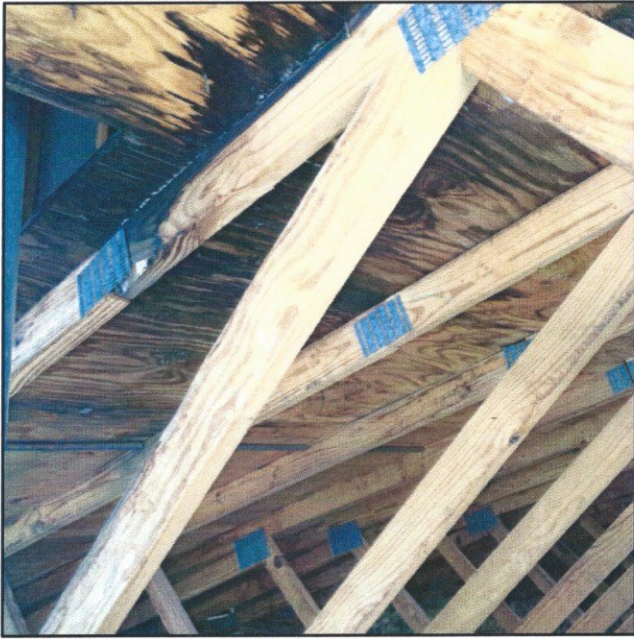
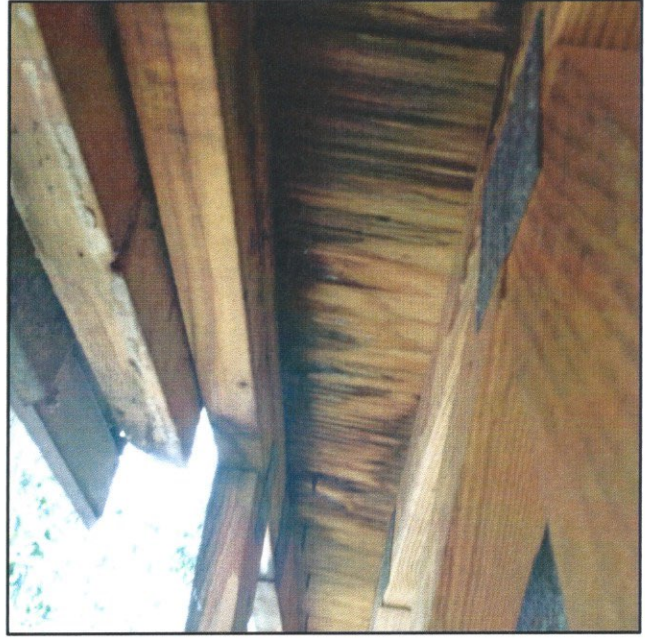
Views taken September 8, 2016.

Views of historic moisture staining to the roof deck boards at the chimney over Unit 310. The roof to chimney intersection was repaired during the previous work at the chimney's for the Frigate Building.

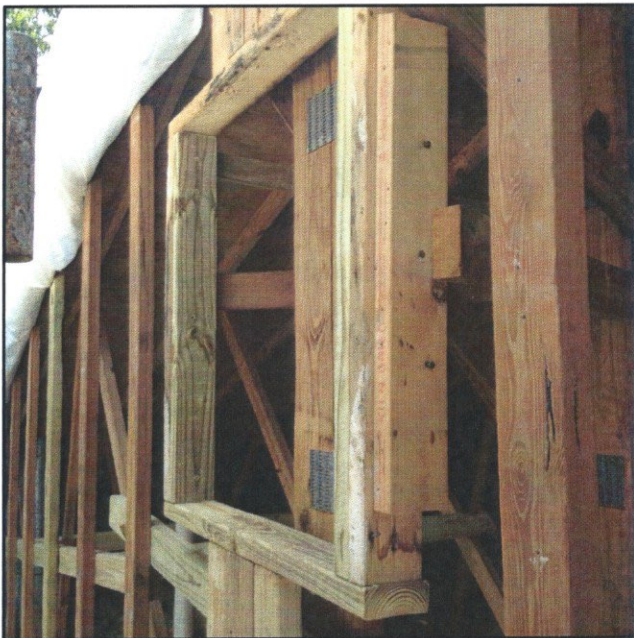
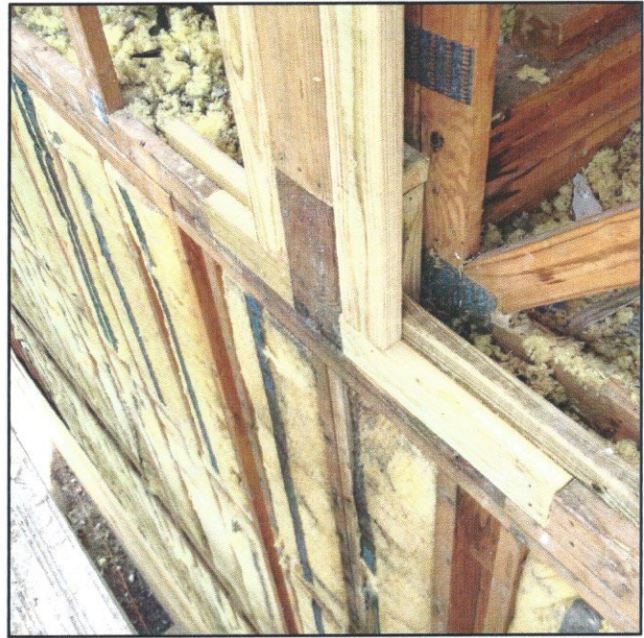
Views of new framing repair in progress at and below the attic louver.
