Summary Progress Report No. 2
For
Repairs for
Emergency Repairs to Schooner / Frigate
Tall Ships Condominium Project
Salem, South Carolina

MCA Architecture, Inc.
Forensics Division
October 10, 2016
MCA Project No. F11705.J

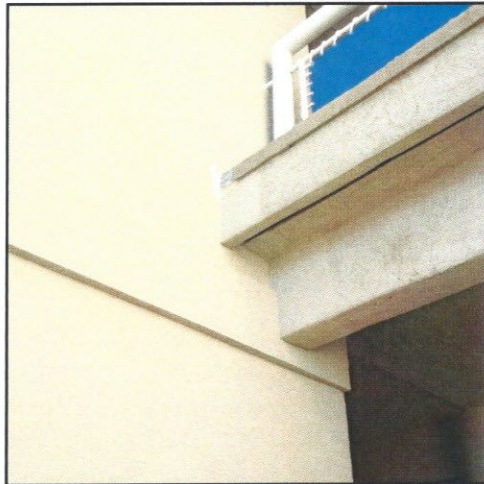
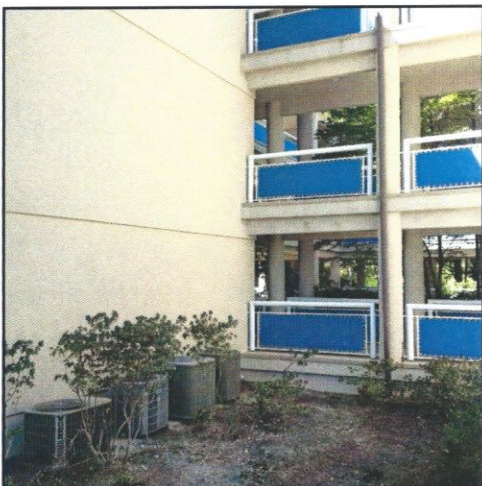
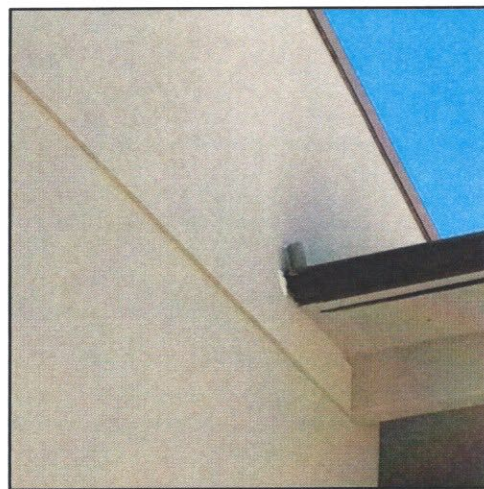
Views taken at Frigate Building September 21, 2016.

Views of the finished work at the north wall of Units 110, 210 and 310.

At the Frigate building north wall, scaffolding erection started August 4, 2016. Demolition work was completed on September 7, 2016. Framing rot repair is in progress. New plywood sheathing, gold coat waterproofing, foam board insulation and the EIFS finish system is complete. New copper flashing was installed at critical intersections of the wall to floor and wall to chimney.

At the Frigate building north wall the demolition work exposed multiple areas of moisture intrusion and wood rot similar to the previous building end walls. Moisture intrusion at the north wall was occurring at the intersection of roof and walkway floors, attic louver and chimney to wall intersection.

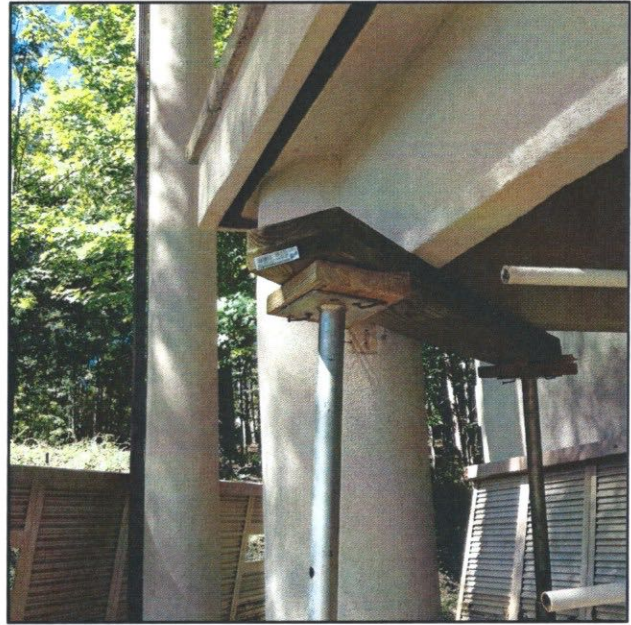
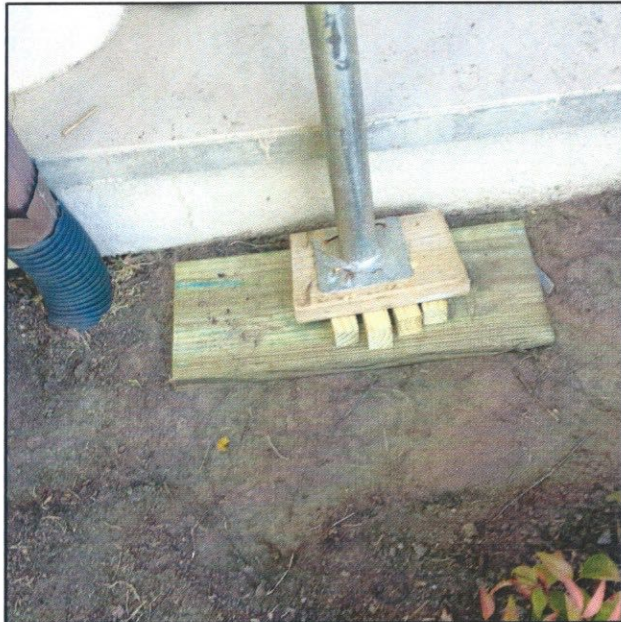
Views taken at Schooner Building September 21, 2016.

Views of shoring posts installation in progress.

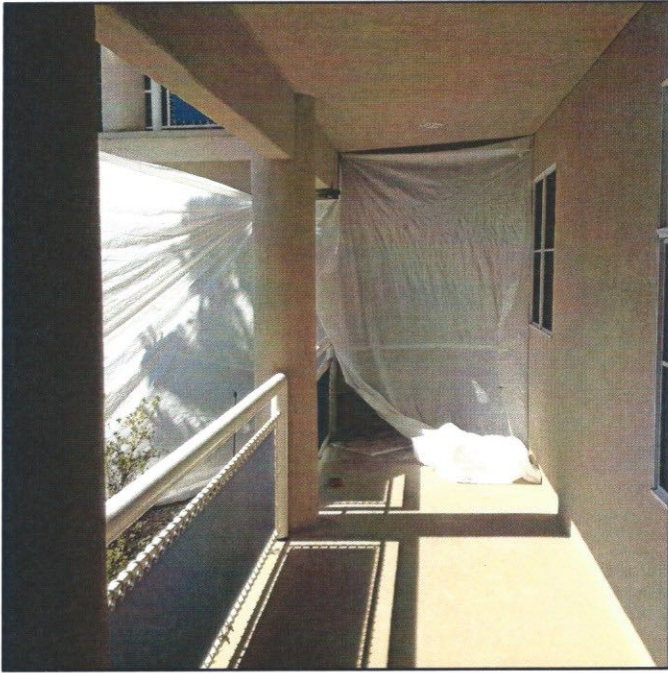
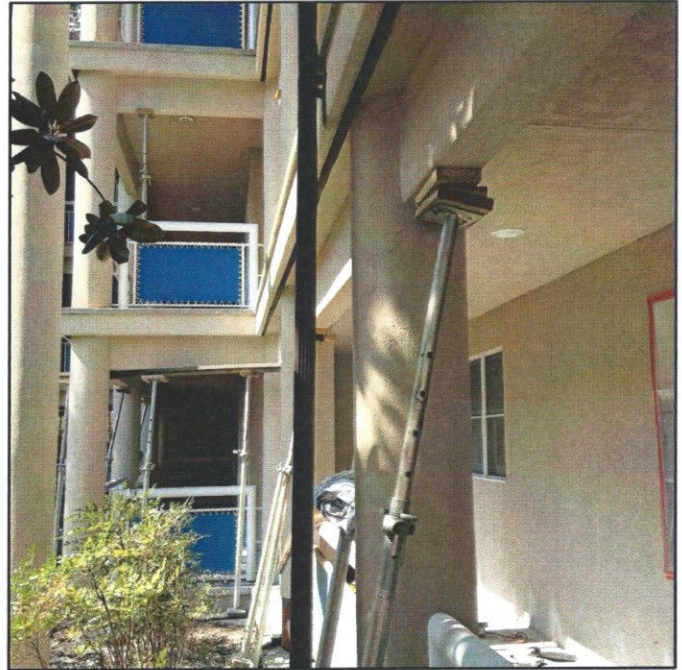
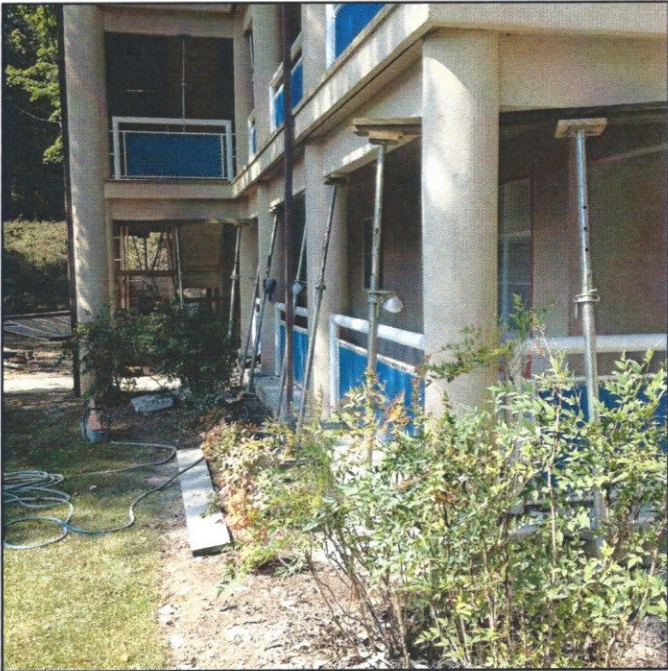
Views taken at Schooner Building September 26, 2016.

Views of shoring systems secured in place. Temporary dust barriers are in place.

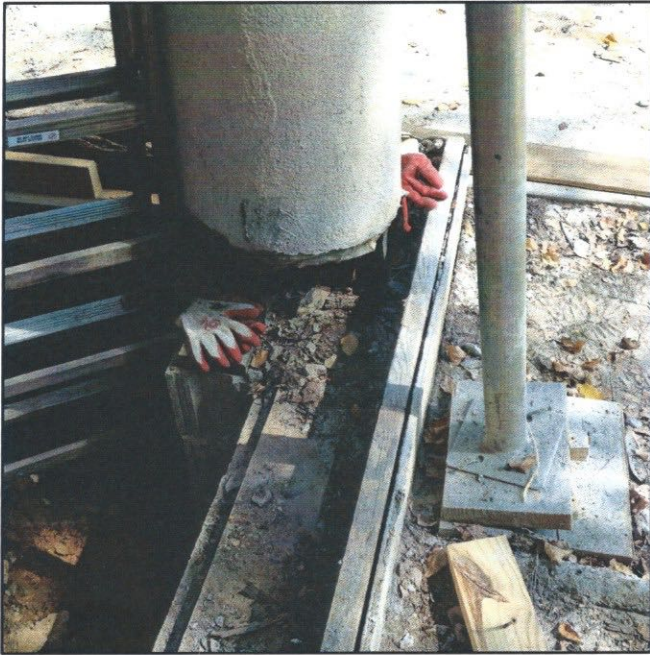
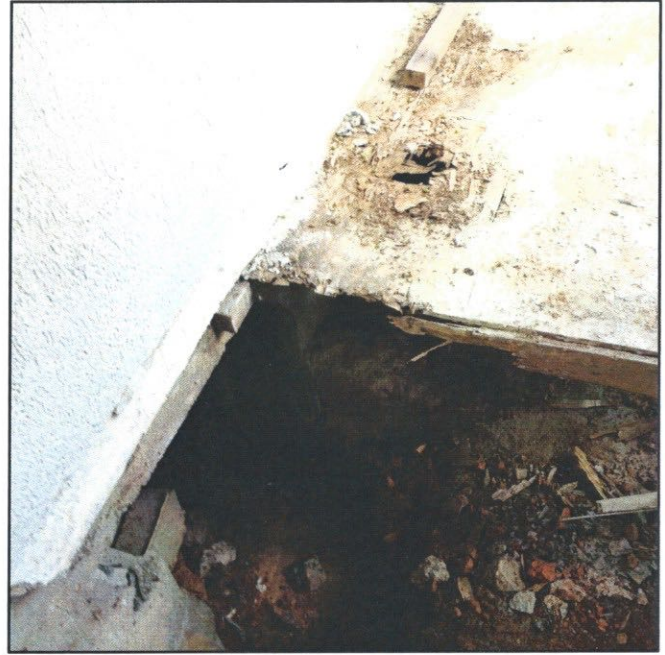
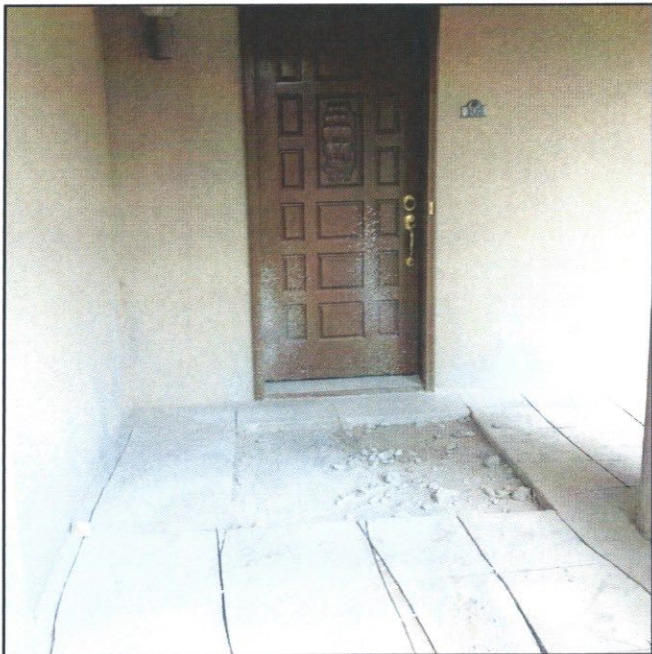
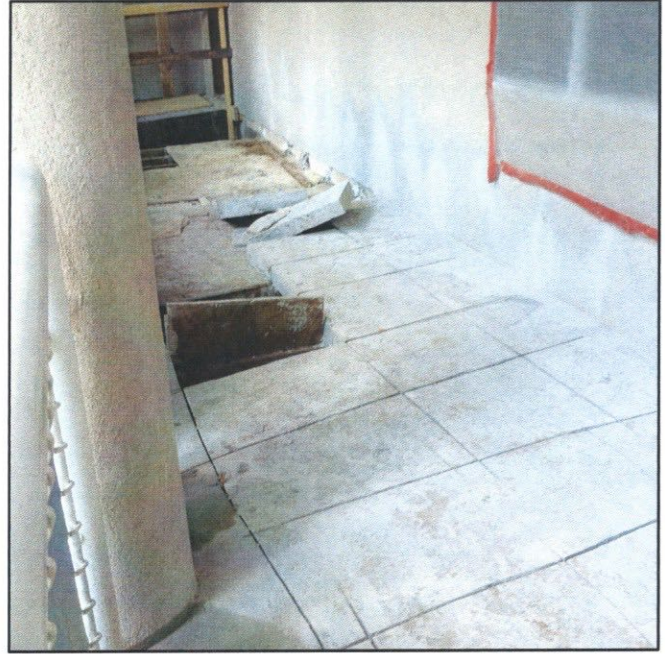
Views taken at Schooner Building September 26, 2016.

Views of rotted wood framing and concrete removal in progress.

The work at the Schooner building first floor started the week of September 26, 2016. Structural shoring was installed at each column location. The existing concrete floor was removed. The existing earth crawlspace was exposed. A substantial amount of wood framing was found rotted and damaged by infestation of termites. All damaged wood framing has been removed. The existing concrete masonry foundation walls have been repaired and reinforced.

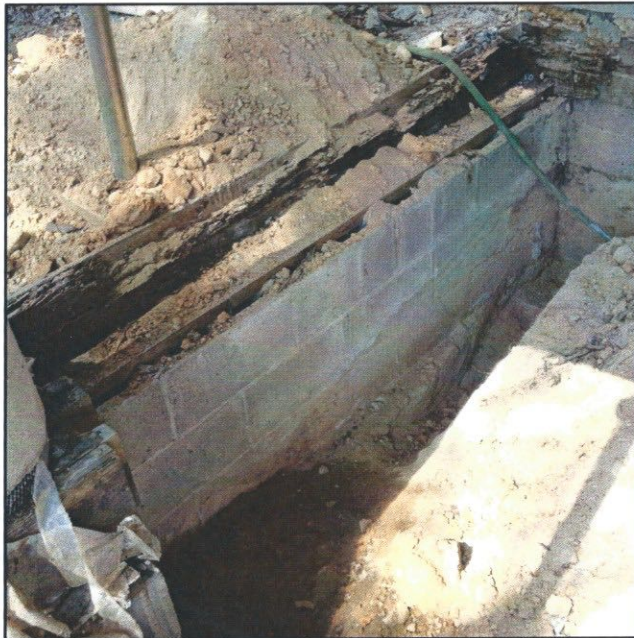
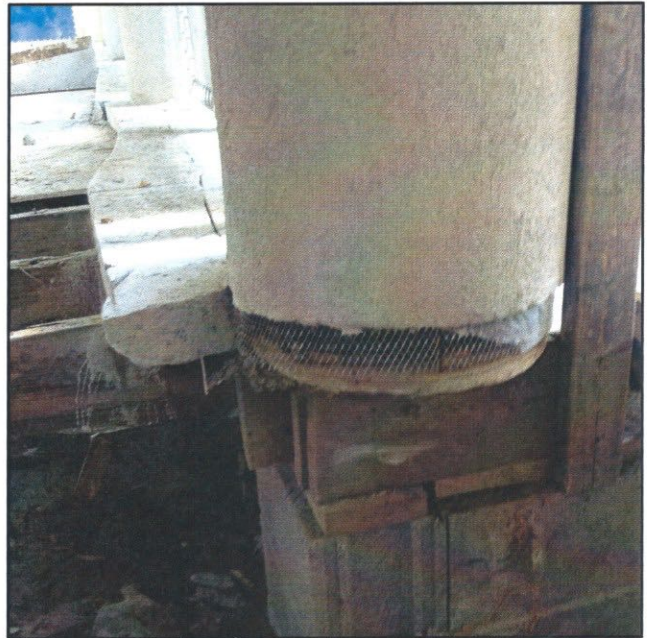
Views taken at Schooner Building September 26, 2016.

Views of temporary access walkway to Unit 101. Views of deteriorated wood condition under columns and at wall.

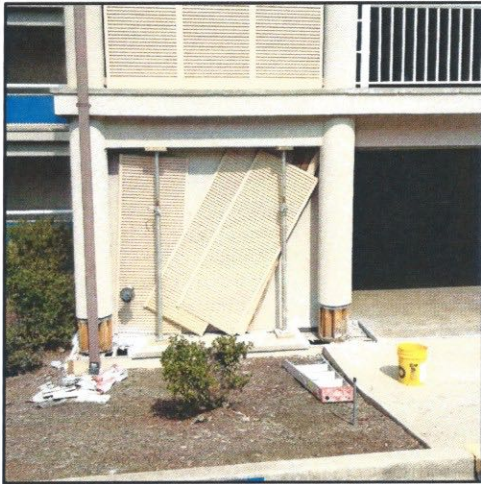
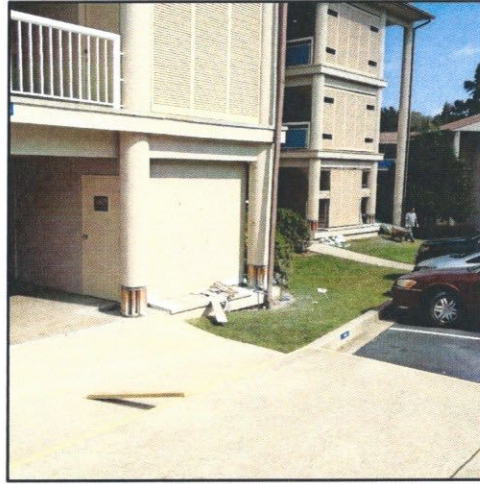
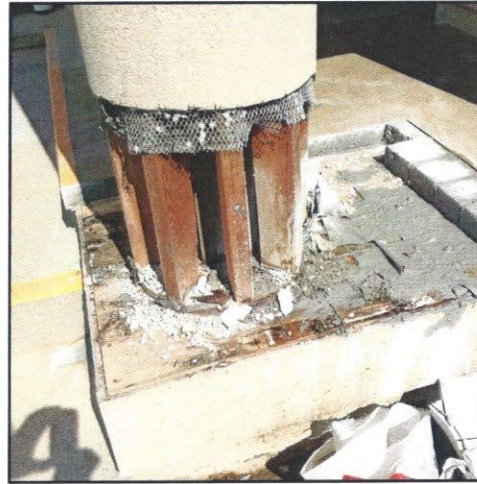
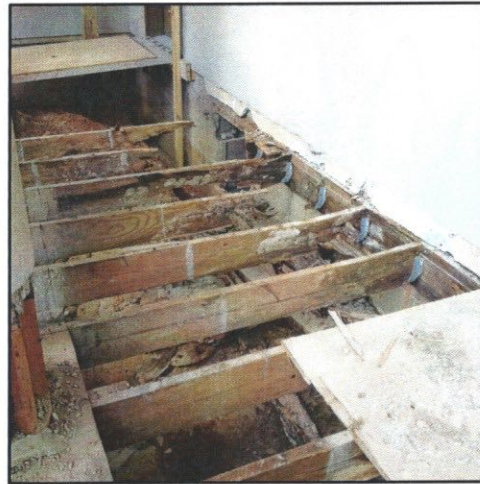
Views taken at Schooner Building September 28, 2016.

Views of work in progress at column bases and removal of floor wood framing.

The repairs to the 18 stucco and wood columns and the two columns at Clipper Building are in progress.

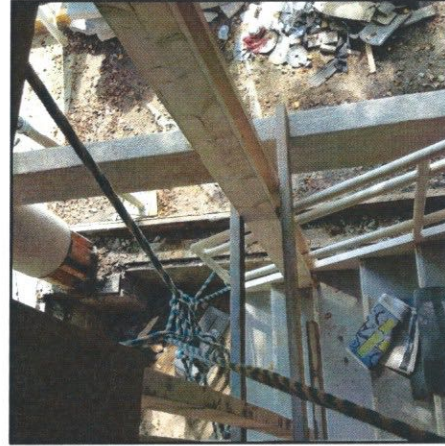
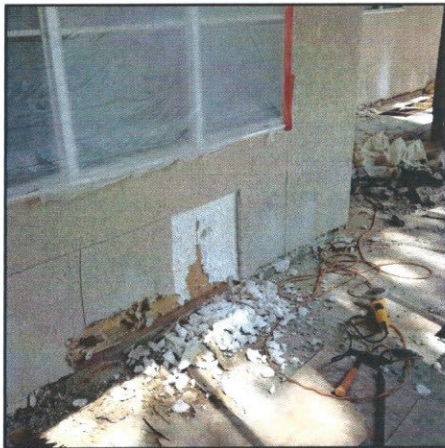
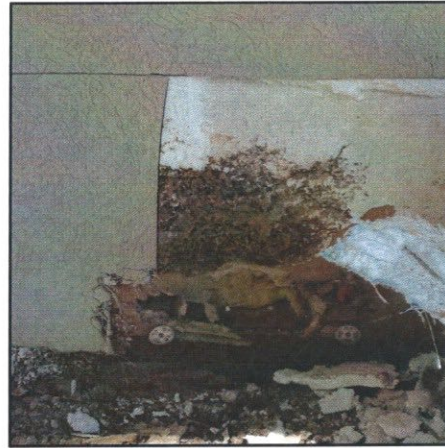
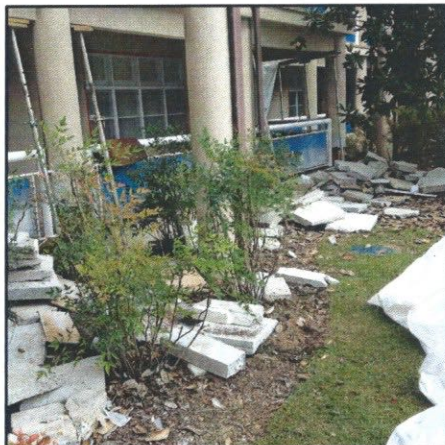
Views taken at Schooner Building September 28, 2016.

Views of temporary support for existing stair. Evidence of an abandoned termite home in the existing foam board of the wall. Views of concrete removal and delivery of new washed stone fill material. Termite treatment will be applied to all soil before gravel is spread.

New washed stone gravel has been installed to support the new concrete floor slab. Reinforcing mesh and bars have been installed in preparation for the new concrete floor slab on grade. Wood forming work for the new floor slab edge is in progress.
